# An Investigation of the Remains of the Confederate Gunboat *CSS Chattahoochee*

Produced for  
The James W. Woodruff, Jr.  
Confederate Naval Museum  
Columbus, Georgia

Produced by  
Gordon P. Watts, Jr.,  
Richard Stephenson,  
William N. Still, Jr.,  
Wesley K. Hall,  
Bradley A. Rodgers  
Kathryn Bequette  
David Beard  
Kevin Foster

The Program in  
Maritime History  
and Underwater Research  
Greenville, North Carolina 27858  
1990

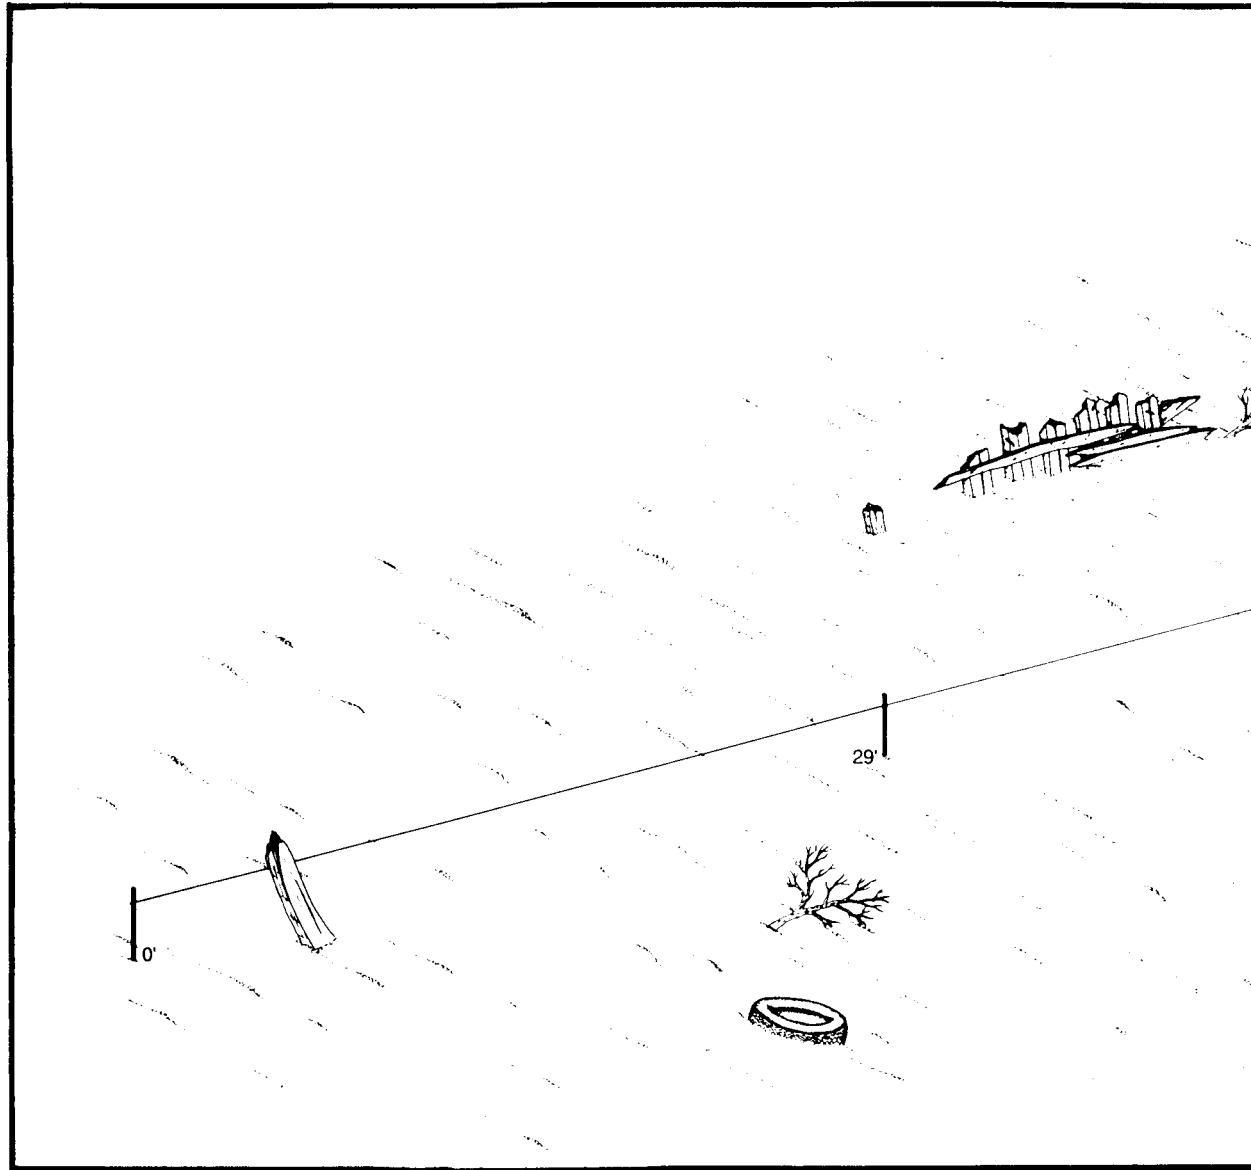
Examination of the final magnetic target site confirmed that the signature was associated with the remains of a vessel (Figure 11). The site was buoyed and a more detailed investigation carried out to determine if the wreck could be the CSS *Chattahoochee*. A brief reconnaissance of the exposed structure established that the wreckage consisted of the lower hull of a wooden ship and confirmed that a substantial portion of the bow or stern was missing. Exposed sections of the vessel's keel, frames, and bilge ceiling were found to compare favorably in size and configuration with construction details of the CSS *Chattahoochee's*

Figure 11. An Artist's Concept of the Exposed Remains of the CSS *Chattahoochee* P and Underwater Archaeology

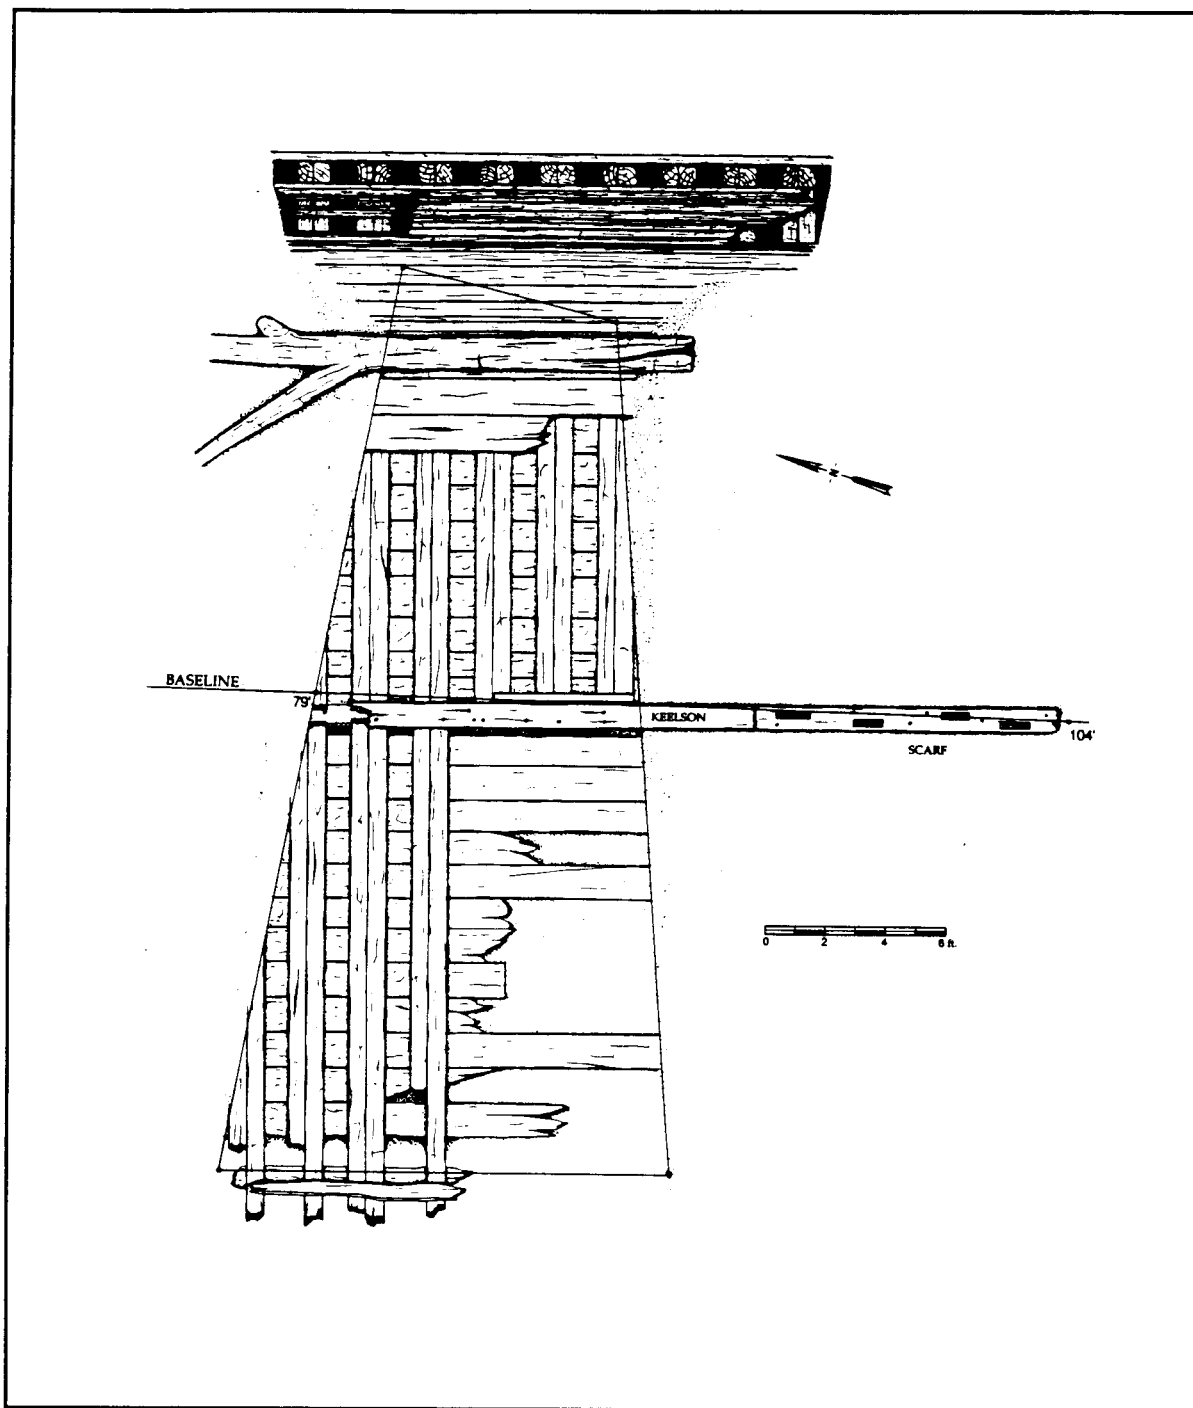
Figure 16. Plan of the Remains of the CSS *Chattahoochee* Exposed by Test Excavation.

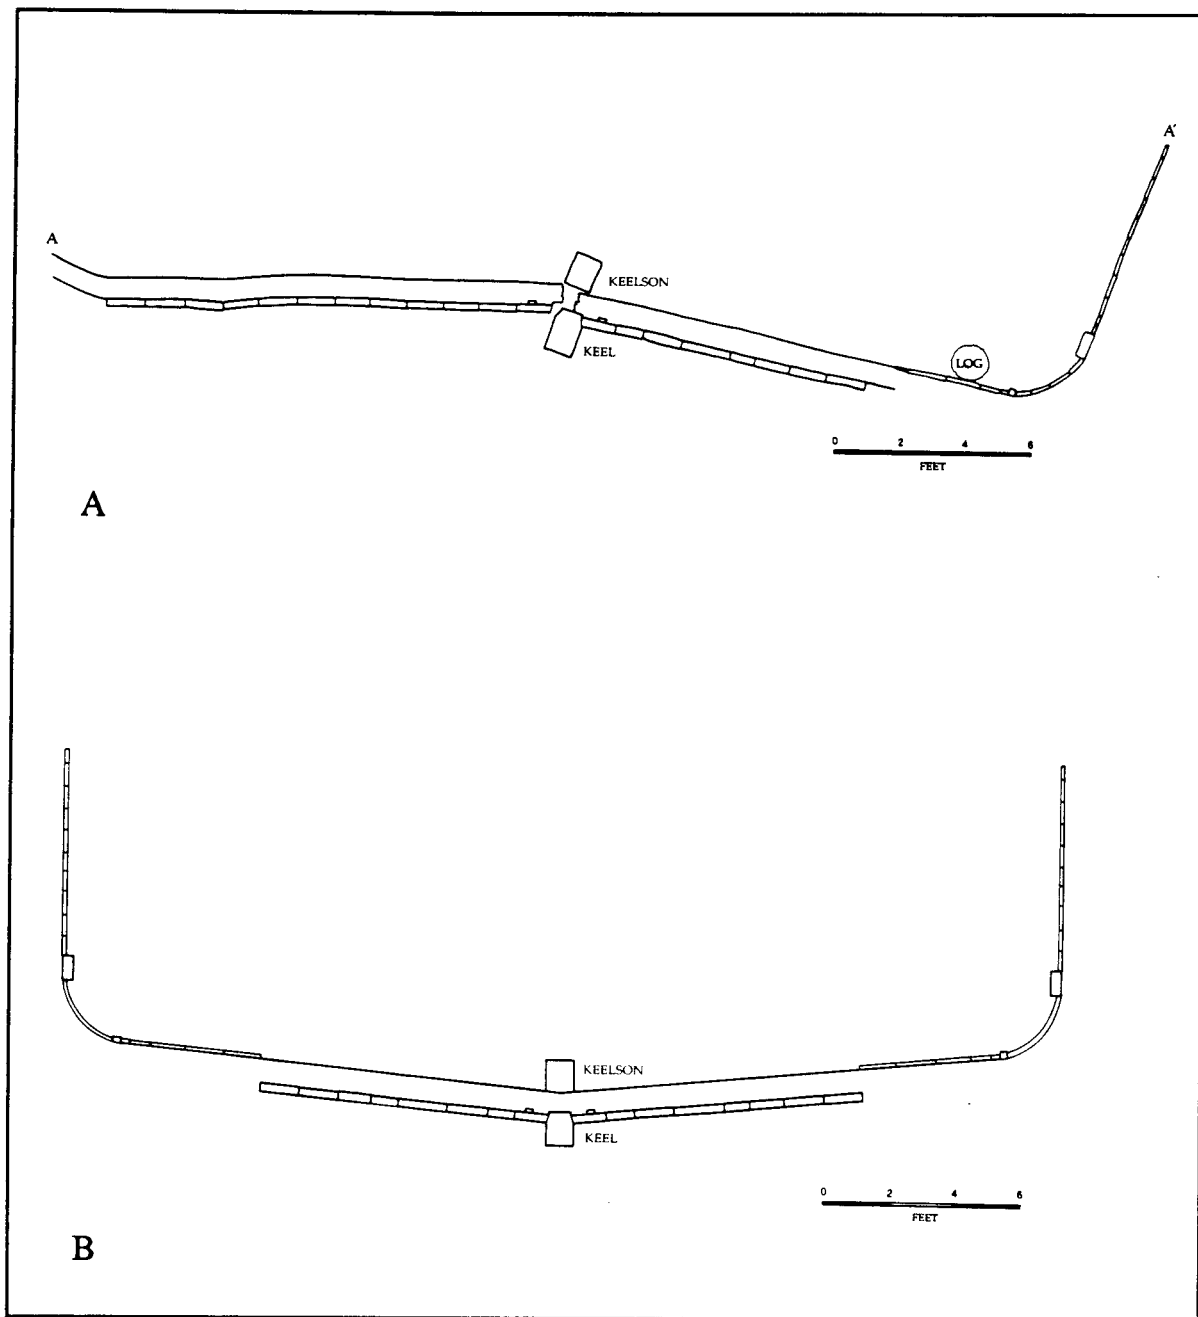
Figure 17. A: Profile of the CSS *Chattahoochee*'s Hull as Recorded on the Site.  
B: Profile of the CSS *Chattahoochee*'s hull as Reconstructed Based on Information Recovered from Surviving Structural Remains.

Systematic probing of the wreck identified the ship's stem. Although obscured by a concentration of snags and debris, the badly deteriorated remains of the stem post were located immediately southwest of the north baseline extremity. The stem was mapped *in situ* by triangulation from datum points on the baseline. Probing also located a concentration of iron shot along the keelson near the stempost. Several of the iron shot were recovered so that their size could be compared with historical records of the CSS *Chattahoochee's* ordnance.

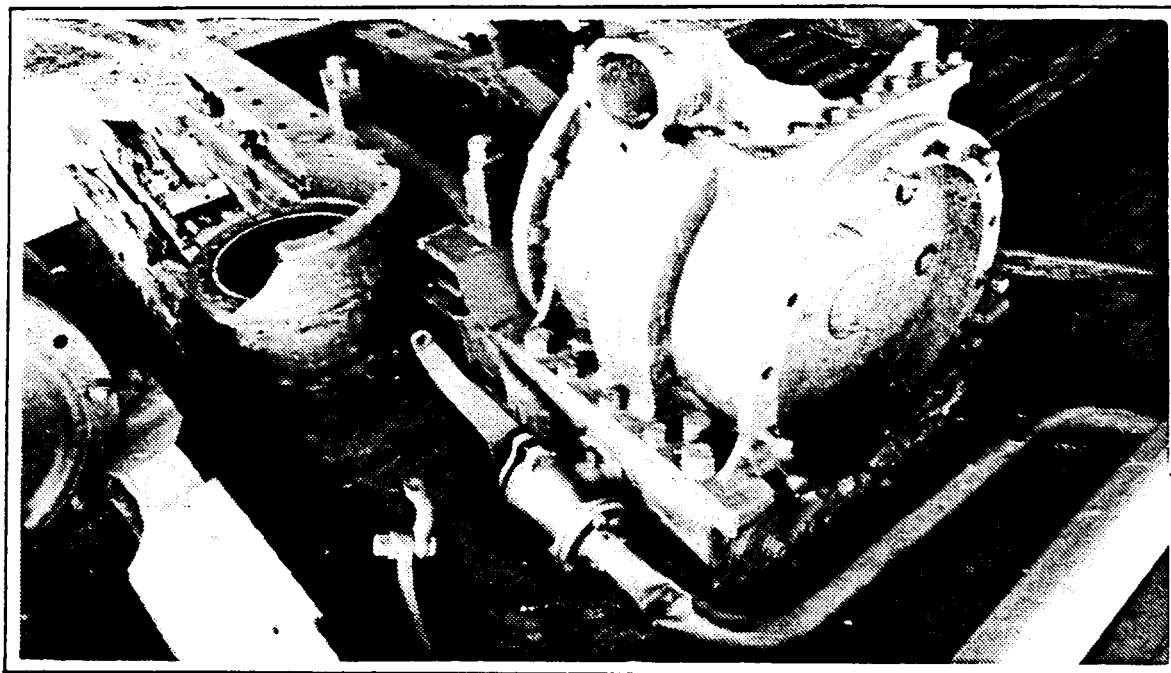
Figure 25. Starboard Steam Cylinder, Valve Chest, and Air Pump Showing Damage Done in Scuttling the *CSS Chattahoochee*.
