**Preliminary Report on the Phase I Pre-Disturbance Survey of the  
Morgan's Island Wreck Site,  
Somerset Bermuda, May 2017**

Bradley A. Rodgers, Ph.D.  
Program in Maritime Studies  
East Carolina University

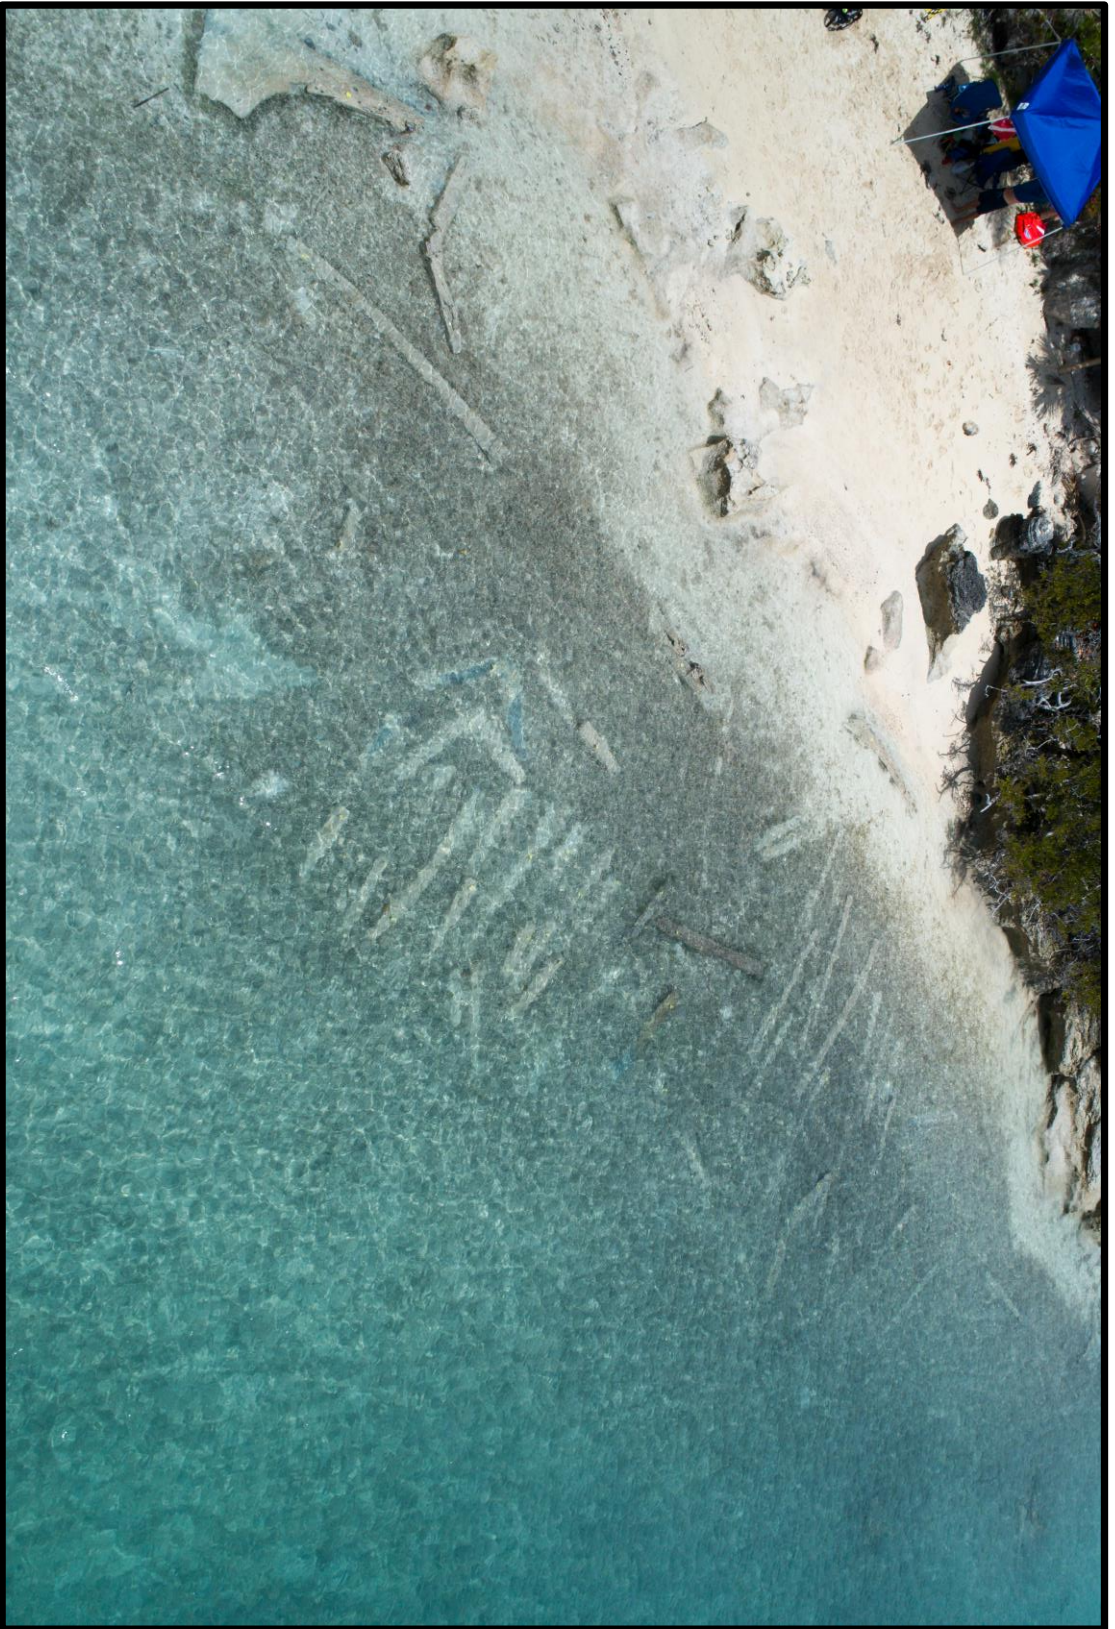
**Figure 1.** An aerial view of the wreck site at Morgan's Island. While it is difficult to confirm due to the disarticulation of the wreck, the stern appears to be to the left in the photo (identified by the rudder) and the articulated bow section is out of the photo to the right.

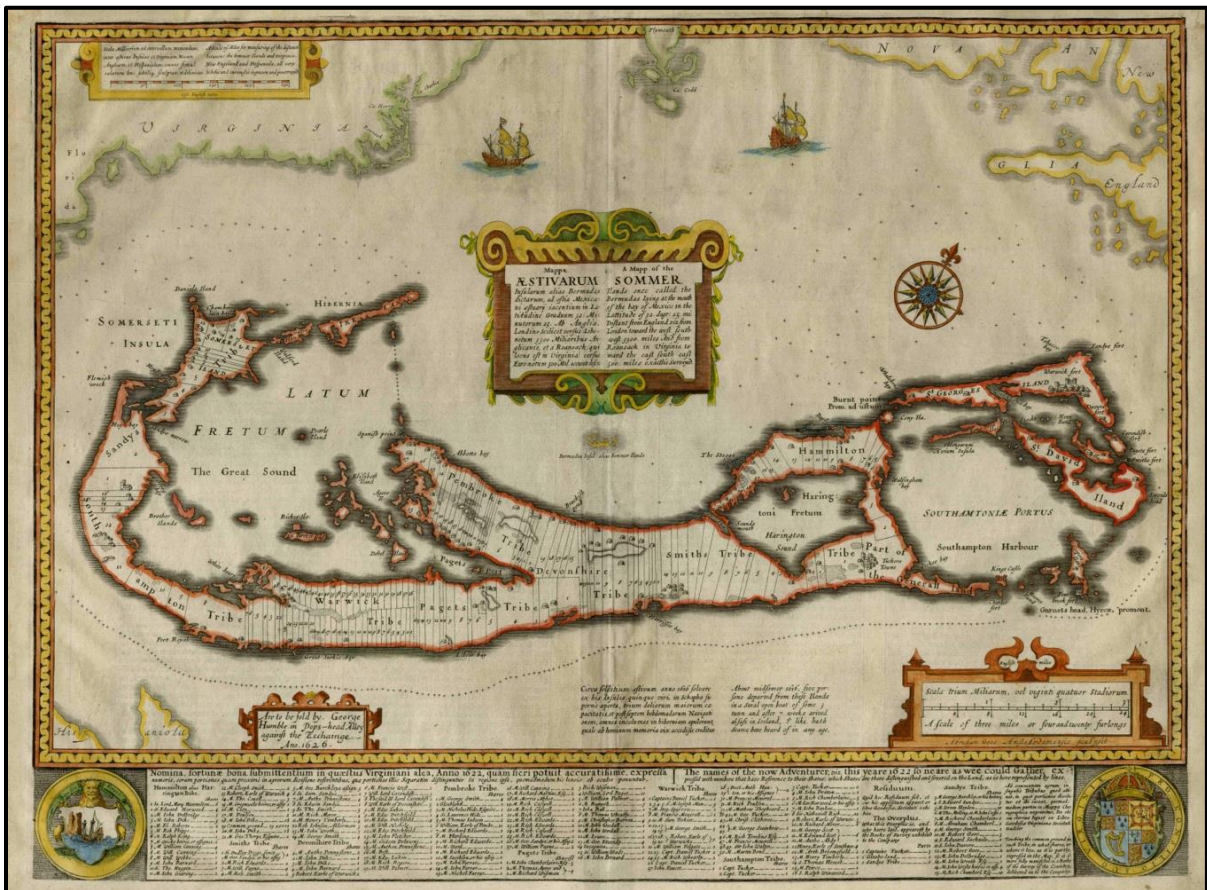
**Figure 2.** A Mapp of the Sommer Ilands, Once Called the Bermudas, published by John Speed, 1626/27

In Norwood’s detailed island map of 1626 is a cryptic description of a “Flemish Wreck” just below Wreck Hill (figures 2 and 3). Archaeological surveys and hydrographic maps, indicate that it would be unlikely that an intact ship – even one in the process of wrecking – could make it over the reef to be deposited that close to Wreck Hill. It can be theorized, however, that a buoyant hull fracture (floating portion of a ship) became separated from the vessel and may have floated in over the reef only to disintegrate near Wreck Hill. What is important historically, is that the loss of the “Flemish Wreck” of 1616, is a distinct event from that of the Dutch pinnacle which disappeared in 1619. Thus, there should be two distinct Dutch-built vessel remains located near the West Reef and Wreck Hill - the Flemish Wreck (on or before 1616) and the Dutch pinnacle (1619). As research continues, historical and archival sources will no doubt prove invaluable in providing information related to the Morgan’s Island site. Future investigations of historic sources held in archives in the Netherlands, as well as the Port Royal records housed in The National Archives in London, could confirm the activities of the Dutch pinnacle, perhaps find its name, and possibly locate accounts of the marooned sailors once they returned home from Bermuda.

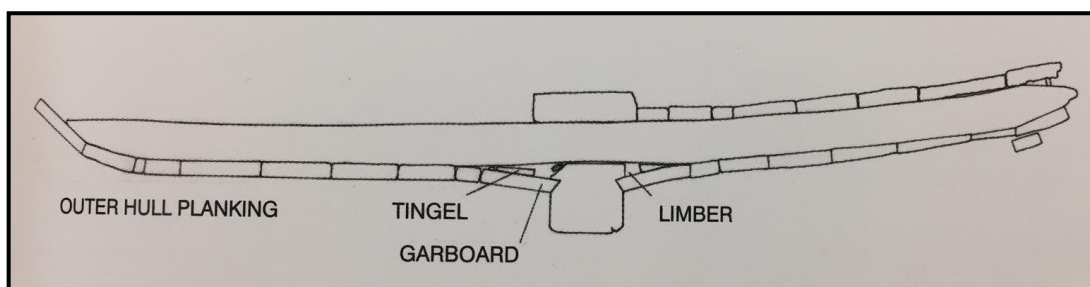
**Figure 5.** Flat bottom construction of New Old Spaniard (Watts 2014:111).

The closest known relative to this vessel was also wrecked on Bermuda’s western reefs and is known as the New Old Spaniard (NOS). Representing the possible remains of a late 16<sup>th</sup> or early 17<sup>th</sup> century Dutch-built ship, this site was found and investigated by Teddy Tucker and Mendel Peterson in the 1960s and subsequently investigated by archaeologists from the Smithsonian Institute and later East Carolina University (Watts 2014:109-112). The experience of having previously worked on this site allowed me to better visualize how the flat bottom of the ship was designed and why there were no limbers – channels cut into floor timbers that allowed water to drain into the pump well (Steffy 1994:274) (figure 5).

triangular filler pieces called tingles (figure 5).

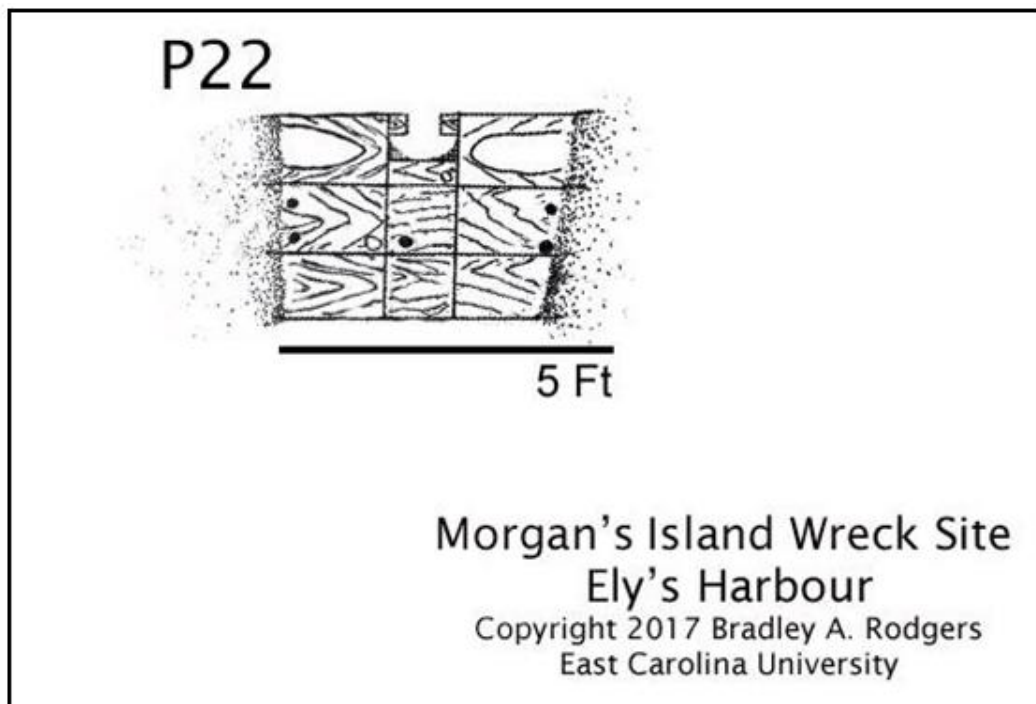
**Figure 6.** Morgan's Island Wreck timber feature P22, which is possibly a triple buttressed mast support structure.

*Buttressed mast support timbers (P22 and P4):* The most salient and diagnostic features of the Morgan's Island wreck are perhaps the mast step partners; one large, three-buttressed step support feature (figures 6, 7 & 8) and a smaller, single-buttressed step support feature (figure 9, 10 & 11). First appearing in the archaeological record in the mid-15<sup>th</sup> century, buttressed mast steps remained a fixture on ships of all nationalities until 1600, when they were quickly replaced by other designs. The existence of buttressed mast supports on the Morgan's Island Wreck may indicate that the ship was built in the 16<sup>th</sup> century, or that the importance of this mast step tradition lasted longer than previously thought.

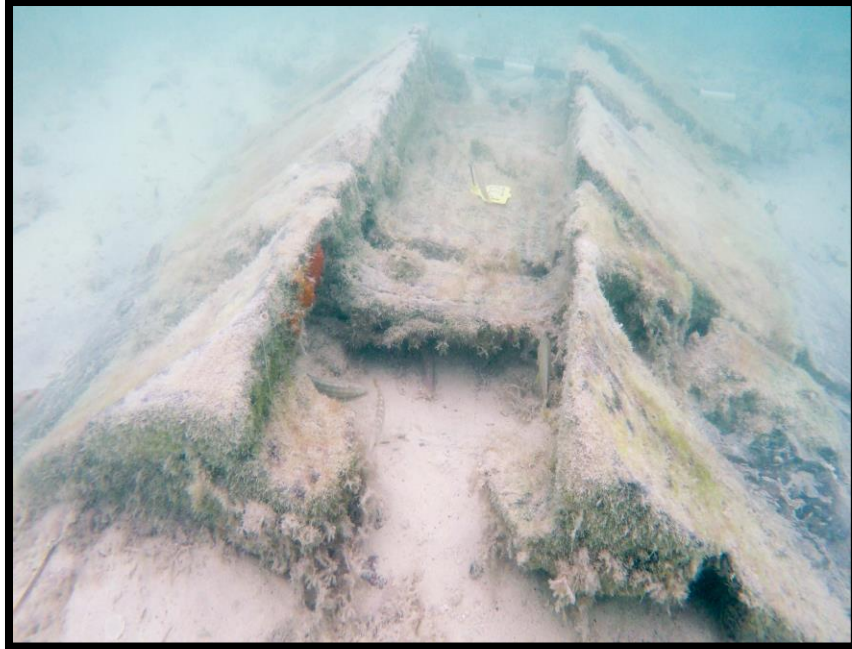
**Figure 7.** Morgan's Island Wreck timber feature P22. Note deterioration of southernmost of the three buttress pieces.

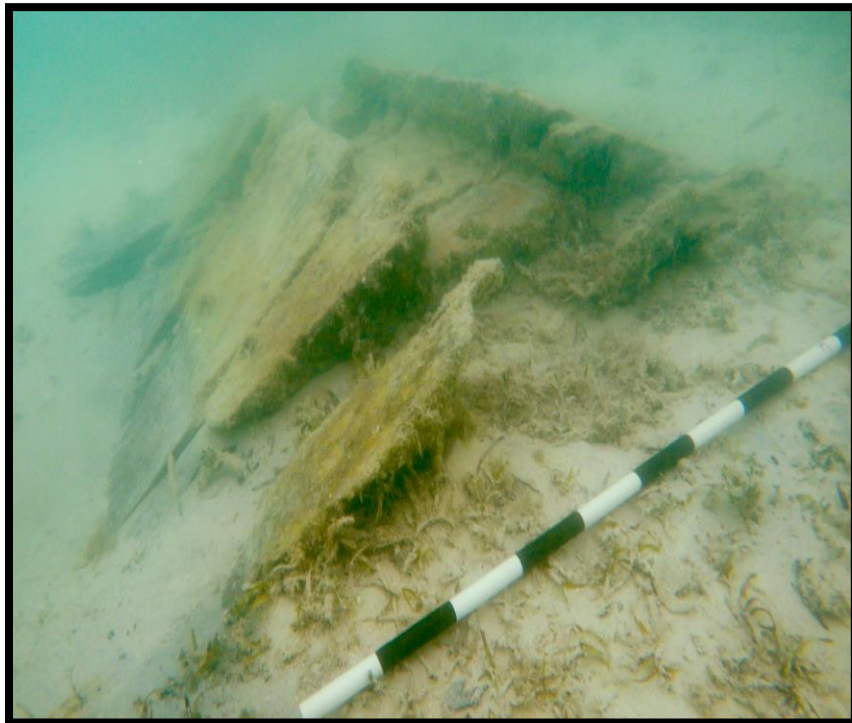
**Figure 8.** North facing photograph of Morgan's Island Wreck timber feature P22.

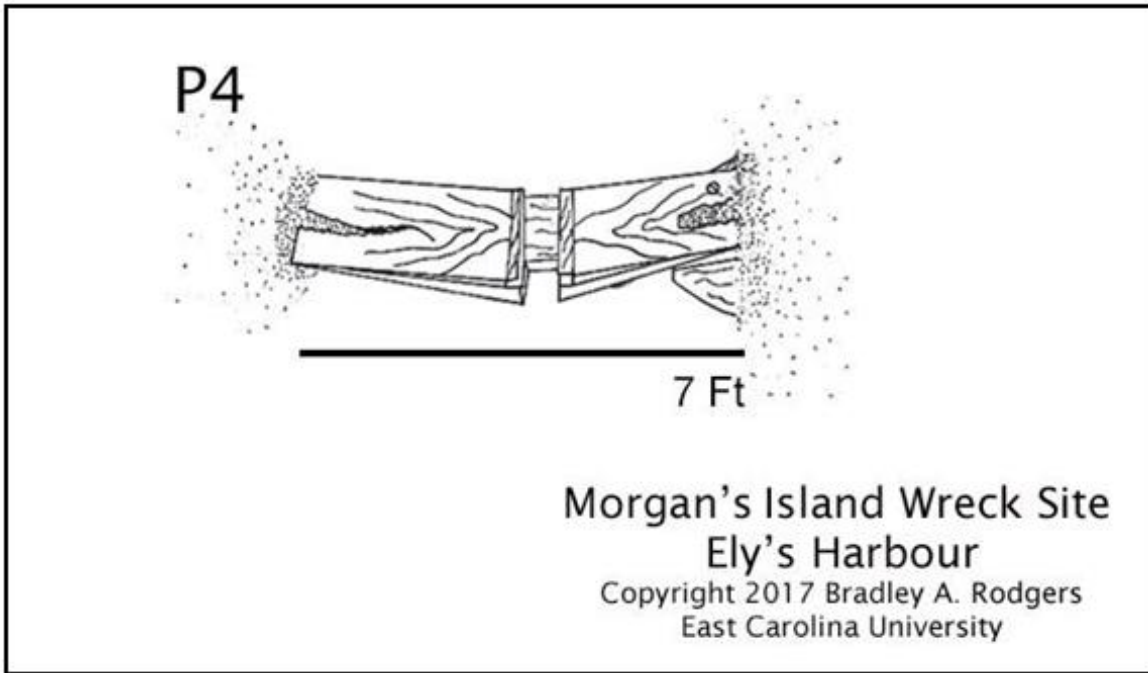
**Figure 9.** Illustration of Morgan's Island Wreck timber feature P4, which is possibly a single buttressed mast support structure.

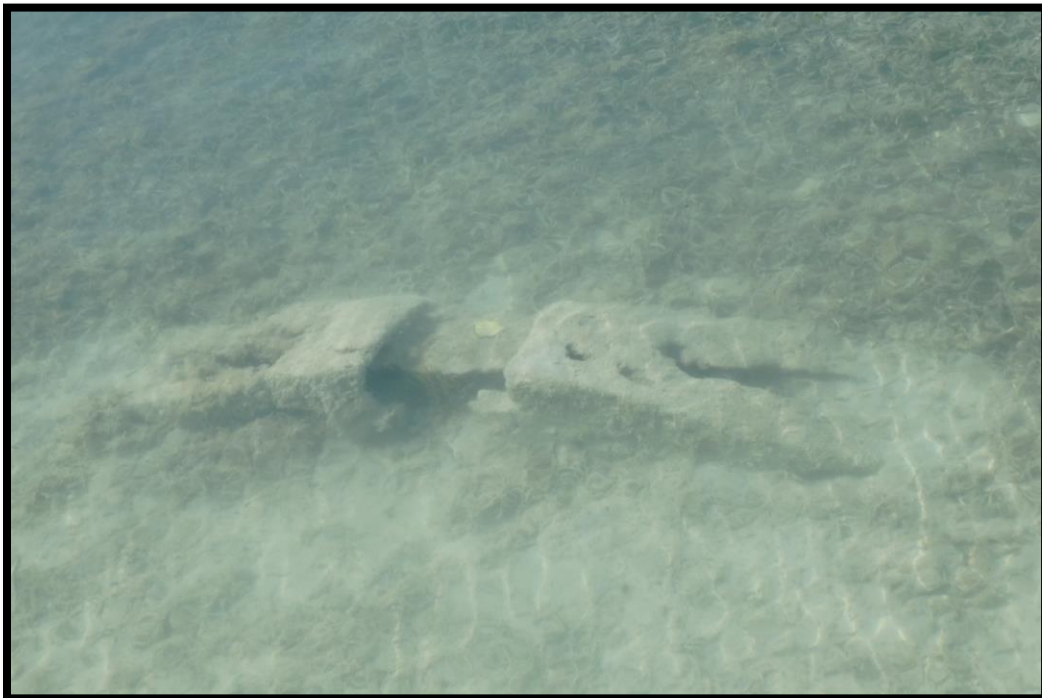
**Figure 10.** Morgan's Island Wreck timber feature P4, it is unclear if the buttressed mast supports are double or split timbers.

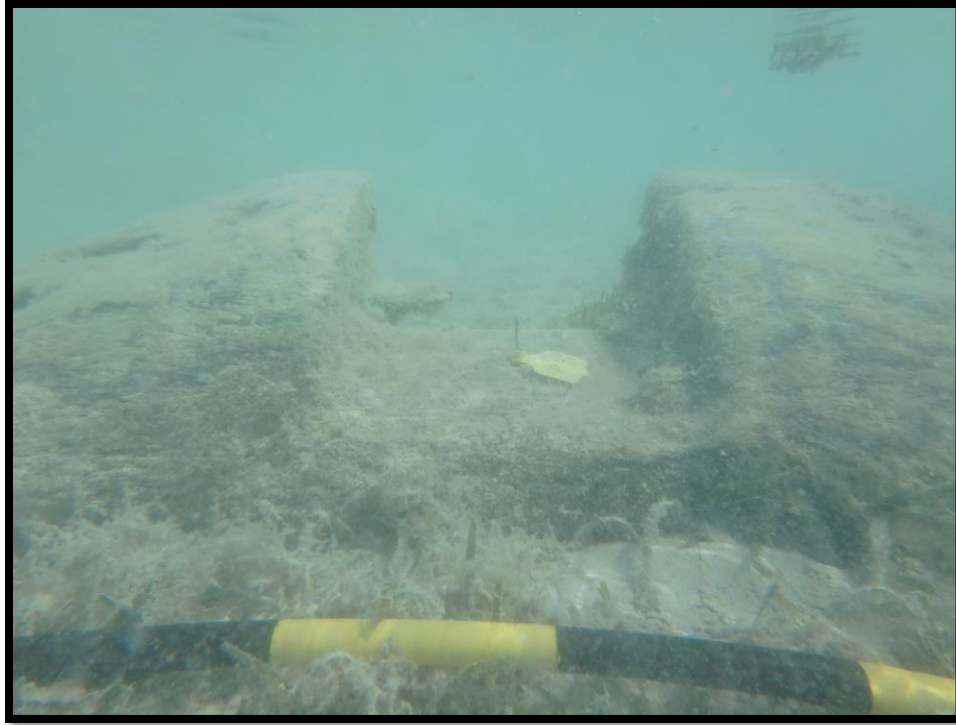
**Figure 11.** Morgan's Island Wreck timber feature P4; note rounded edge on face.

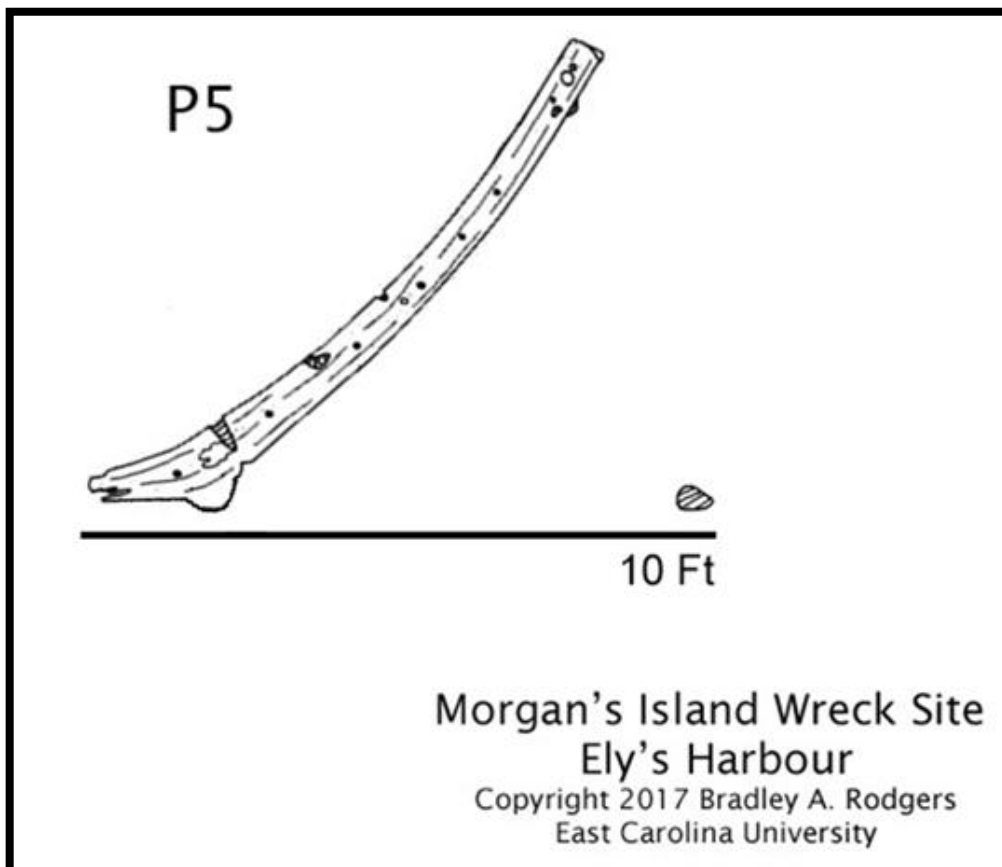
**Figure 12.** Morgan's Island Wreck timber P5, a futtock timber.

*Futtock Timber (P5) and Floor Timber (P25):* Possibly the most important evidence concerning the Morgan's Island Wreck site began to take shape when the detailed drawings of individual scantling timbers were completed. The first inkling of the shape of the Morgan's Island ship came from the careful observation of timber P5 (figure 12). This timber is a well-preserved transitional futtock that connected a floor, or where the ship turns at the bilge, to where the ship begins to tumble home. It was marked with fasteners for trunnels and iron nails on all four sides.

Furthermore, there were two very unusual things about P5. First, as it curved down to the turn of the bilge it contained a bulbous knob that would have protruded out from the chine. Second, at the chine the futtock still contained the cut surface where it lap scarfed with the floor to form the bottom of the ship. The angle of the lap joint with the floor showed that the bottom of the ship turned at nearly 130 degrees from the chine, which gave the vessel an almost completely flat bottom and gently outward sloping sides. This is a very unusual way to build a ship and indicates its northern European origin

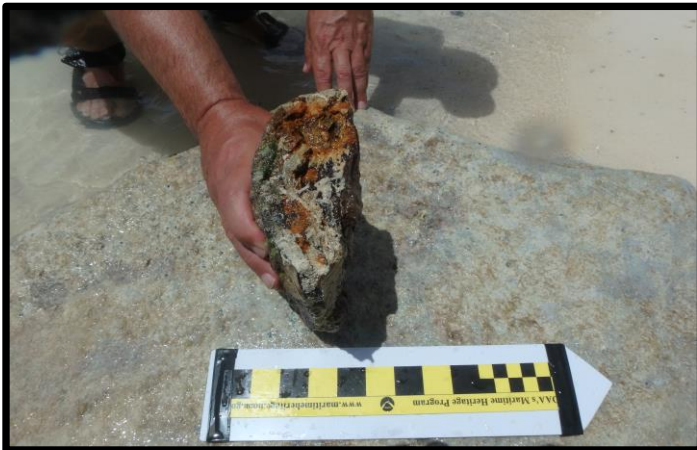
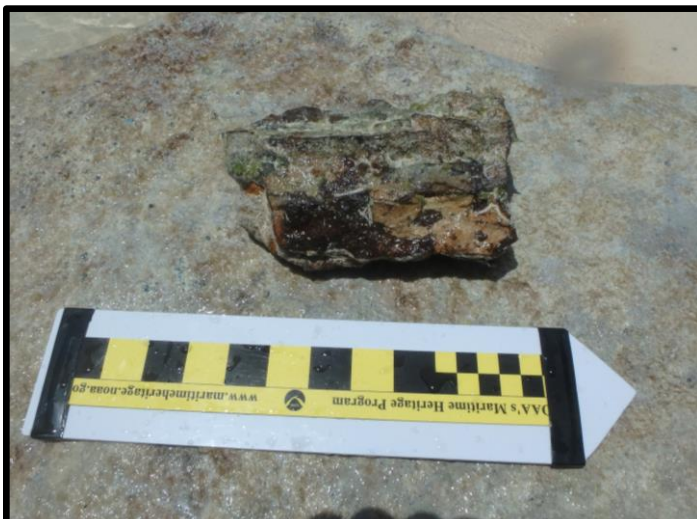
### P5 Concretion Measurements

**Figure 13.** Concretion associated with timber P5, dimensions indicate the room and space of the floor/futtock timbers. Interior of concretion contains an iron fastener. The cross section (top) shows the "D" shaped chine knob.

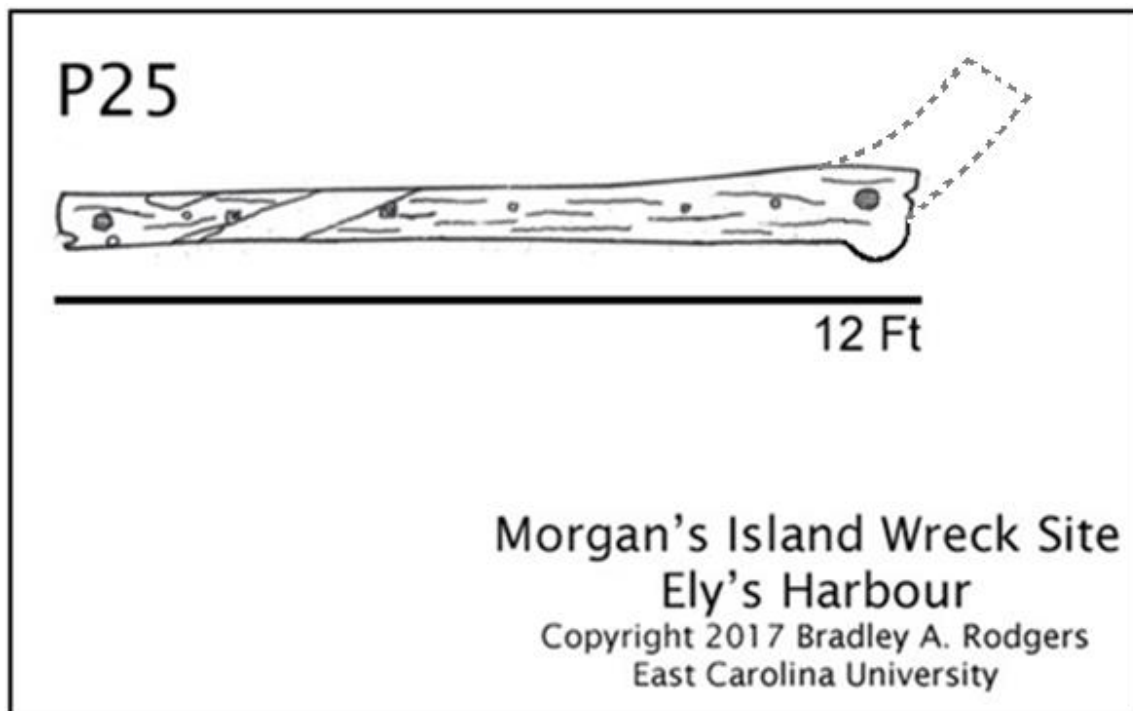
**Figure 14.** Morgan's Island Wreck timber P25, a floor timber.

It was also noticed that the bulbous knob described above as an unusual feature on P5 was reflected in timber P25, though P25 was certainly not a futtock. Timber P25 (figure 14), nearly straight in appearance, is a very long and heavy timber with fastener marks on all four surfaces. With the help of a paper cutout of both pieces it could be seen that when the bulbous knobs were aligned at the turn of the bilge, P25 became a straight, flat floor timber situated 130 degrees from the side of the ship. As further evidence that this is how the floor and futtock were attached to one another, a fastener concretion was found near P5 that had obviously lain for some time in the bilge at the chine (figure 13). Because it was iron, it had concreted and corroded to expand and fill the space between the futtocks. This concretion gave us the shape of the chine, and its measurements as well as the space between the futtocks (0.6 feet). It was "D" shaped in cross section giving us a perfect mold of the bulb or knob at the turn of the bilge. This bulb was likely planked with a single heavy plank with the interior scooped to contain the bulb shape. Thus, the bottom of the ship represented by the Morgan's Island Wreck remains was almost entirely flat.

The one problem with P25 being a floor was that it had no limber holes. Limber holes were channels cut into timbers that allowed water to run to the pump well for removal via the bilge pump. In northern European ship construction timbers, however, limbers were naturally formed by rabbeting the garboard strake further down on the keel, thus allowing for two triangular limbers to form below the floors and removing the need for notching. A good example of this can be seen on the NOS shipwreck site, where the garboard and natural limbers are further supported with

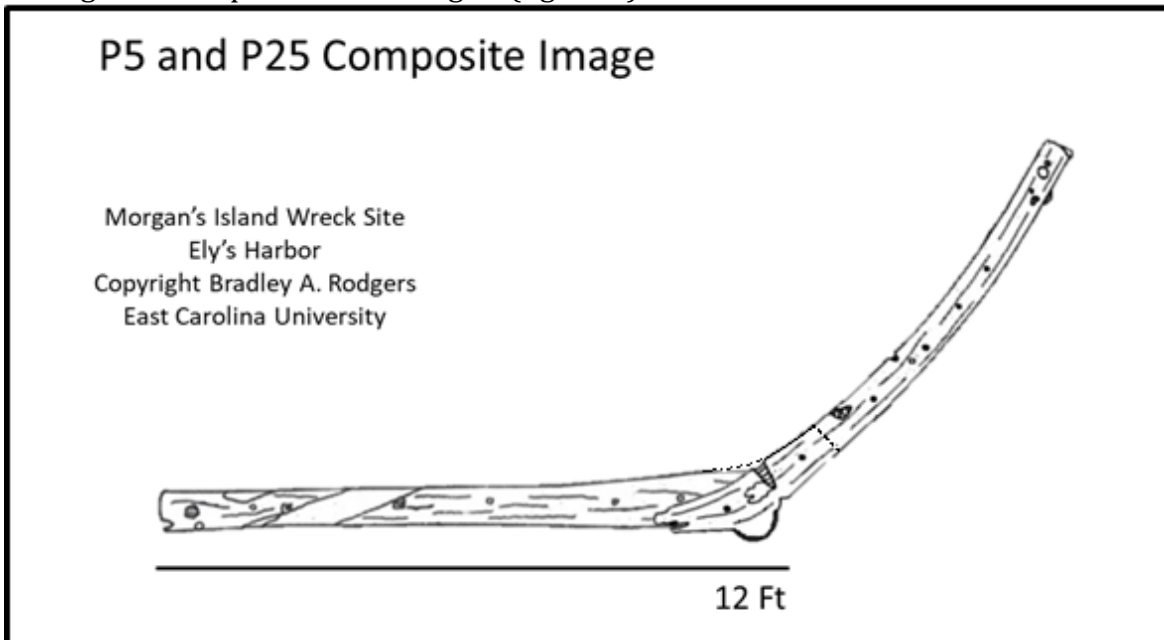
**Figure 15.** Composite image of P5 and P25 timbers as they would fit together on the ship.

Aside from more modern vessels, such as 18<sup>th</sup> and 19<sup>th</sup> century scow schooners, river flats, steam river boats, and plantation schooners, one of the few ship construction traditions that extolled the virtues of flat bottomed ships is the northern Dutch tradition. After the examination of timbers P5/P25, site analysis and historical research took a decidedly new turn, towards northern European shell-first, bottom-based ship construction.

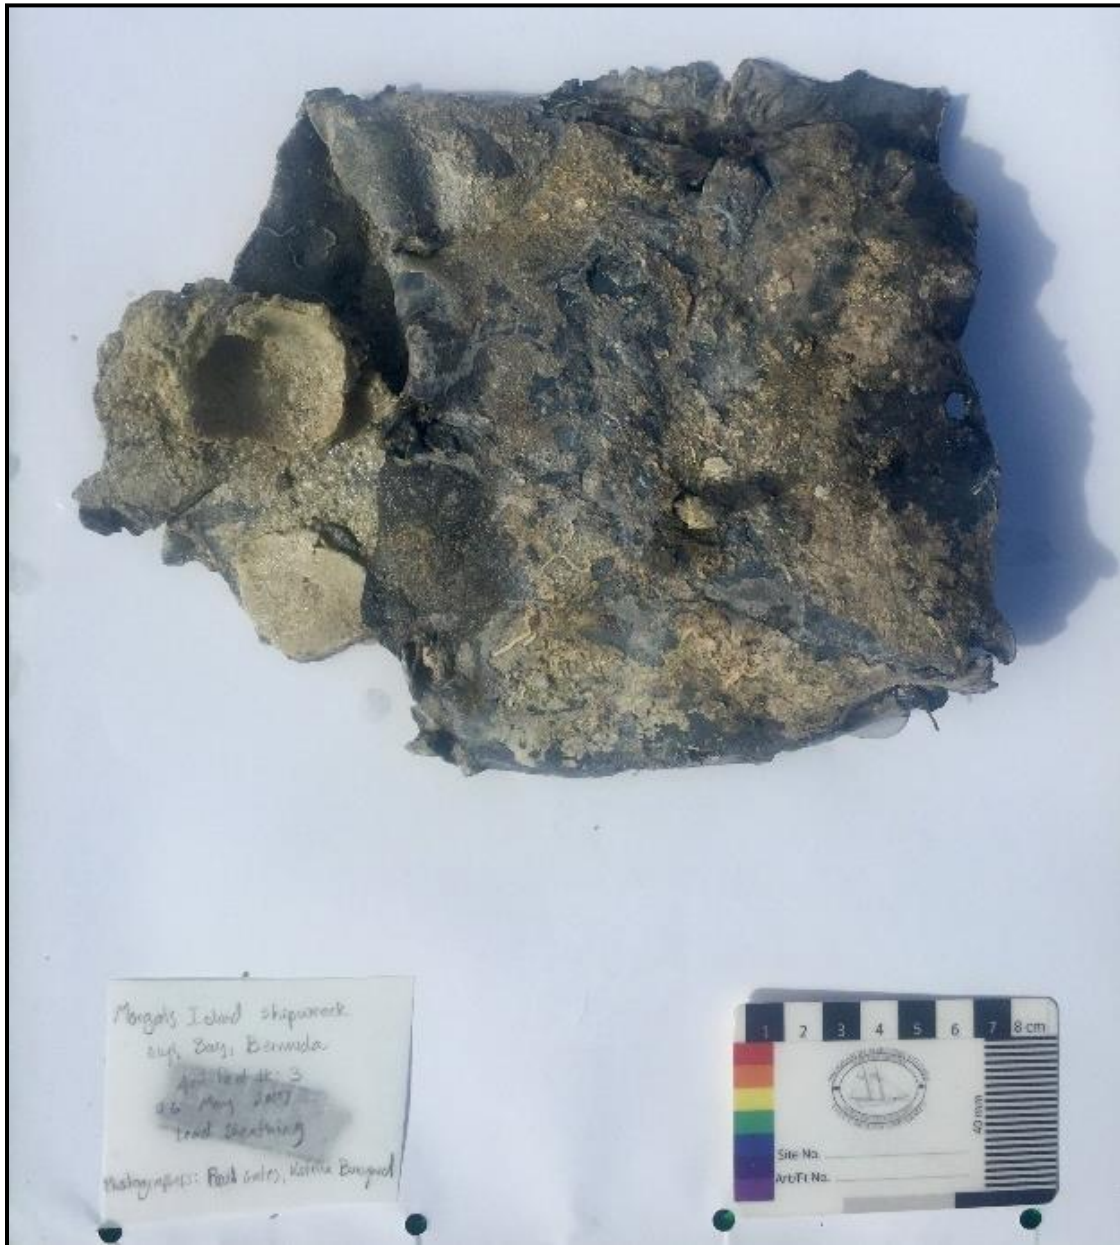
**Figure 17.** Folded sheet of disarticulated lead sheathing with included copper tacks recovered from the Morgan's Island Wreck site.

*Lead Sheathing:* Lead sheathing fastened with brass tacks was found in-situ on portions of the bow section and rudder of the Morgan’s Island Wreck. A small section of disarticulated lead sheathing was also noted in an anchor scar near the main concentration of timbers. Since the piece of disarticulated sheathing was found to be loose, it was considered to be in peril of removal by cultural or natural forces. An addendum to the research permit was granted and the artifact (figure 17) was recovered for study and curation at the National Museum of Bermuda.

Lead sheathing has been well studied in various ship construction treatises. Though used extensively by ancient Mediterranean shipbuilders its use waned by the middle ages and is not seen in the archaeological record until its reemergence with 16<sup>th</sup> century Spanish and Portuguese shipwrights (McCarthy 2005: 102). Likely influenced by the southern European designs, the Dutch incorporated the use of lead to sheath vessels at the end of the 16<sup>th</sup> century. Importantly, the Dutch discontinued using only lead sheathing around 1606 and, thereafter, combined it with sheet copper in alternating layers (Van Duivenvoorde 2015). Lead was also used by English shipwrights for a short period beginning around 1670, but they soon found that it did not work well with iron fittings and they soon discontinued the practice (Harris 1966).

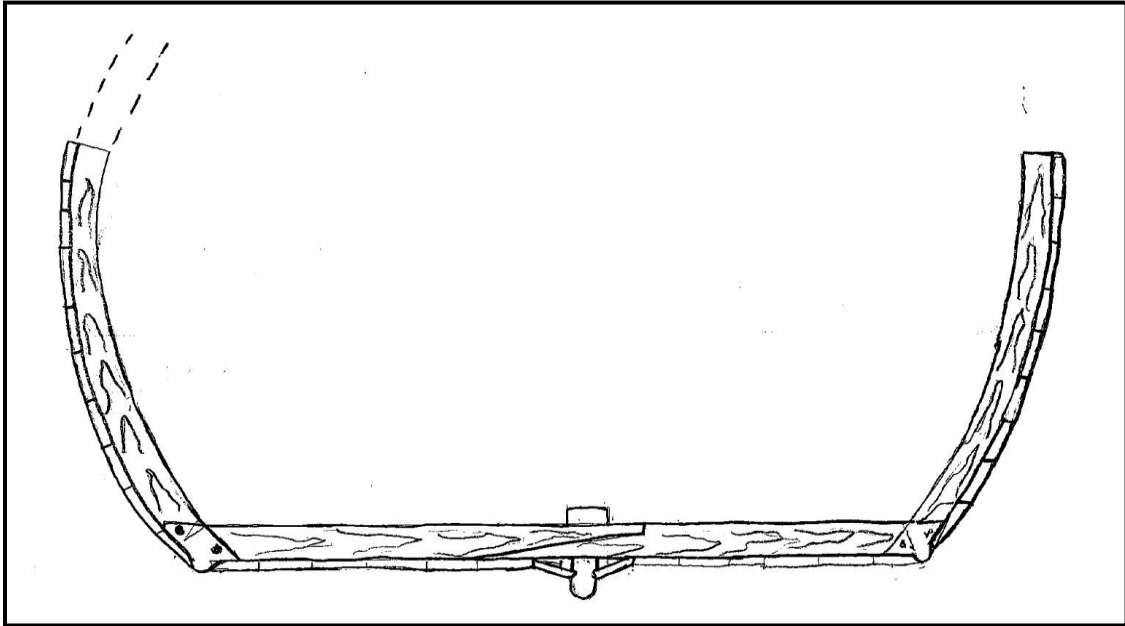
**Figure 18.** A hypothetical reconstruction of the floor and futtock timbers from Morgan's Island Wreck (illustration by author).

the first time to see enough of the scantlings at the wreck site to diagram a conjectural cross section of the ship using the connection of timbers P5/P25 (figure 18). This was done without knowledge of Witsen's translated text. Herein is included this sketch, as compared with some original drawings by Witsen (1671). The cross-section drawings speak for themselves and are nearly identical.

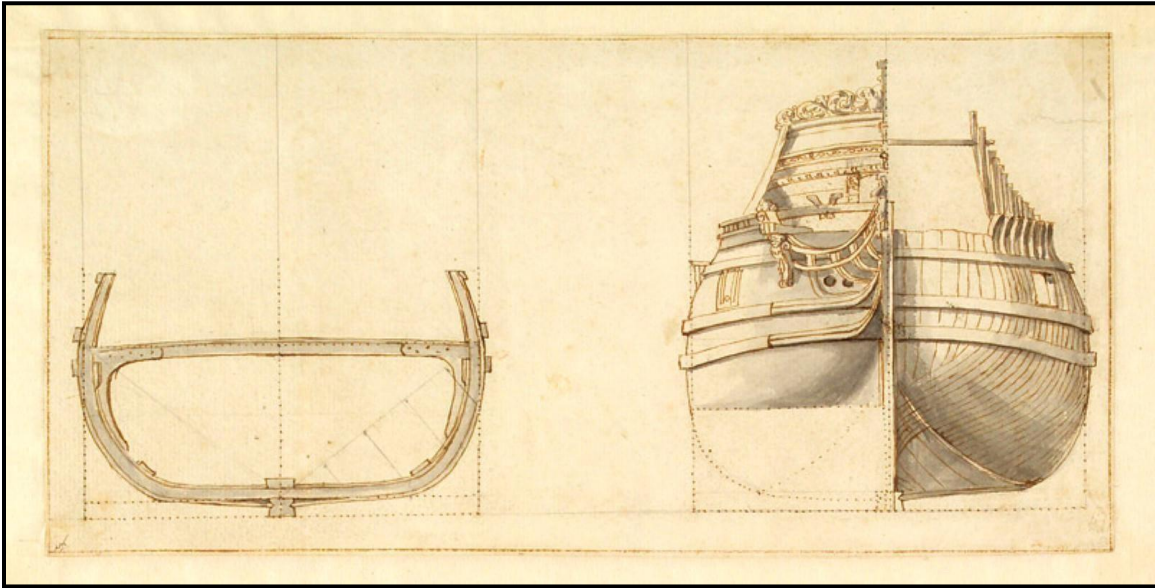
**Figure 19.** Seventeenth century Dutch pinnace cutaway illustration (<https://www.flickr.com/photos/49225014@N05/8398082134>).

*Pinnace:* The definition of the term pinnace, sometimes spelled *pinas*, *pinnance*, *pinnasen*, changes over time. In reference to the early to mid-17<sup>th</sup> century, it can generally be defined as a heavily armed version of a Dutch *fluyt*. Pinnaces were used to escort convoys of *fluyts* and allowed the Dutch to expand their trading empire in a cost-effective manner. Other nations built their trading vessels with an eye to converting them to warships when need be, thus making them on average more expensive and much heavier than the purpose built Dutch vessels. Though much like the flat bottomed *fluyt* in form, the pinnace was more heavily-constructed to accommodate additional ordnance (figure 19). Most importantly, however, 17<sup>th</sup> century pinnaces were made of hardwood, unlike the *fluyt*. The remains of the vessel investigated at Morgan's Island certainly meets the definition of Pinnace. Interestingly, it is thought that the term pinnace and the ship class it represents, later evolved into the type of vessel known as the frigate.

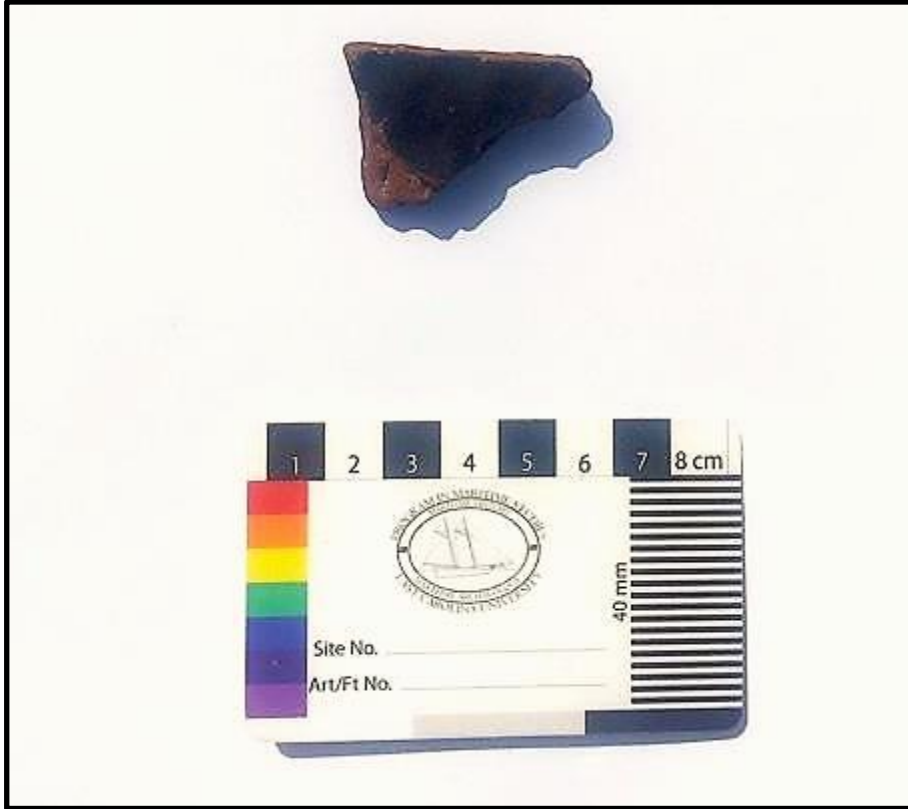
**Figure 20.** Sherd of Lead Glaze Coarse Earthenware recovered from the Morgan's Island Wreck site.

A singular piece of earthenware ceramic was located on the surface near 140 feet along the baseline (figure 20). Through visual observations, artifact recordings, and typology research the ceramic fragment was identified as a piece of Spanish lead glazed coarse earthenware (Deagan 1987:47). Though this red-bodied dark glazed ceramic is generally considered to date from the 16<sup>th</sup> century, its terminus post quem looks to be 1622. Since the sherd was found to be loose, it was considered to be in peril of removal by cultural or natural forces. An addendum to the research permit was granted and the artifact was recovered for study, conservation and curation at the National Museum of Bermuda.

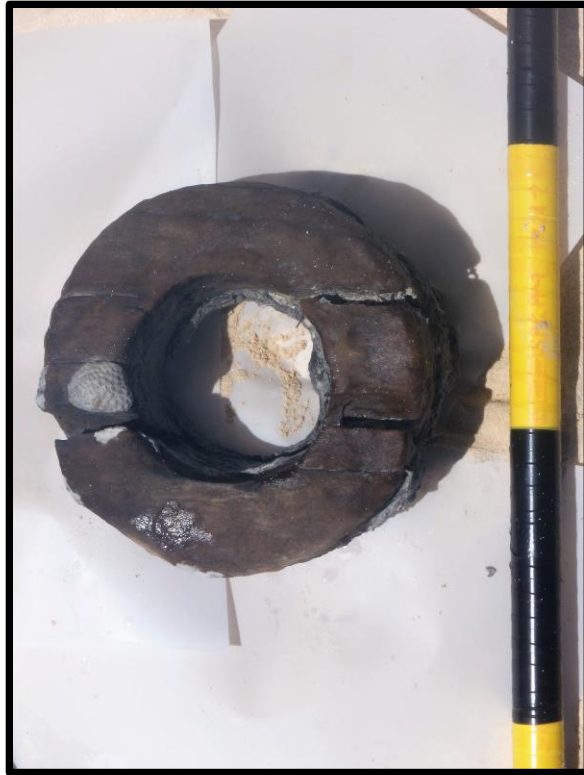
**Figure 21.** Wooden gun truck wheel recovered from the Morgan's Island Wreck site.

In addition to the ceramic, a gun truck wheel was also located on the surface near 140 feet along the baseline (figure 21). These artifacts are ubiquitous on armed vessels of the time period and do not shed a great deal of light on the project analysis – other than proving beyond doubt that this was an armed vessel. This gun carriage wheel appears to be made of greenheart (*Ocotea reodiei*) wood and its specific gravity can be tested for this in the future. If this artifact is indeed crafted using greenheart it may show that the ship was completely built and fitted out in the Americas. A knee timber also recorded at the site (timber S39) corroborates that this was an armed vessel as it includes an eye bolt mounted through its throat that would have likely been used to attach gun tackle (figure 22). Since the wheel was found to be loose, it was considered to be in peril of removal by cultural or natural forces. An addendum to the research permit was granted and the artifact was recovered for study, conservation and curation at the National Museum of Bermuda.

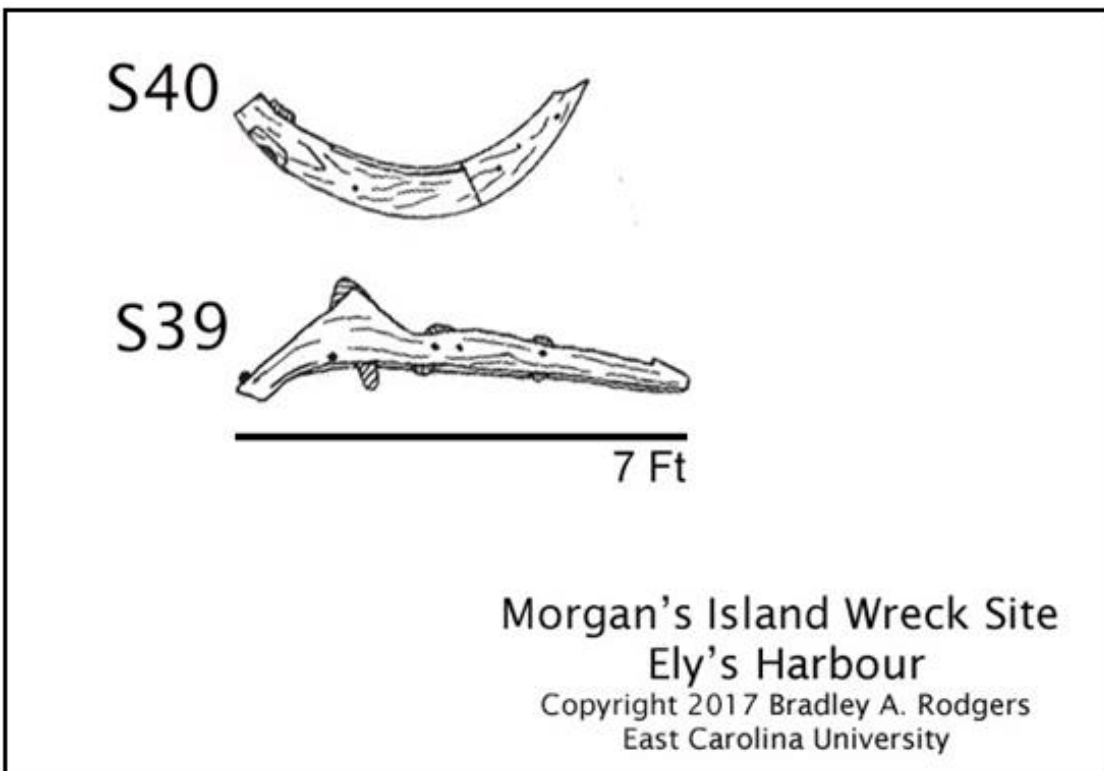
**Figure 22.** Wooden knee timber (S39) recorded at Morgan's Island Wreck site.

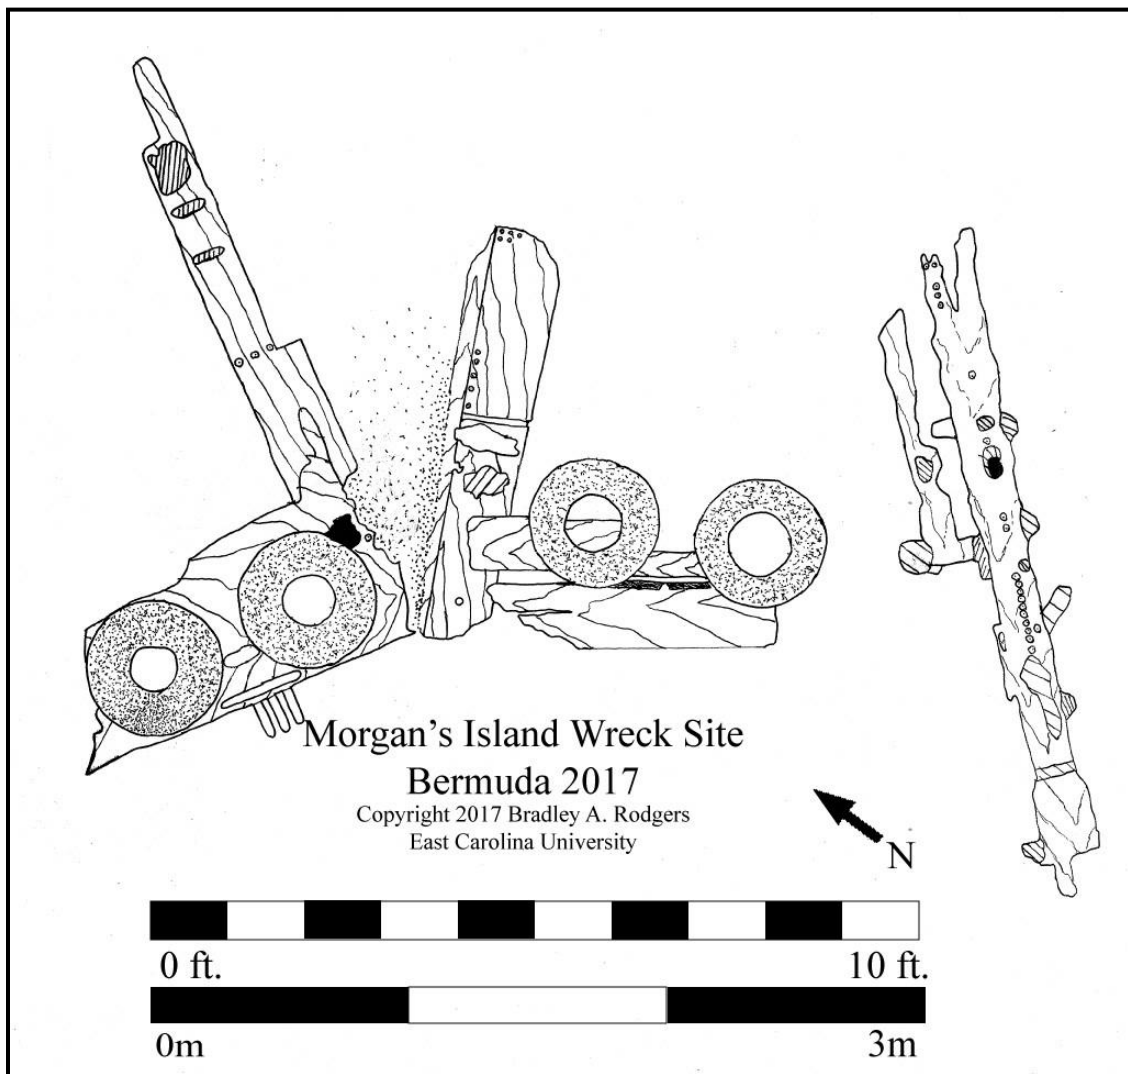
**Figure 23.** Bow section of the Morgan's Island Wreck site with four possible hawse pipes.

*Possible Bow Feature:* The bow section (figure 23) is a very rare and interesting find from a wreck of this period. Generally speaking the bow and hawsers located high up on the stem of the ship are lost when the upper works of a ship are broken away in the wrecking process. If not lost during wrecking, they are subject to water movement and biological attack as site formation progresses. The decks, upper works, and bow of a ship are simply not expected to survive archaeological interment, and are not often seen at all on wreck sites. The Morgan's Island site is very special in this instance, the bow has not only survived but gives us invaluable insight into interpreting and dating the site.

**Hawse Hole Liners:** The Morgan's Island Wreck site includes a section off the baseline that is thought to be a partially intact piece of the ship's bow (figure 23). This area includes planking timbers, a possible portion of the stem, and four round objects situated in two pairs. On visual inspection, these were determined to be iron lined anchor hawser holes, two on each side of the stem (figure 24).

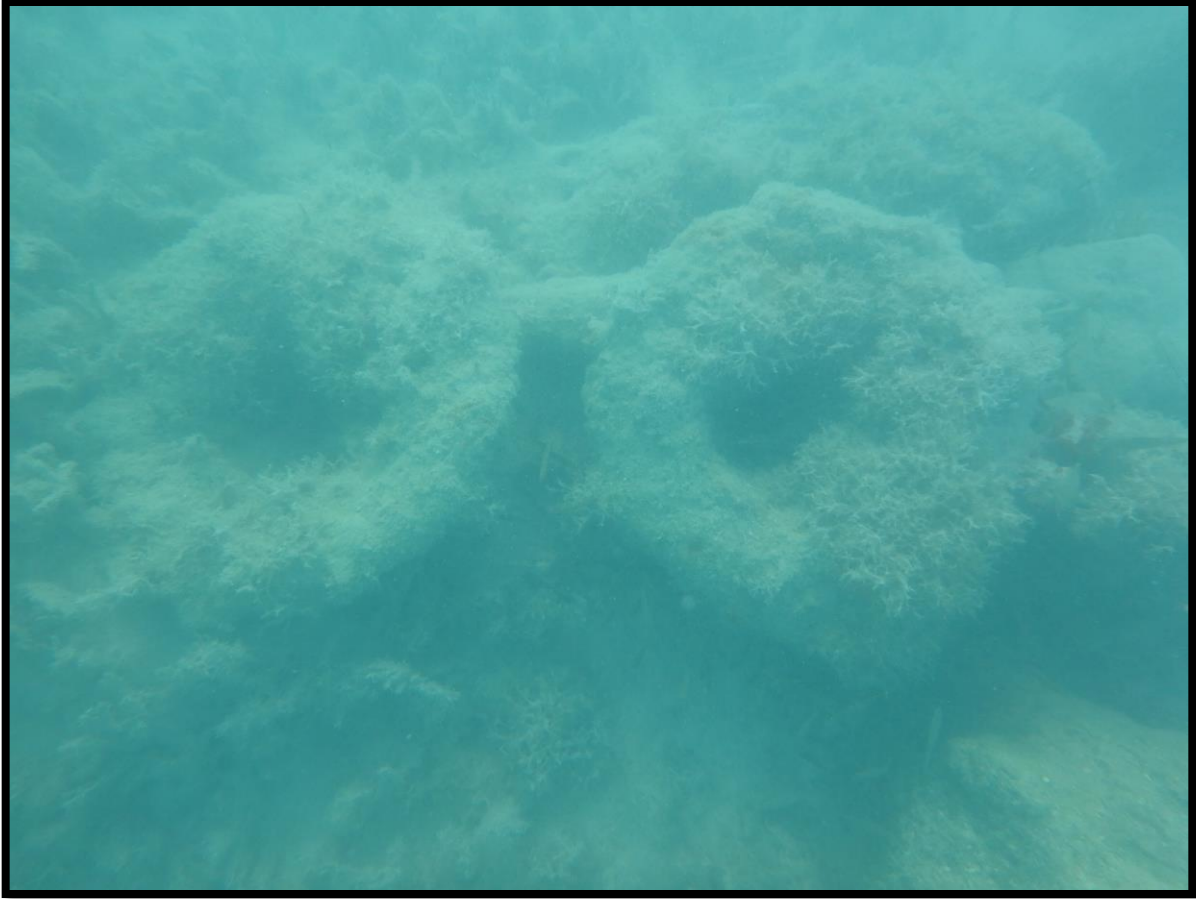
**Figure 24.** Two of the four possible iron hawse pipes recorded on the bow section of the Morgan's Island Wreck site.
