An Investigation of
Blossom's Ferry
on the
Northeast Cape Fear River

Gordon P. Watts, Jr. and Wesley K. Hall

Program in Maritime History and Underwater Research

ECU Research Reports No.1
January 1986

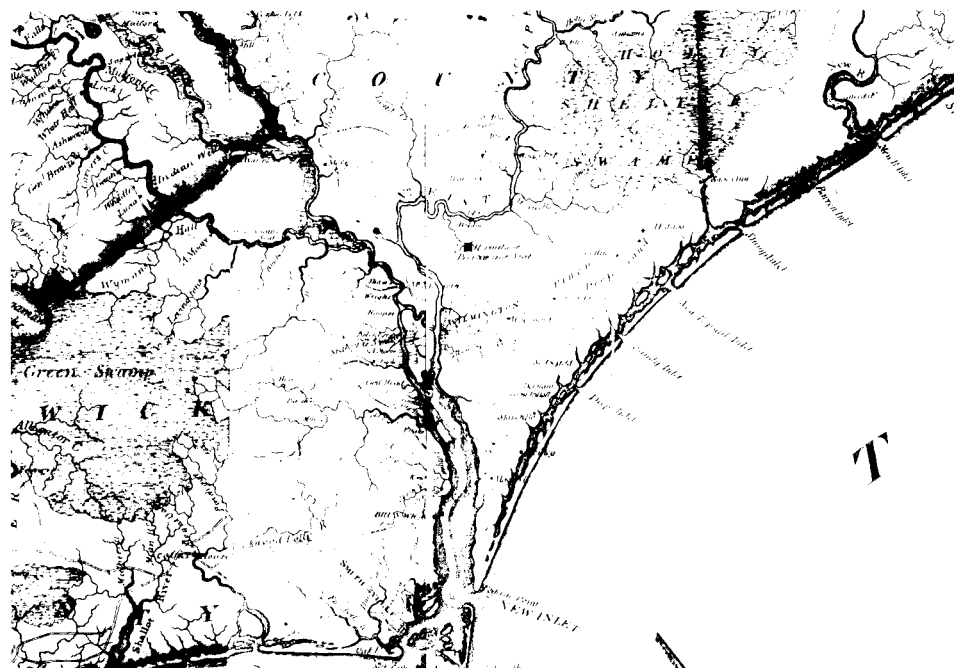
Figure 5. The site of "Big Bridge" on an 1803 map by Jonathan Price and John Strother.

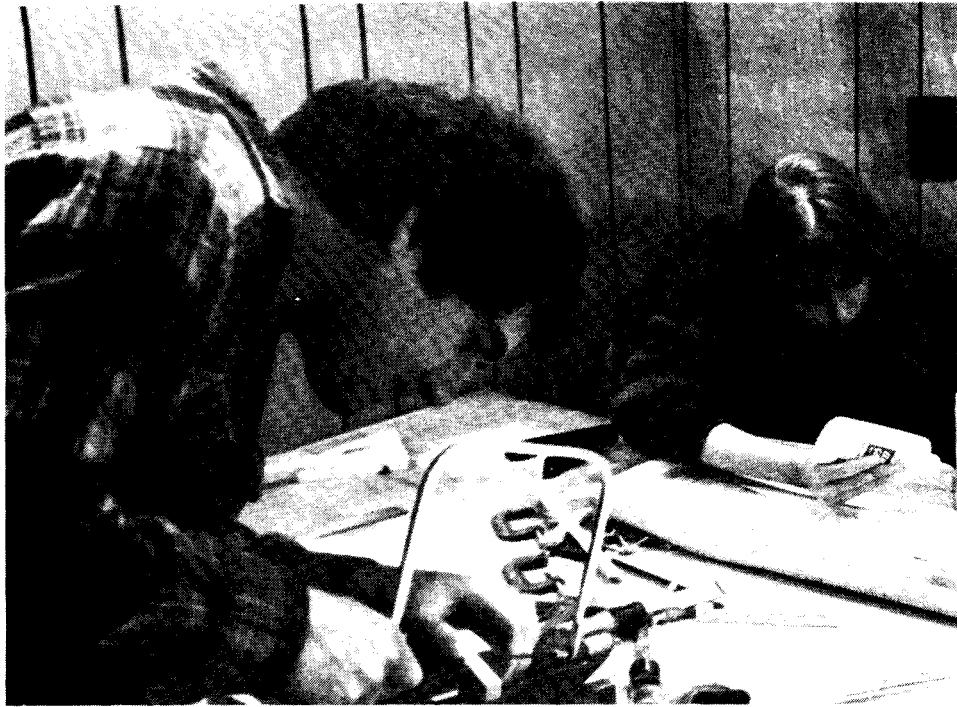
Figure 20. Wes Hall and Kim Elmore examine preliminary ferry models to identify areas requiring additional documentation.

the 1981 field project based on information from the initial reconnaissance. By building 1/4-inch scale reconstructions of each ferry hull, gaps in field data could be identified along with specific design and construction features that required further investigation. Priorities for additional research could then be formulated on a highly specific basis. The preliminary models were taken into the field in 1983 so that errors and specific features could be more effectively addressed (Figures 20-21; 23-24).

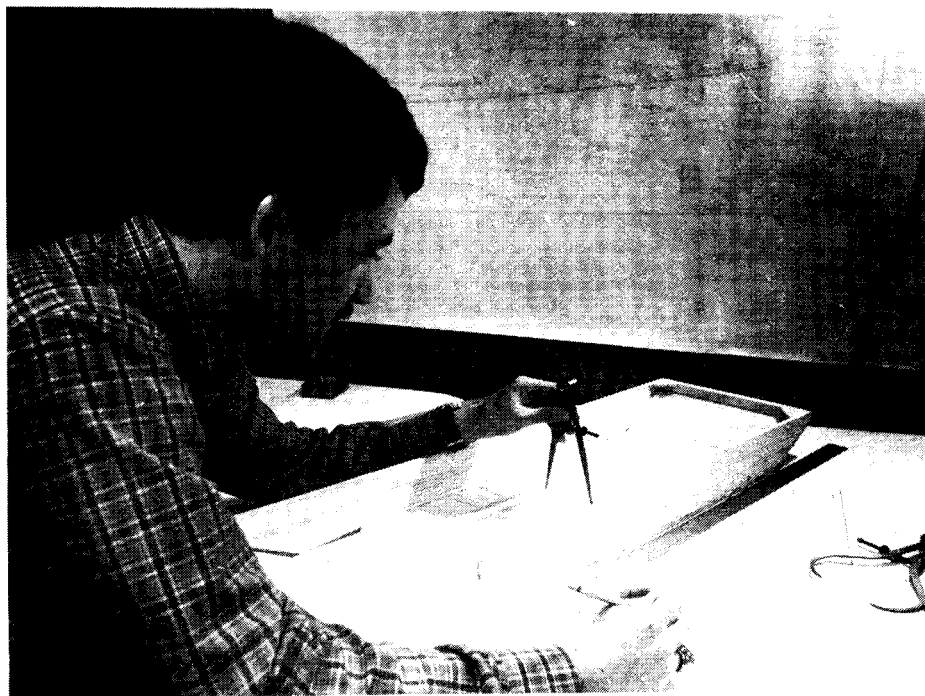
Figure 21. Stuart Morgan uses first generation ferry models to prepare research objectives for the 1983 investigation.

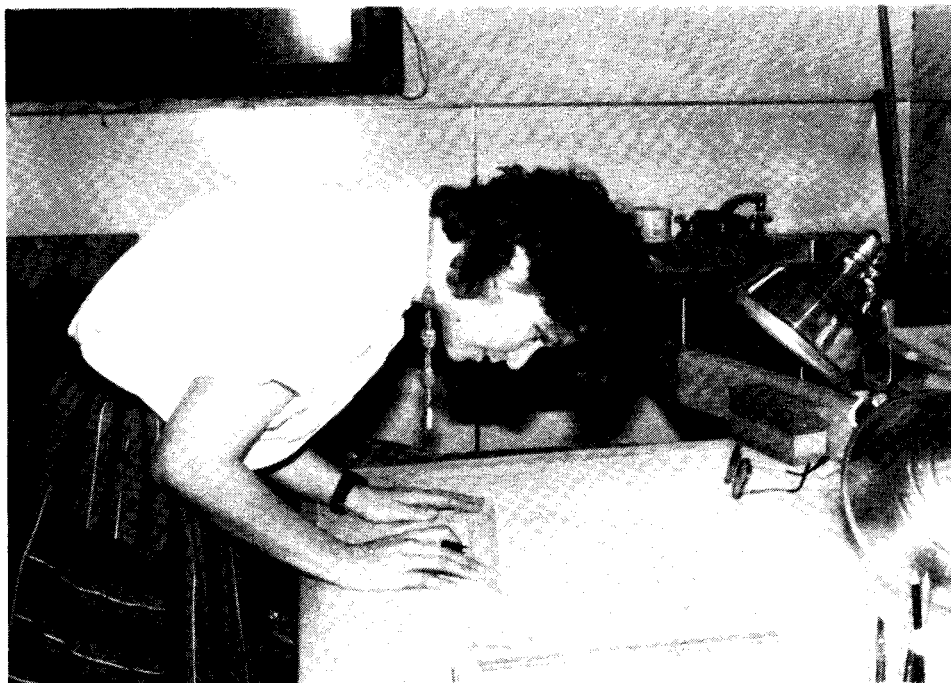
Figure 22. Kaea Morris records artifact details at the East Carolina University Conservation Lab.

ARTIFACT CONSERVATION (Figure 22)

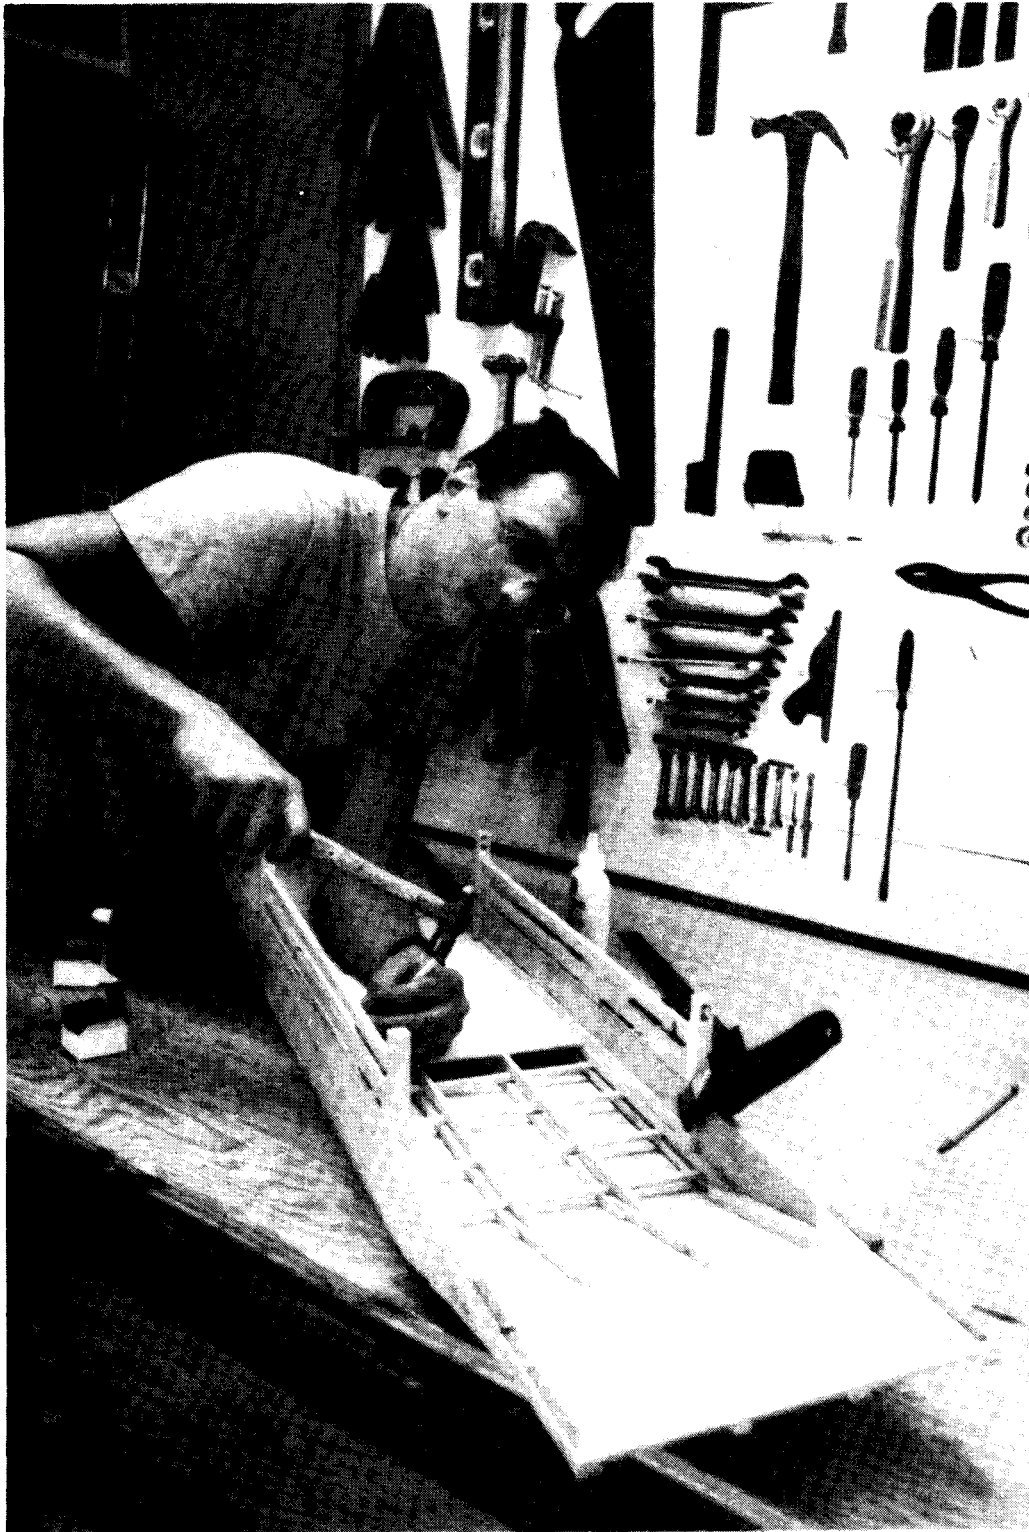
Figure 24. Bob Schneller completes the final research model of the mid-eighteenth century vessel at Blossom's Ferry.
