The Cypress Landing Shipwreck of Chocowinity Bay:
A North Carolina Sail Flat

An Archaeological and Historical Study

Ann M. Merriman

Program in Maritime History and Nautical Archaeology East Carolina University

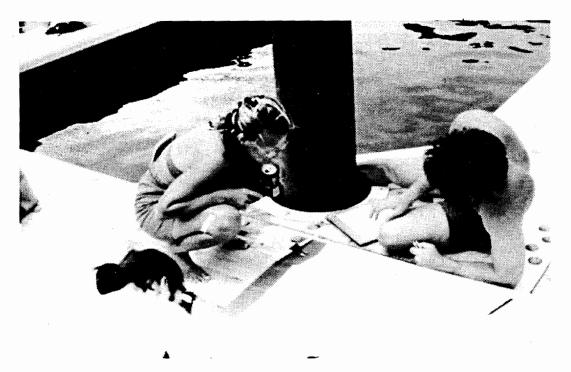
Plate 5. Preliminary measurements are placed on the site plan. Photograph by Julep Gillman-Bryan.

their drawings to scale in student notebooks. Crew chiefs and project directors checked these drawings; questions not resolved led to a re-examination of the student's assigned work area. Students then placed corrected scale drawings on the site's base map (Plate 5). At this stage, if students recognized additional discrepancies because adjoining map units did not agree, mappers re-entered the water after consultation to resolve these problems.

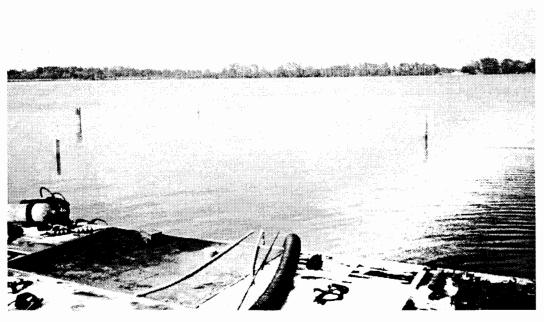
Plate 7. Protective signs around the wreck are highly visible from the dock and the bay. Photograph by Ann Merriman.
