Research Report No. 15

# The 1996 Anguilla Shipwreck Survey

Anguilla, British West Indies, September 1996

Program in Maritime Studies  
East Carolina University  
Greenville, North Carolina

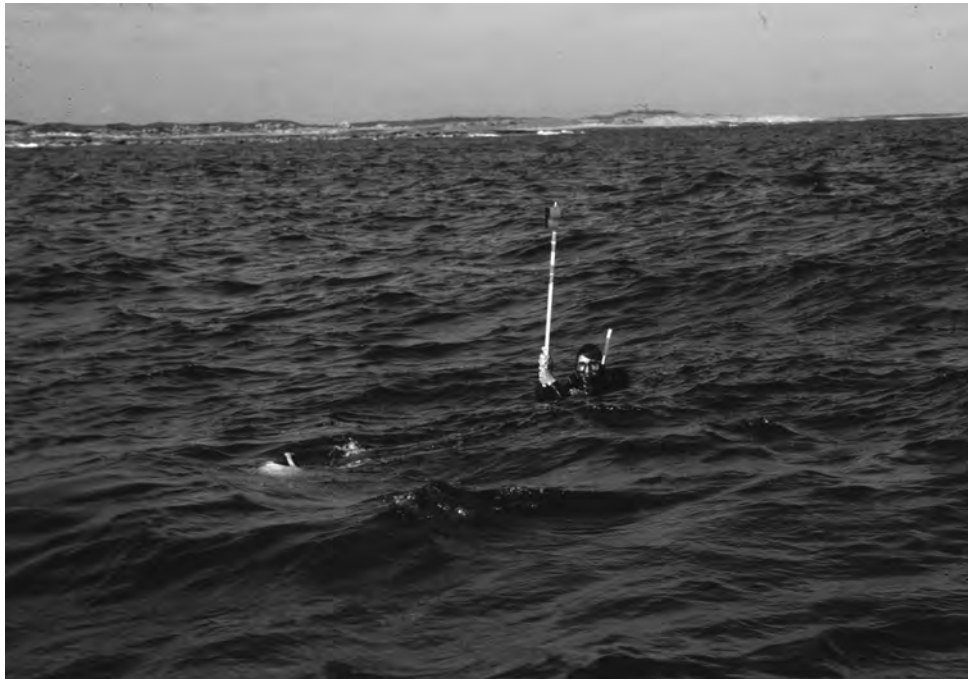
**Figure 3.** Frank Cantelas holds the mirror target for the Electronic Distance Meter to measure the distance from the shore datum to submerged wreck features (Program in Maritime Studies, 1996).

Diving operations were conducted from the 38 foot (11.6 m) research vessel *Cobra 2* supplied by the Anguilla Fisheries Ministry. *Cobra 2* was equipped with a global positioning system, VHF, and CB radios. The GPS allowed for the accurate positioning of the boat via orbiting satellite transponders while the radios permitted communications with the shore station. A shore station datum was set up on the rugged shoreline near the wreck site. The datum (an iron reinforcing rod cemented upright in the rock) allowed the archaeological teams to coordinate all offshore activities and orient the entire site from a single point. The datum was located on a rocky point that offered a panoramic view of the entire site. A transit with a laser distance measuring device was set up at the datum permitting the creation of a sophisticated and accurate map of the shoreline and wreck site (Figures 3 and 4). This device is accurate to 0.1 foot at over a one mile distance.

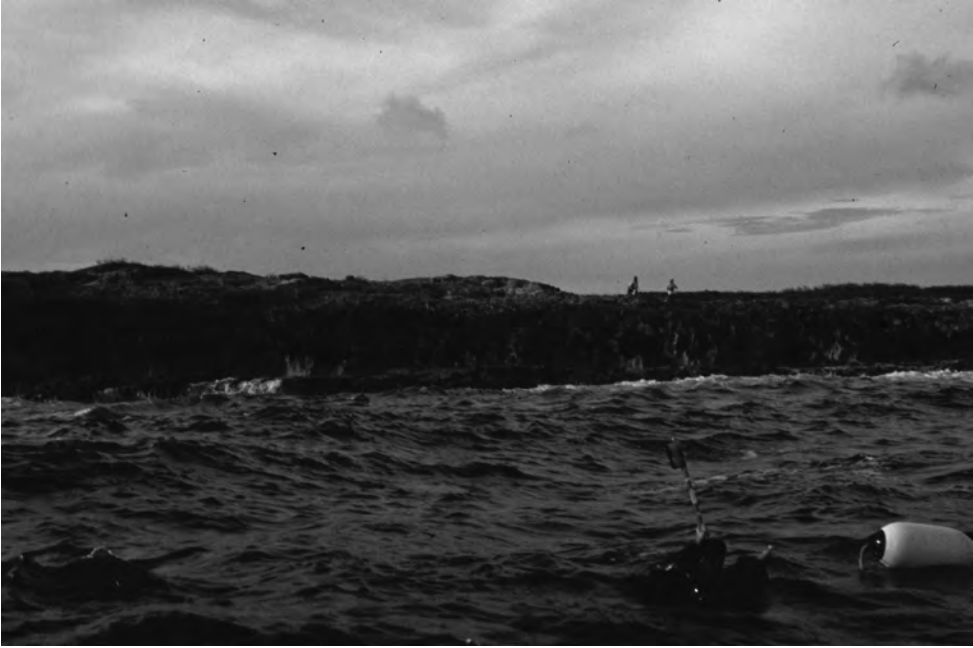
**Figure 4.** The process of buoying and shooting the site from the shore datum station was not always an easy process, especially in heavy sea conditions (Program in Maritime Studies, 1996).

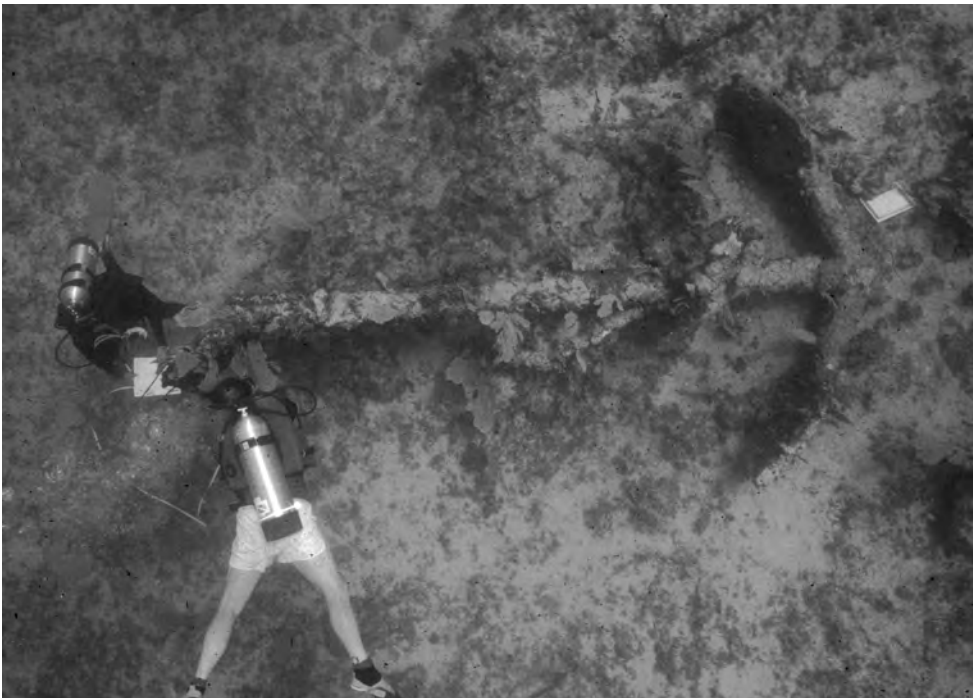
**Figure 5.** The first anchor dropped by the crew of *El Buen Consejo* did not catch (Program in Maritime Studies, 1996).

Although the ship dropped its first anchor soon after the initial alarm, the device apparently did not slow the vessel. Today, this anchor lies flat on the bottom with its flukes pointing away from the shore (Figure 5). This may indicate that the wooden stock of the anchor broke, or was fouled in the anchor line when it was dropped, as it was dragged uselessly across the hard rock bottom. With the stock broken or fouled, the anchor flukes could not be positioned upright to dig in and stop the ship's headlong rush toward shore.

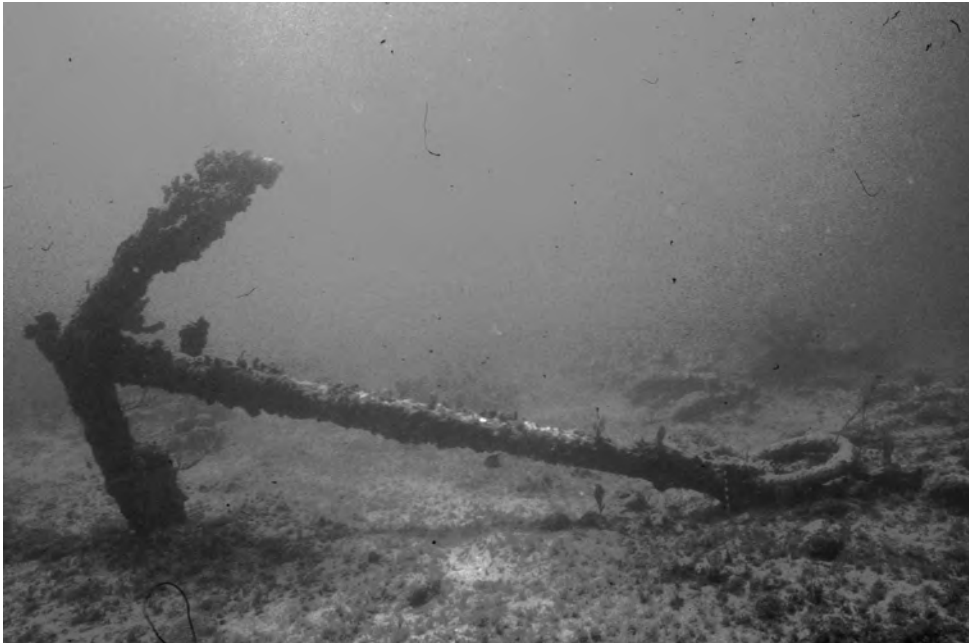
**Figure 6.** The second anchor of *El Buen Consejo* did catch, but too late to prevent the wrecking of the ship (Program in Maritime Studies, 1996).

Within about two minutes, while some of the sailors no doubt frantically fought to reef the sails, the ship traveled nearly half the distance to the island. Here, 900 feet (274.3 meters) from the first anchor, a second was dropped. This anchor dug into the hard coral and limestone bottom and held (Figure 6). By this time, however, it was too late. The draft of a vessel this size would have been 12 to 14 feet (3.6 to 4.2 meters), and it was already too near the shore. The first rending shudder likely tore holes in the bottom of the ship allowing it to settle near the shoreline with at least its main deck above the waterline.

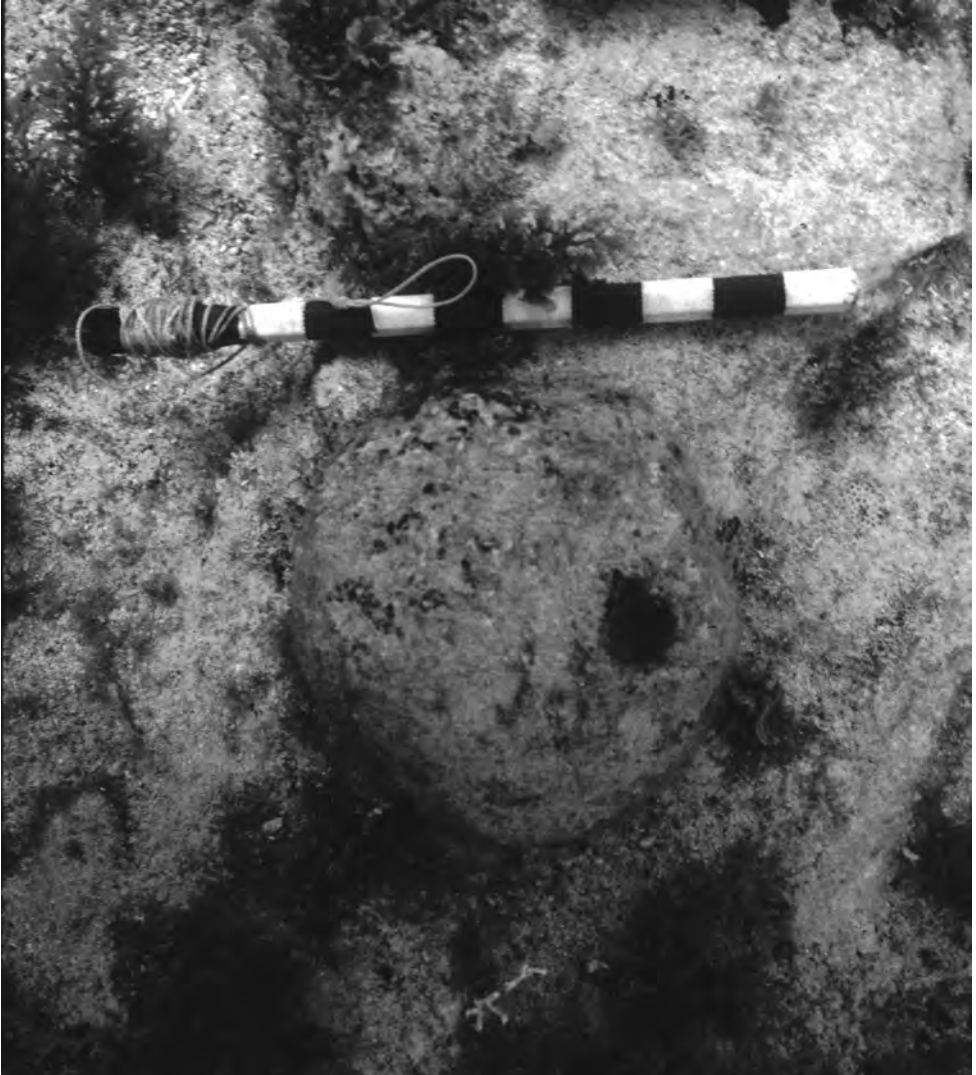
**Figure 8.** A thirty-two pound cannon ball (Program in Maritime Studies, 1996).

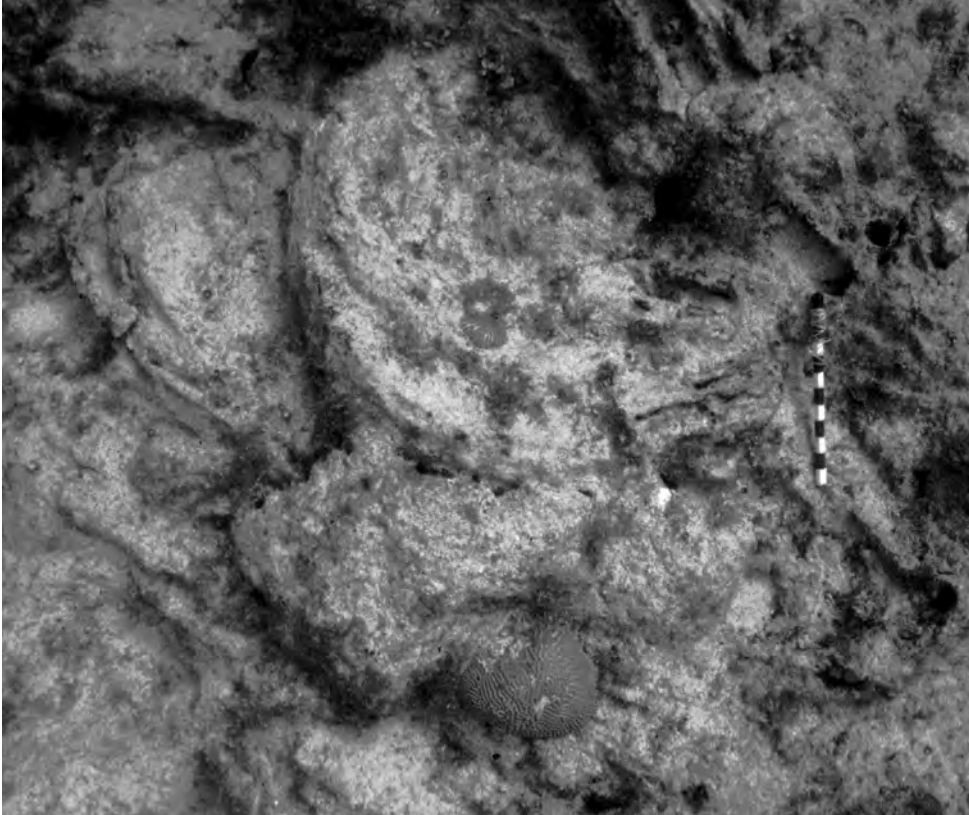
**Figure 9.** Concretions originally formed on wooden containers (Program in Maritime Studies, 1996).

There is no sign of the wooden hull of this vessel nor are there any wooden scantling pieces lying in the vicinity. It appears likely that the high energy nature of the site combined with the natural biota to eliminate all wooden artifacts. In addition, there are no signs of fasteners or ballast at the site, lending credence to the theory that the vessel tore its bottom elsewhere before being driven to its present location. The main features of the wreck site are 18 large cannon scattered across nearly 400 feet (122 meters) of sea floor (Figure 7). These guns made excellent anchoring points for the baseline. Among the cannon are cannon balls (Figure 8), iron concretions (Figure 9) and, in two locations, small trade goods obviously intended for colonial holdings (Figures 10-12). These trade goods include rolls of brass, pocket knives, thimbles, needles, brass pins, pewter utensils, glass beads, paste jewels as well as numerous brass religious medallions (Figure 13). All of these artifacts appear to be located near two mounds of what must have been packing boxes. Amazingly enough, though the wood of these boxes has disintegrated, it has been replaced with coral which retains the outlines of the original packing boxes. Indeed some of these goods are packed inside the coral boxes just as they would have been in the hold of the ship.

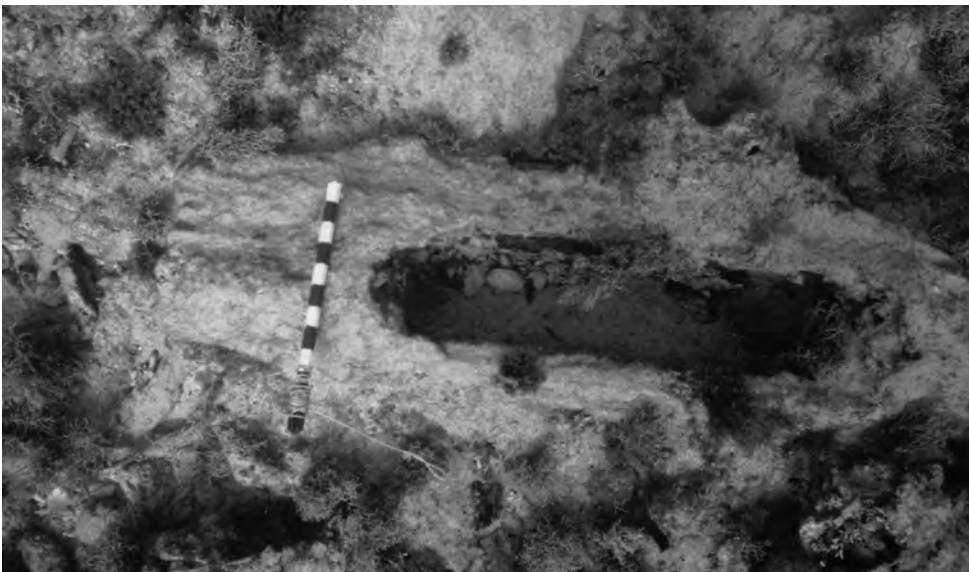
**Figure 10.** Remains of box, originally made of iron or iron strapping over wood. Now lies open on the site, its contents (if there were any) removed (Program in Maritime Studies, 1996).

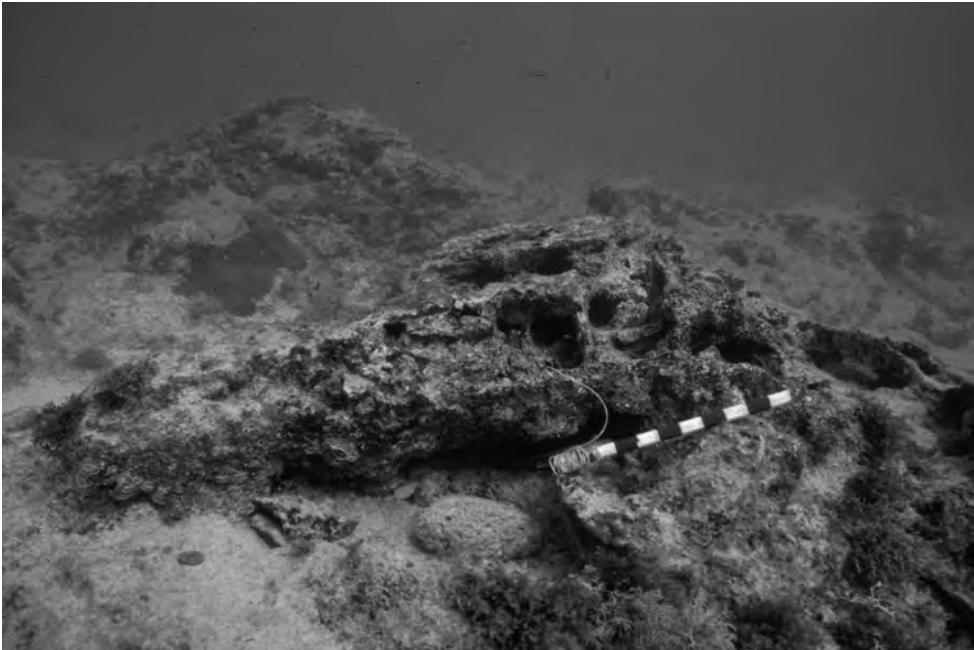
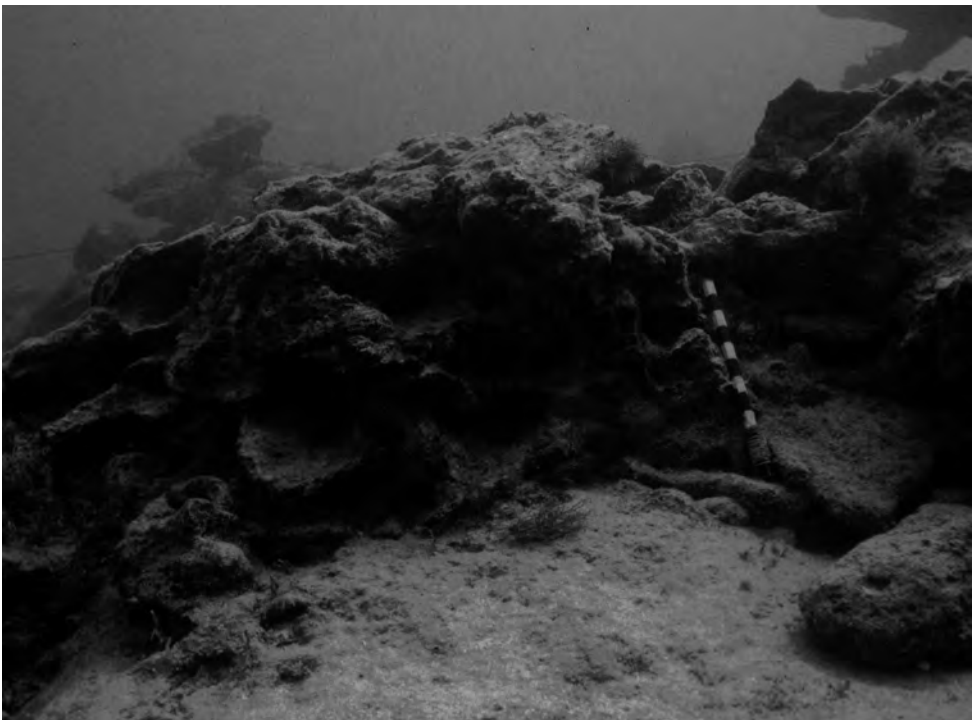
**Figure 11.** This small hill of coral was originally made of wooden boxes packed with trade goods. The square shapes of crates are still discernible. Though many of the boxes are empty, some still contain glass, knives, pins, needles, and thimbles (Program in Maritime Studies, 1996).

**Figure 12.** Alternative view of Figure 11 (Program in Maritime Studies, 1996).

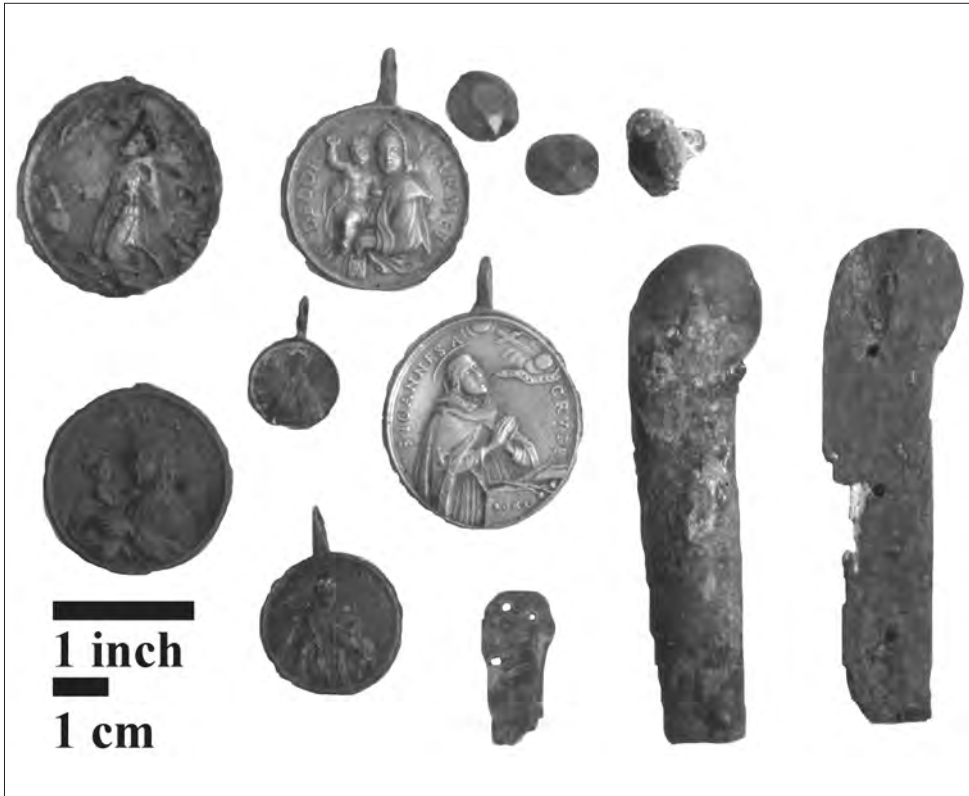
**Figure 13.** Selection of bronze medallions, utensil handles, and paste jewels from the wreck of *El Buen Consejo* (Program in Maritime Studies, 1996).

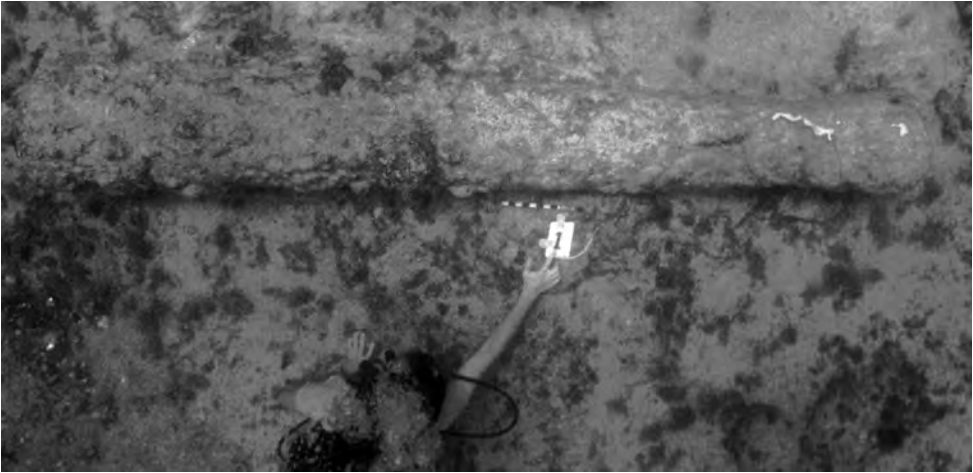
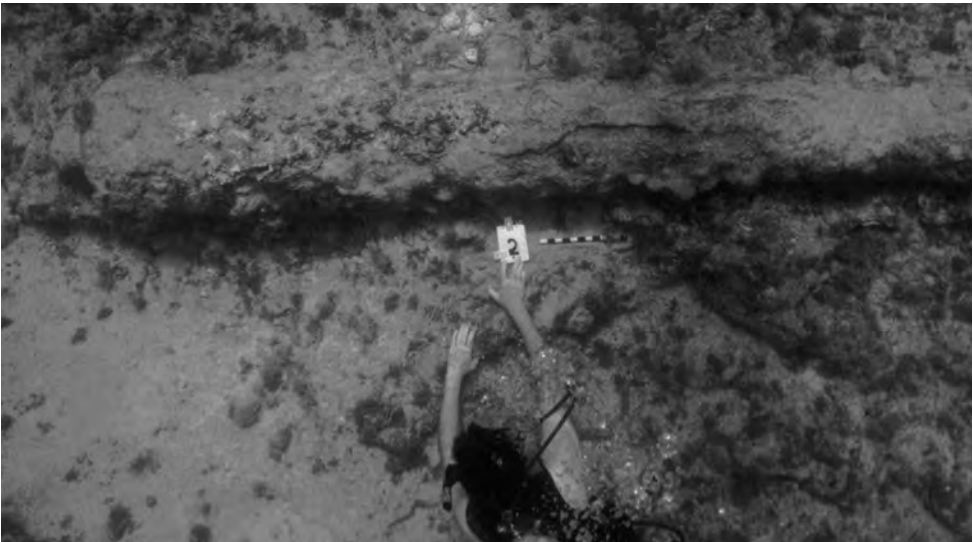
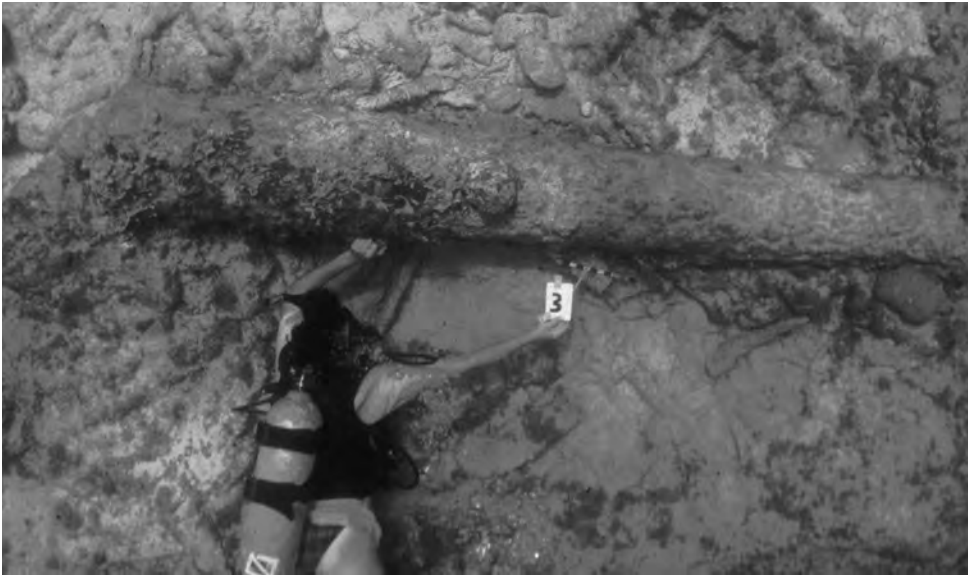
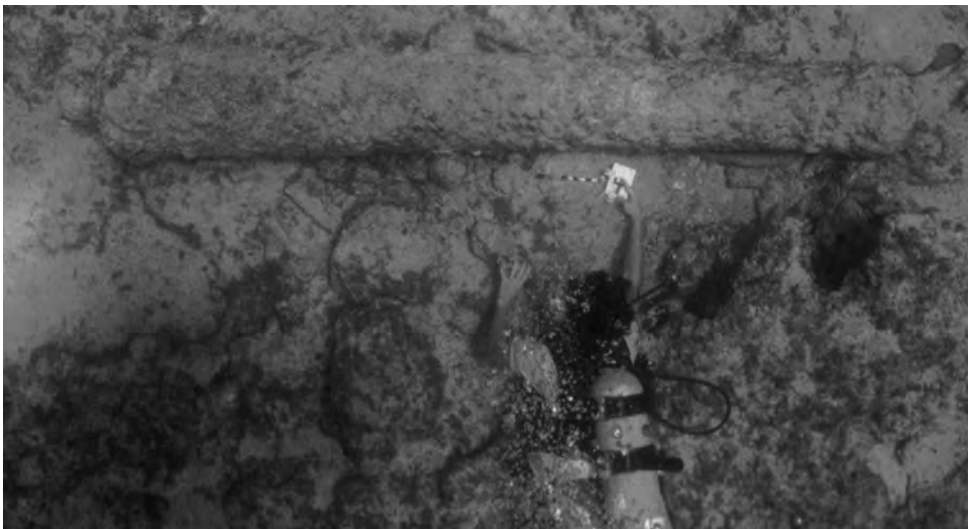
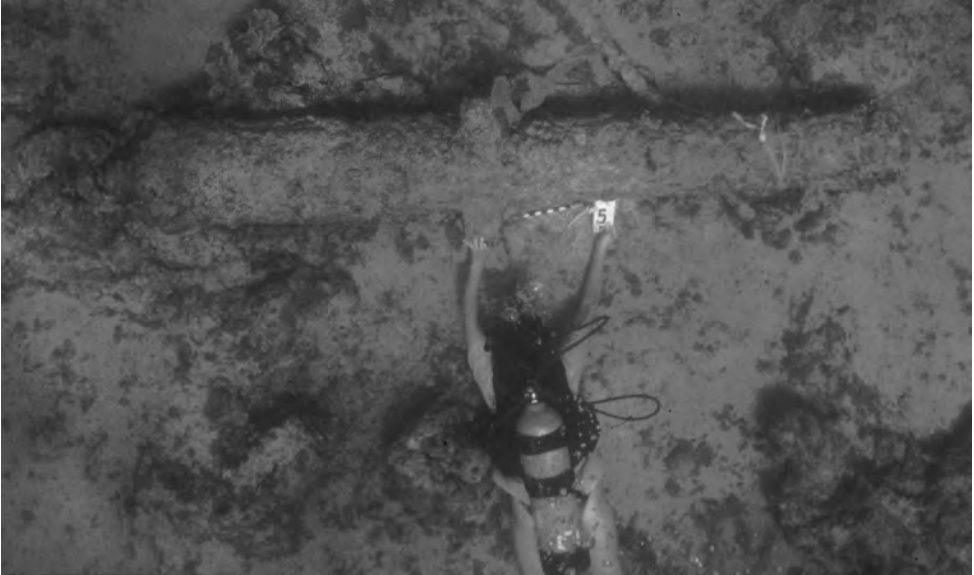
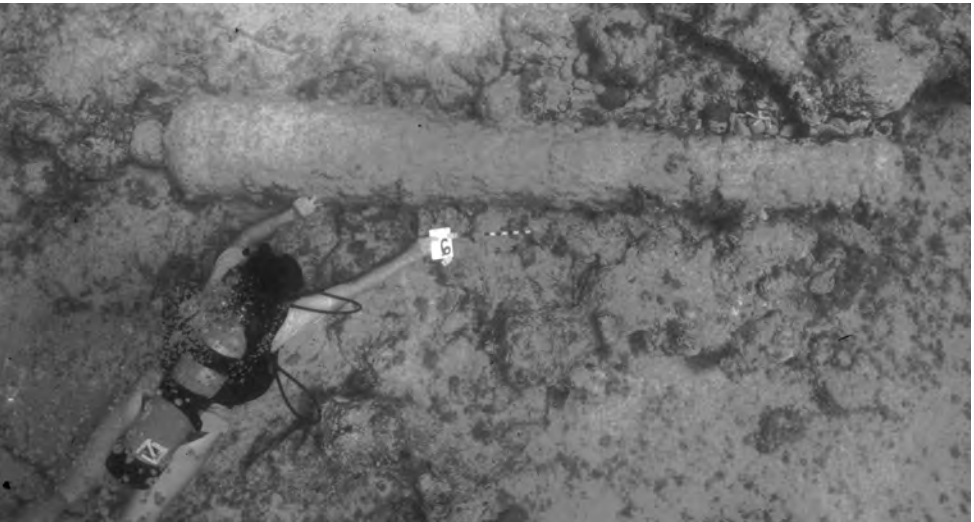
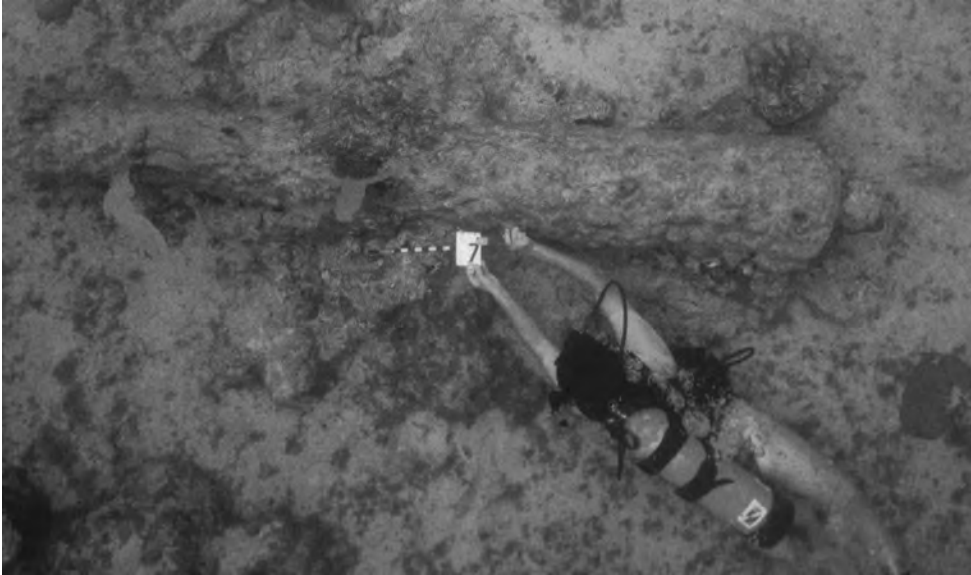
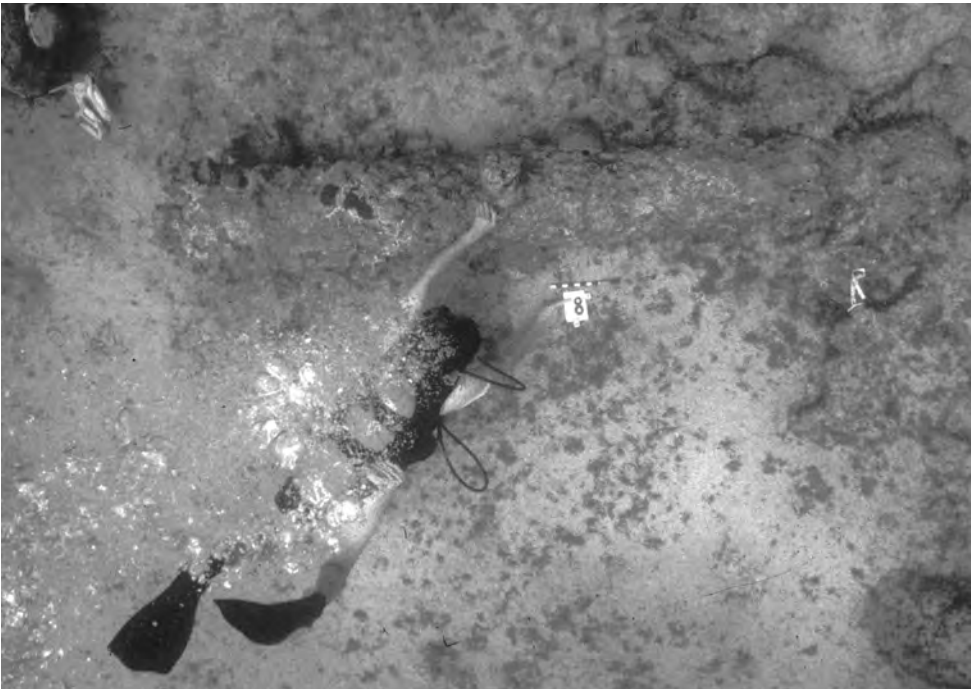
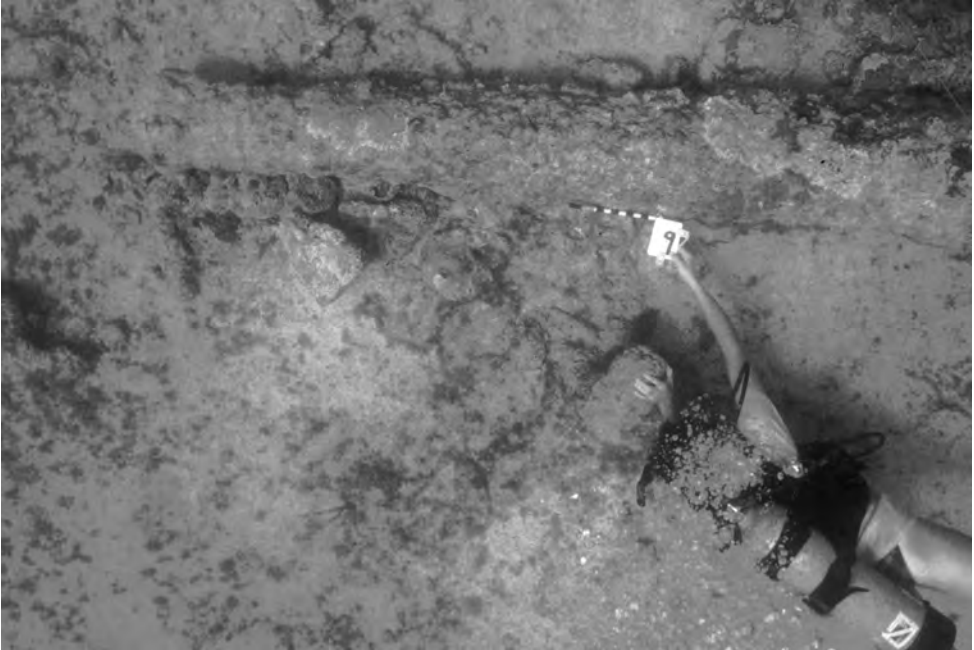
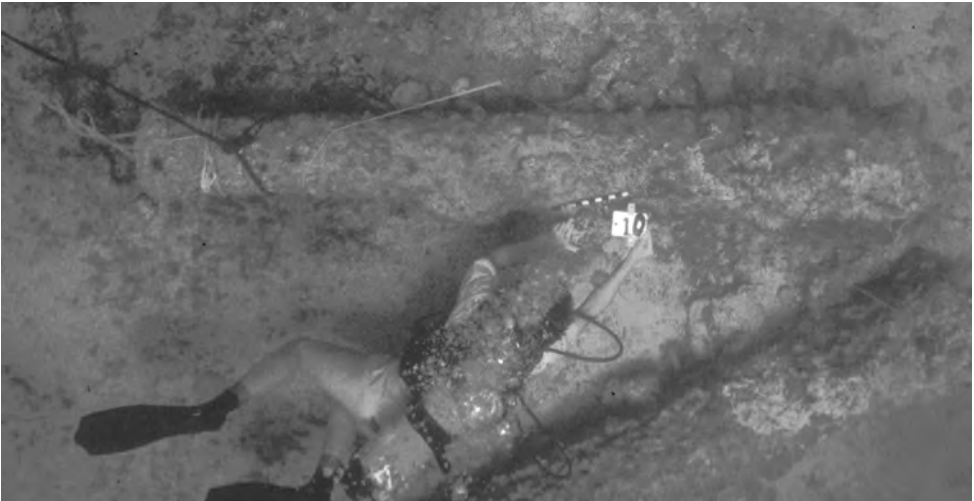
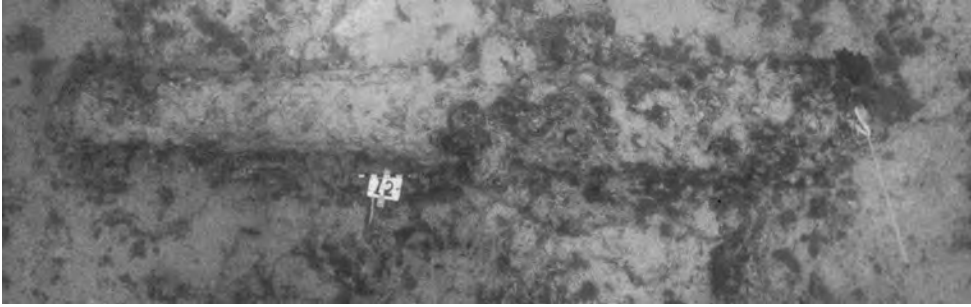
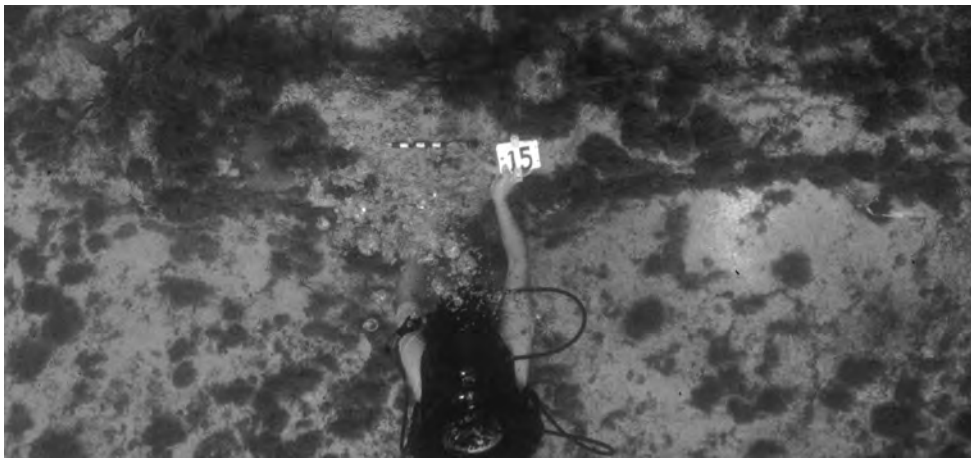
The cannon strewn on the sea floor are nearly identical at 10.5 feet (3.2 meters) long and a bore diameter of nearly 6.5 inches (0.16 meters) (Figures 14-25). Although these are crude measurements (due to the overlying concretion), they indicate that the guns are typical thirty-two pounders. These are very large naval guns for the day and would have fired 32 pound cannonballs. Naval guns of this size are normally found only on the lower gun decks of a battle-ship-of-the-line such as the 3rd rate *El Buen Consejo*. The 18 foot (5.4 meter) long anchors also indicate that this was a large ship, far larger than the other armed vessel wrecked on Scrub Island. These artifacts indicate, therefore, that the ship wrecked on the eastern shore of Anguilla was the *El Buen Consejo* and not the *Jesus, Maria, y Jose* whose remains lie four miles (6.4 km) to the northeast of this site off Scrub Island.

**Figure 14.** Cannon 1 represented the “0” point of the 48-foot baseline (Program in Maritime Studies, 1996).

**Figure 16.** Cannon 3 lying on its side (Program in Maritime Studies, 1996).

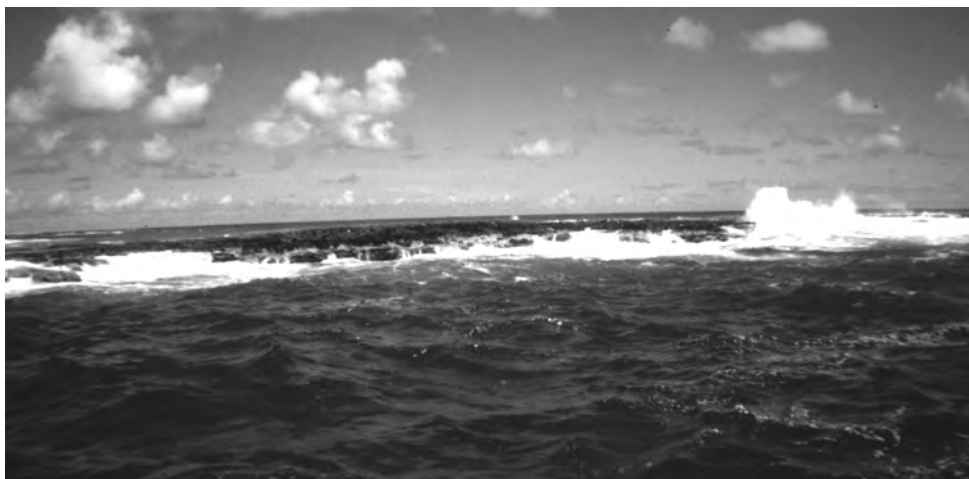
**Figure 27.** High energy conditions at the Scrub Island site shoreline (Program in Maritime Studies, 1996).

The wreck site in the surf zone (Figure 27) off Scrub Island should actually be categorized as two wreck sites. Mingled with 15 or so eight and twelve pounder guns (that no doubt belonged to the *Jesus, Maria, y Jose*), are fasteners (Figure 28), artifacts, and ship's equipment (Figure 29) belonging to a much later wreck of nineteenth century origin. Nothing remains of the Spanish escort vessel except for its guns. A view of these artifacts reveals why. The environment close to Scrub Island is of such a high energy nature and with strong surge that the cannon are continually rolled around and worn away on the hard rock bottom. Many of the guns look as though they have been placed in a "giant pencil sharpener" and ground down to a fraction of their original size (Figure 30). One gun (Figure 31) is worn through so that the cannon ball with which it was loaded is now exposed. Needless to say, if the environment is this hard on artifacts as massive and indestructible as cannon, very little if anything exists of the original ship unless it was washed up on shore. The artifacts lying near the cannon belong to a later ship, and are themselves fast becoming victims of the high energy environment. This nineteenth-century ship had brass fastenings, two 6 foot (1.8 meter) sliding stock anchors, cross linked anchor chain, portholes, and a sophisticated mechanical pump, all of which indicate a vessel of the mid or possibly late nineteenth century. A small number of timbers exists at this site wedged between rocks. As the timber is associated most closely with the nineteenth century remains it no doubt belongs to this later vessel. Additionally, the size of the anchors suggest that the later vessel was not of great size.

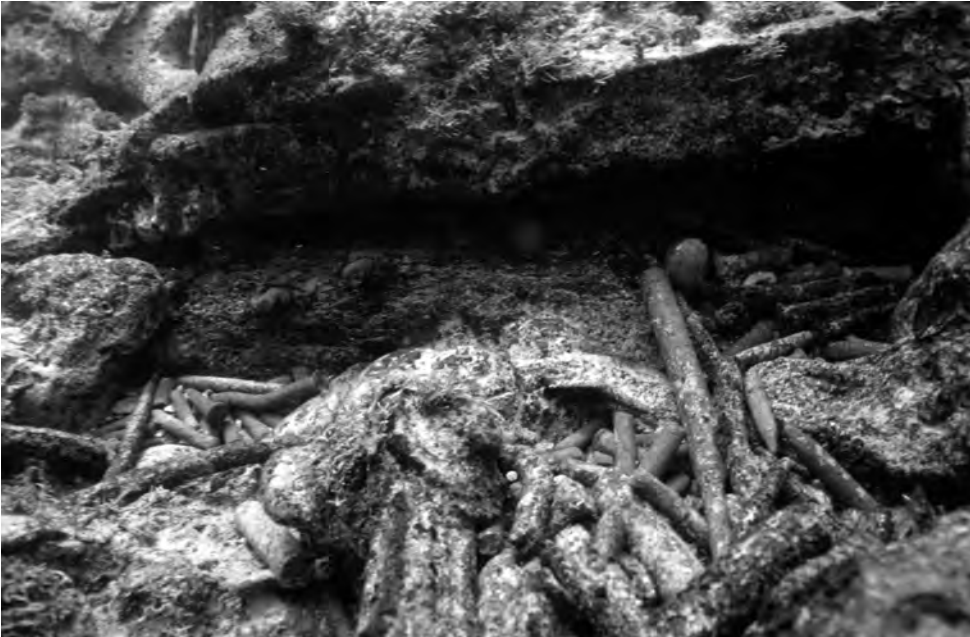
**Figure 28.** Concentration of brass drift pins on the Scrub Island site (Program in Maritime Studies, 1996).

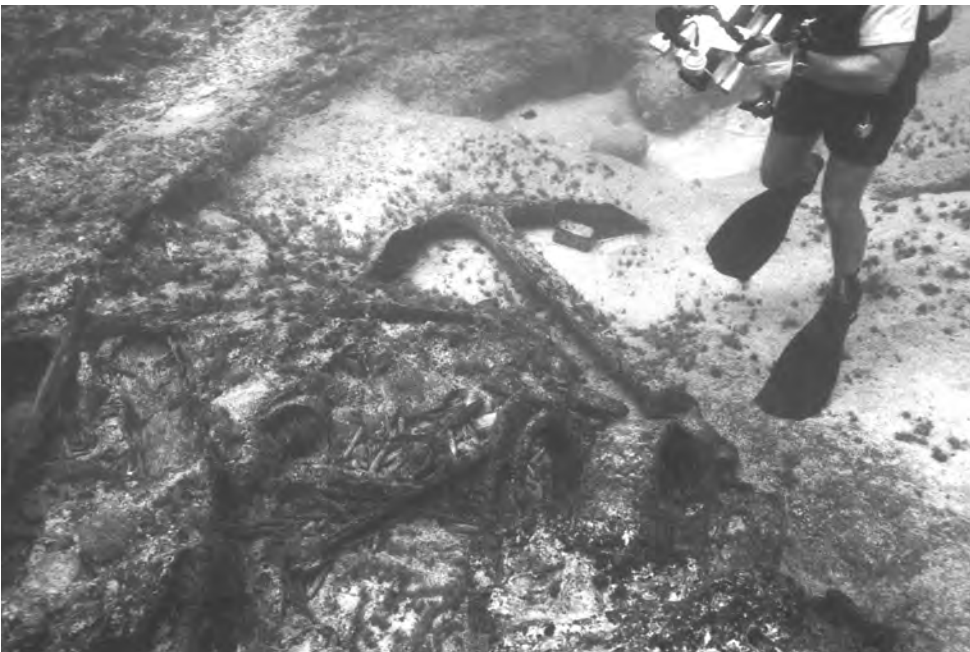
**Figure 29.** The sliding stock anchor and nearby wreckage belong to a nineteenth century vessel wrecked in the same area as the *Jesus, Maria, y Jose* (Program in Maritime Studies, 1996).

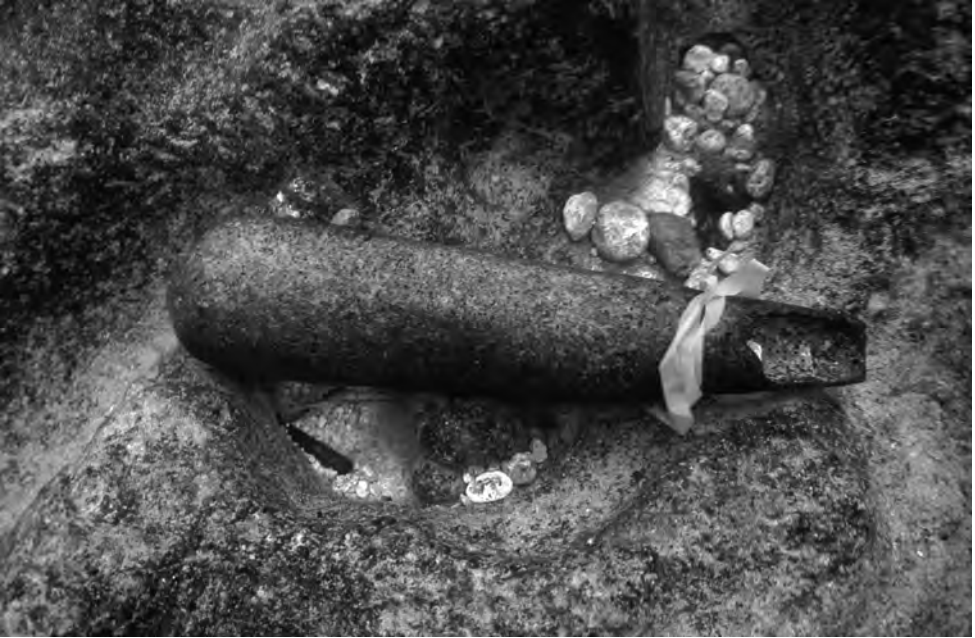
**Figure 30.** Eroded cannon at Scrub Island site probably from the *Jesus, Maria, y Jose* (Program in Maritime Studies, 1996).

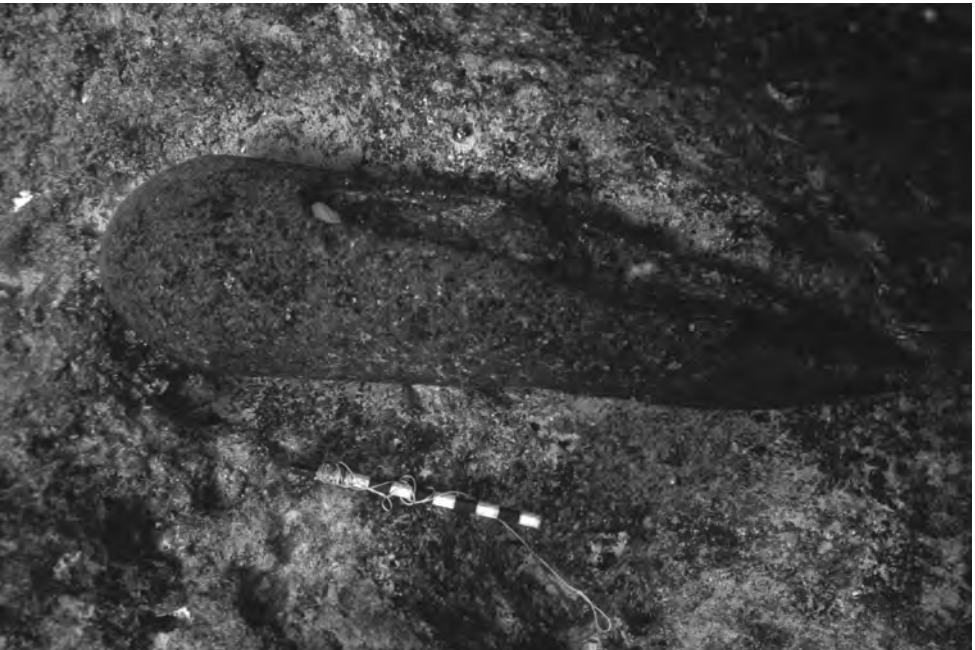
**Figure 31.** Eroded Scrub Island cannon with *in situ* cannon ball (Program in Maritime Studies, 1996).
