In the fall of 2013 and the summer of 2014, graduate students from East Carolina University's Program in Maritime Studies, in collaboration with the UNC-Coastal Studies Institute, carried out a project recording six watercraft from a collection of historical small watercraft collected and maintained by the Whalehead Preservation Trust in Currituck County, North Carolina.

Boats of Currituck:

An Analysis of Six Watercraft from the Whalehead Preservation Trust Collection

East Carolina
UNIVERSITY
Research Report No. 23 (2016)

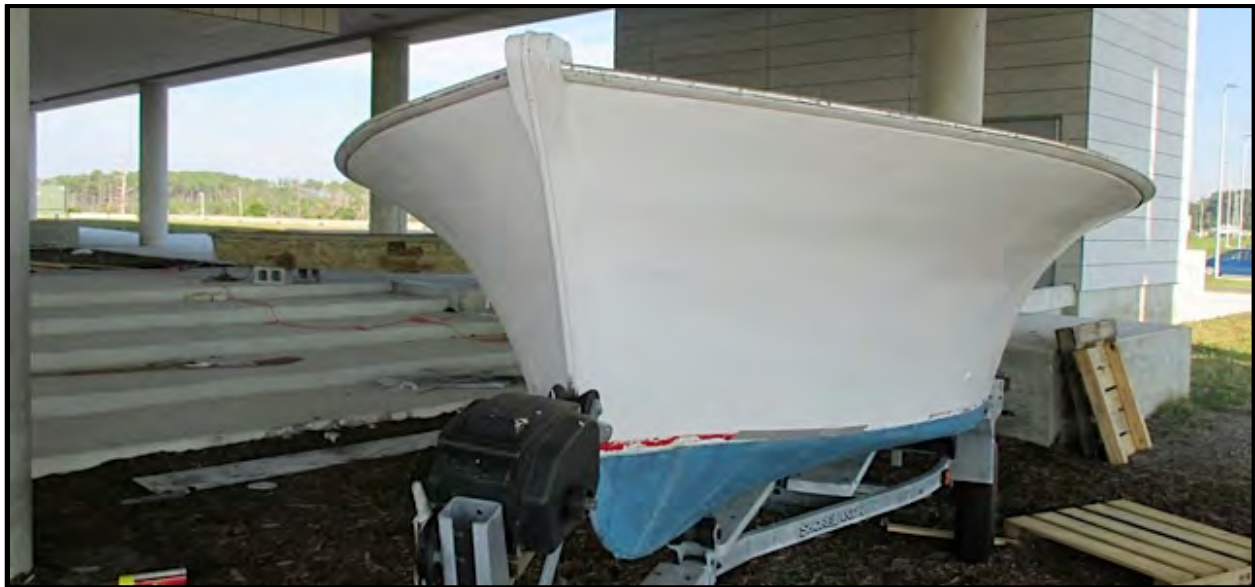
Figure I. *Rebecca's* bow, showing flare and deadrise (Photo by Jeremy Borrelli, 2013).

Rebecca is a V-bottom boat because if the vessel is observed at a cross-section, the lower portion of the boat displays a v-shape that is sharper at the bow and flatter towards the stern, which is indicative of

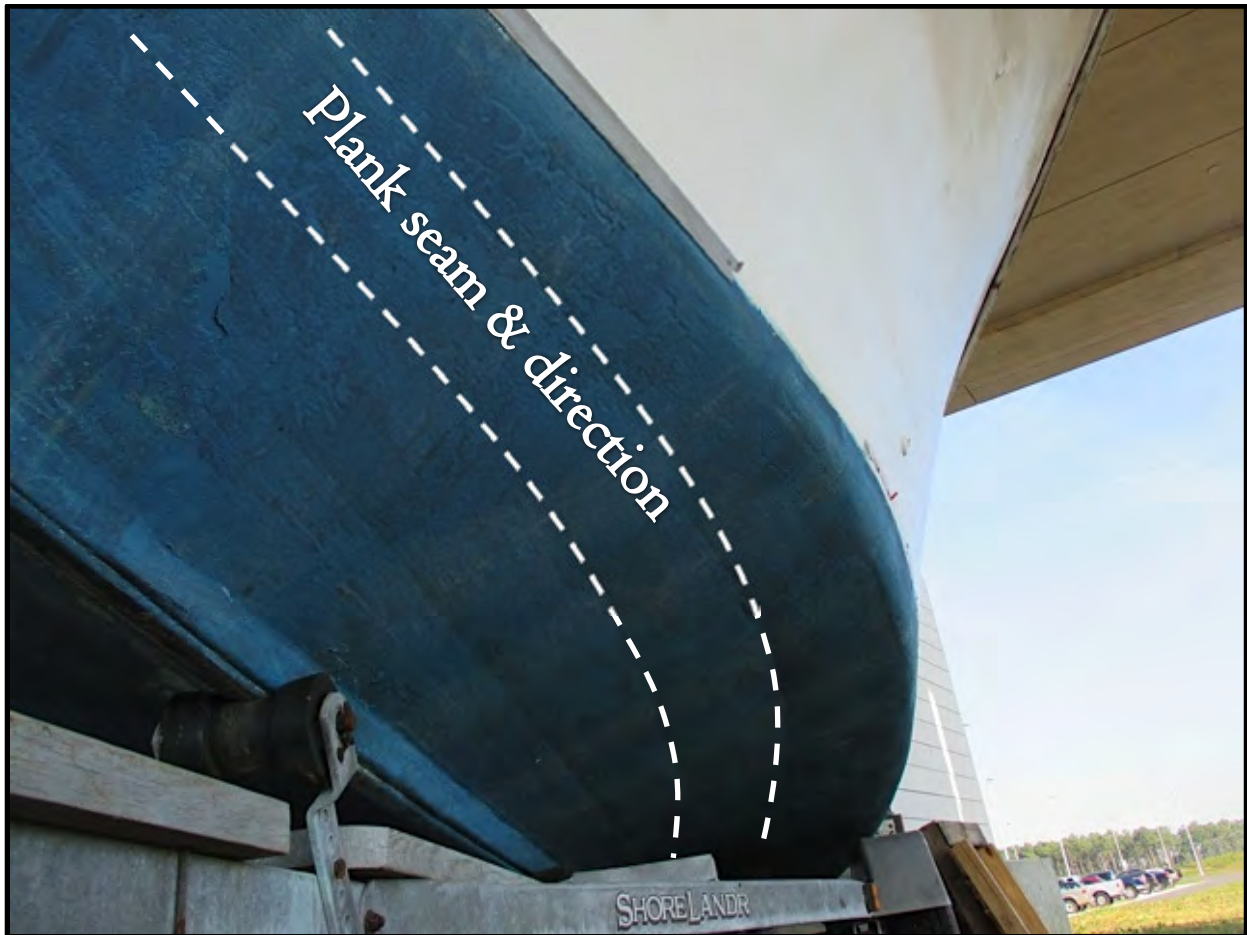
Figure 2. Fore-and-aft running hull planks (Photo by Jeremy Borrelli, 2013).

a v-bottom boat (Alford 1990:11). This construction type is also known as deadrise (Alford 1990:11,44). In North Carolina, a boat building tradition for v-bottomed boats is to run the bottom planks length-wise instead of athwartships (which is the method used for flat-bottom boats) (Alford 1990:2,11). Observations of the underside portion of the vessel reveal large planks which run fore-and-aft (Figure 2). This feature confirms the North Carolina distinctive style of v-bottom boat construction.

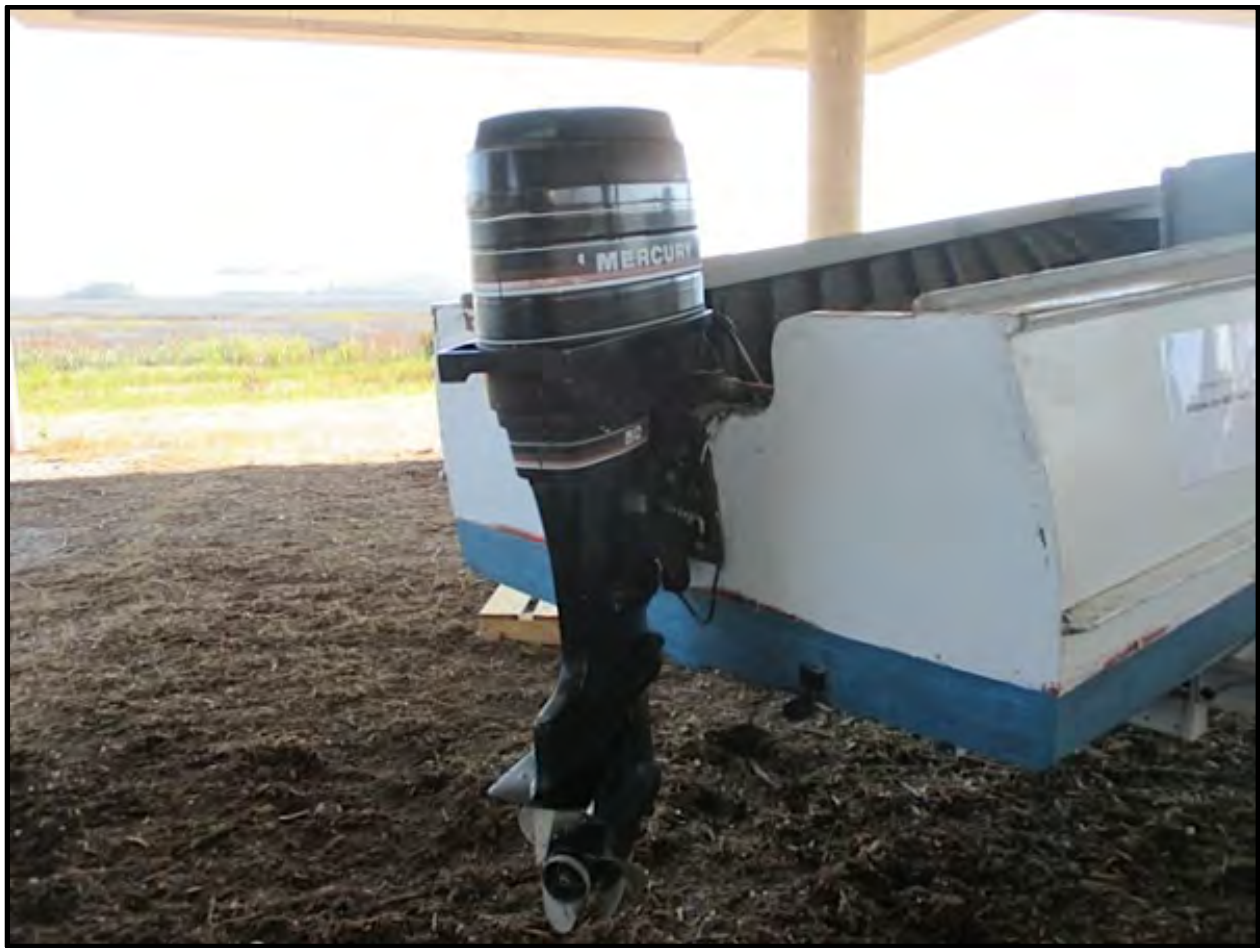
Figure 3. Mercury 50hp outboard motor with single propeller (Photo by Jeremy Borrelli, 2013).

There is an outboard motor on the transom at the stern of the boat. The motor is a Mercury brand two-stroke 50 horsepower (hp) single propeller engine. According to Mark Roberts, the first motor installed on the boat was an outboard motor of 25 hp. This motor was replaced with a more powerful 40

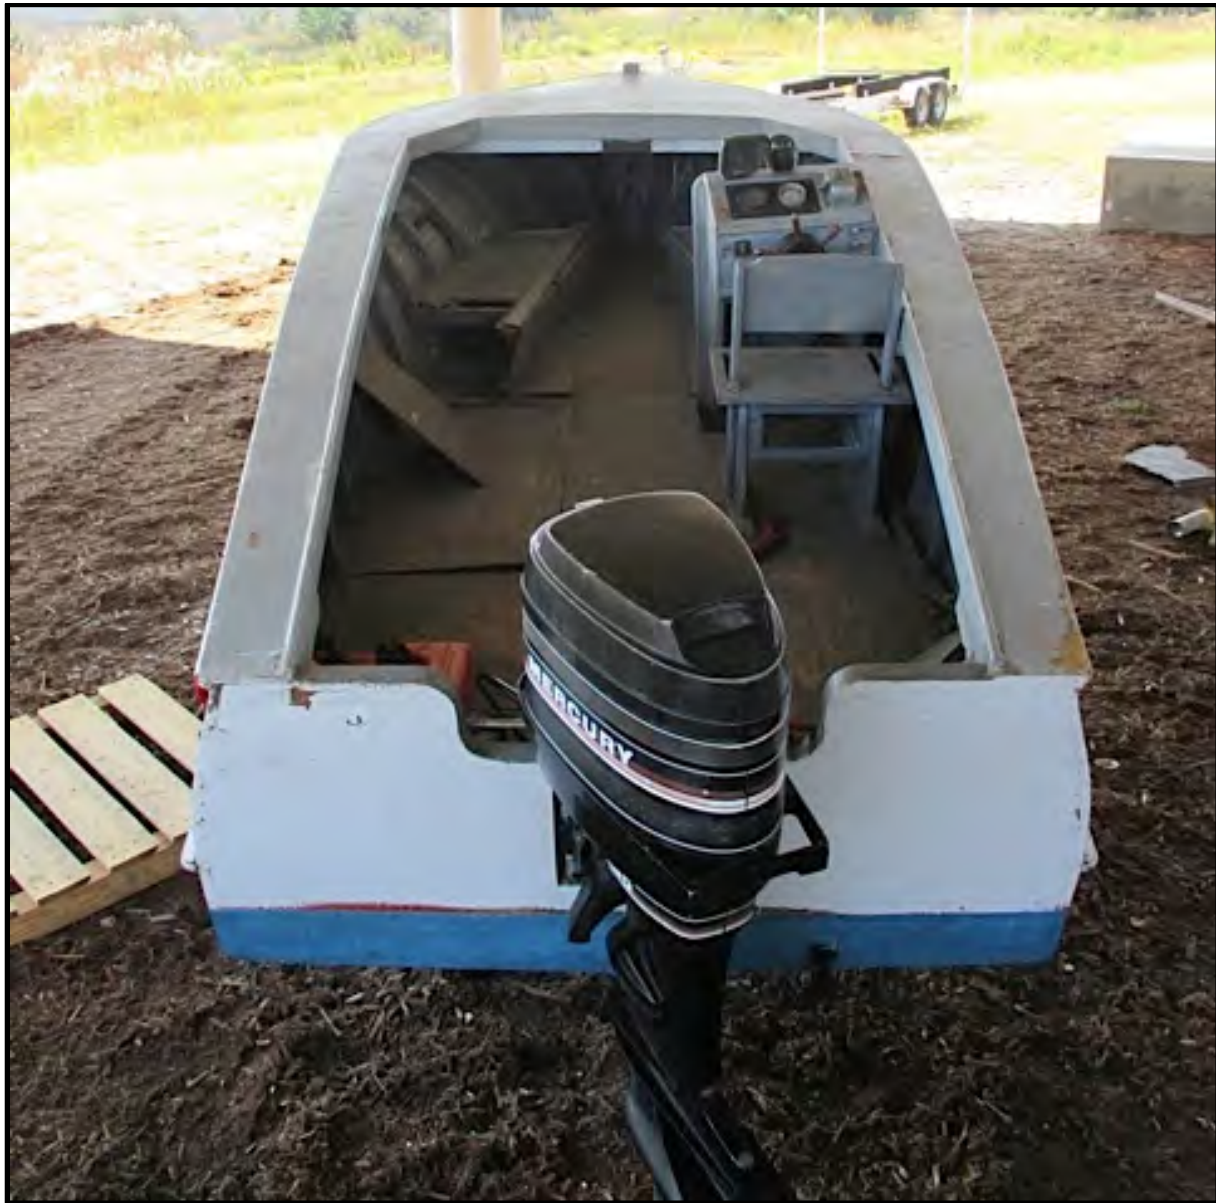
Figure 4. Final Position of the console and chair. (Photograph by Jeremy Borrelli, 2013)

from the center of the boat and moved it to the center starboard side (where it is now). The chairs were designed and built by Oscar Roberts. According to Mark Roberts, Oscar Roberts was a small man and this is the reason why the chairs are somewhat small and also the reason why the console does not provide much leg room. The chairs were designed with a backrest that can be positioned forward or aft depending on the direction a person would like to face while seated (Figure 4). The chairs were not permanently fixed on the boat and could be removed if desired (Mark Roberts, 2014, pers. comm.). The interior of the boat is painted gray-blue.

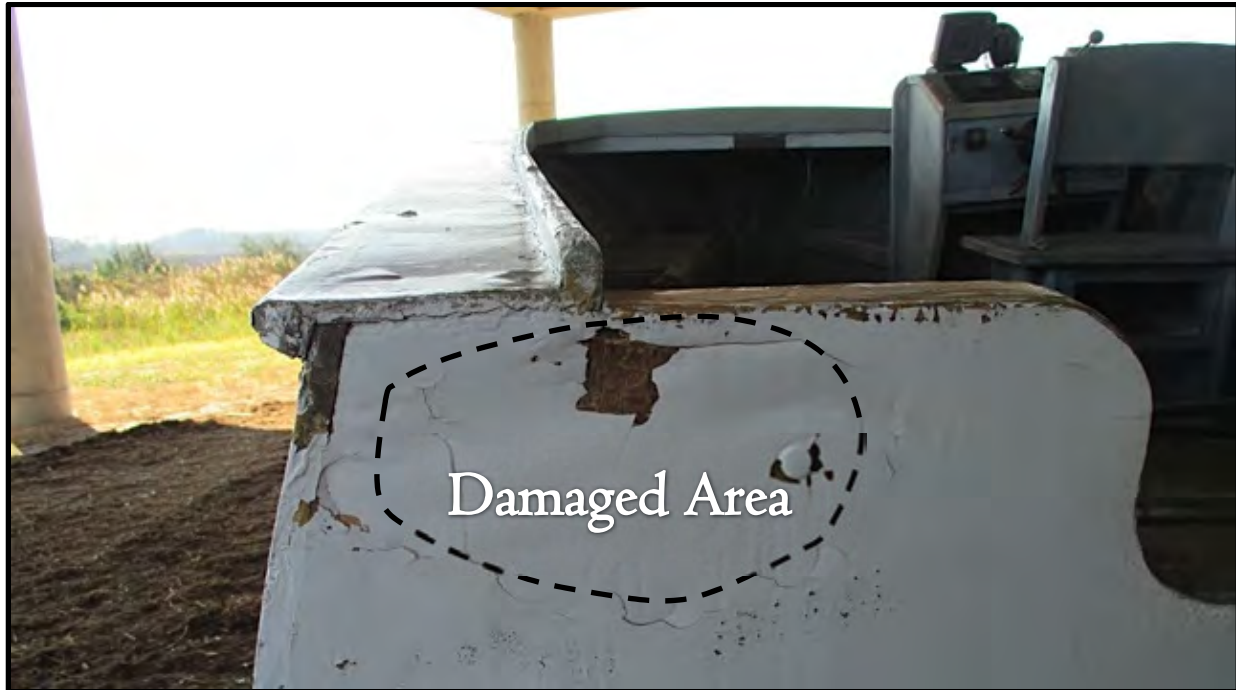
Figure 5. Repaired damage on the portside exterior of the transom (Photograph by Jeremy Borrelli, 2013).

Rebecca is a wooden boat with a fiberglass coating on its exterior. The exterior of the boat appears to have undergone several restorative paint jobs which may indicate that the boat was kept in the water and not pulled up to shore during non-operation. The boat is painted white on the exterior from the rub rail down to the waterline. The waterline and bottom portion of the boat is painted blue, possibly with a lead-based paint to prevent marine growth. Beneath the blue paint, evidence of red paint remains which indicates that the paint from the waterline to the bottom of the boat may have once been red in color before the decision was made to change it to blue. Another possibility could be that the waterline was purposefully painted red and the paint has since faded. Located on the portside exterior of the transom is an area of non-uniformity in both texture and paint layers indicative of damage to the area that underwent repair (Figure 5). During the interview with Mark Roberts, he confirmed the area has been damaged in an accident and was repaired (Mark Roberts, 2014, pers. comm.).

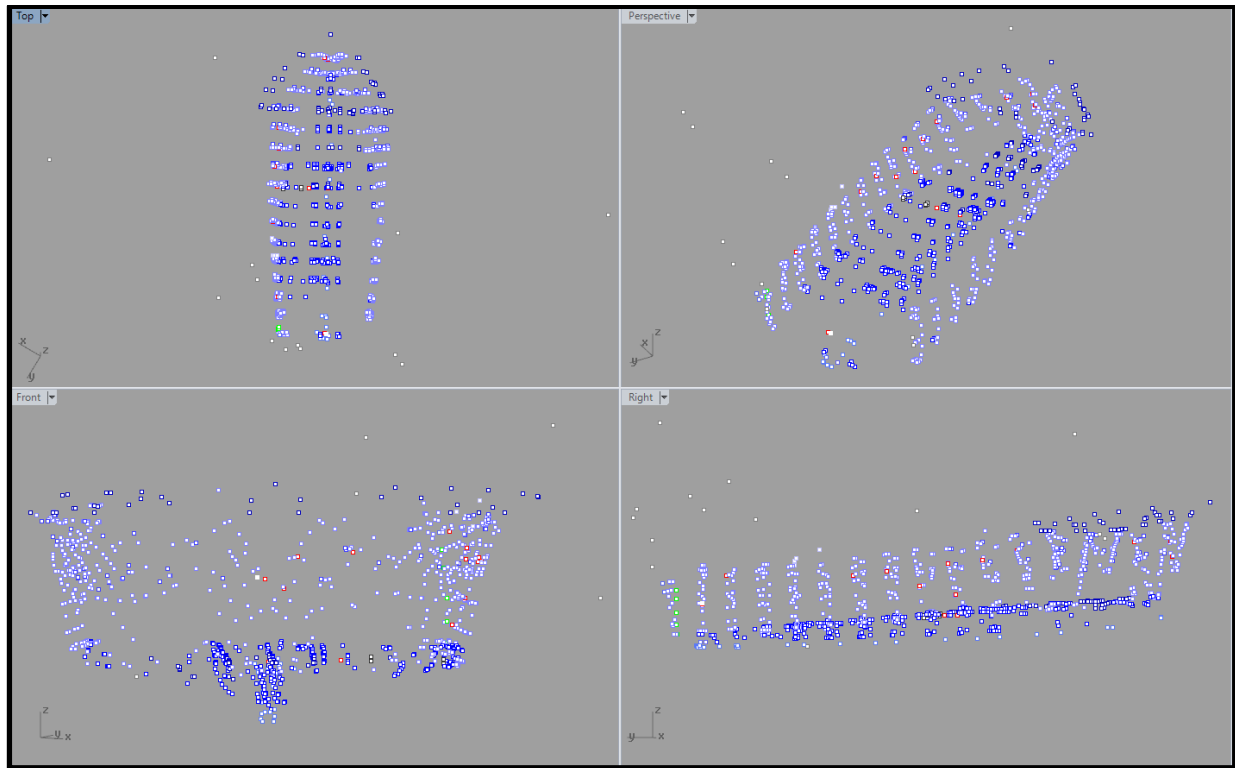
Figure 7. Point data of *Rebecca* displayed in *Rhinoceros*, with features organized by color, with viewports from top, perspective, front, and right (L to R) (Image by Nathan Richards)

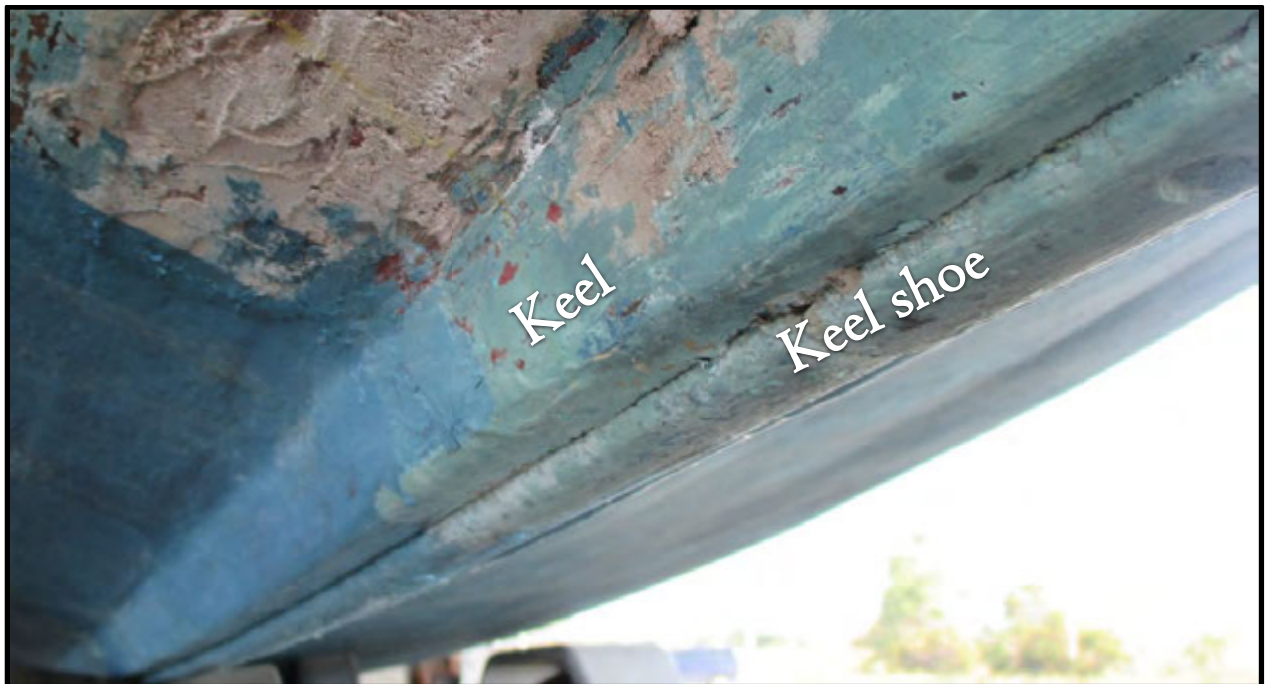
Figure 11. Keel and keel shoe, starboard side (Photo by Jeremy Borrelli, 2013).

The keel measured 431 cm (169.69") long by 6 cm (2.36") sided by 9 cm (3.54") molded. Along the exterior and interior of the keel it could be seen that in various places the wood was joined to make a solid keel. However, due to the fiberglass and paint on the hull it is unclear in what manner the keel pieces were joined together to make a solid structure. The interior part of the keel is block-like. Once it reaches the exterior of the hull it begins to taper in a v-fashion to a thinner dimension. The front of the keel curved up to meet the rise of the bow and the stem (Figure 10). Its molded dimension also decreased as it reached the stern for less drag. It was, however, unclear where the keel ended and the stem began. The stern of the keel had a most interesting feature; 36 cm (14.17") before reaching the transom, the keel was notched, losing the large majority of its depth past the keel. For the last 36 cm (14.17") of the keel it was only 1.3 cm (0.51") deep rather than 9 cm. (3.54"). It does not appear that this portion was lost during an incident--rather it was purpose-built this way, most likely to increase the flow of water over the outboard engine. The keel shoe was quite small, measuring only 2.5 cm (0.98") wide by 0.5 cm (0.2") deep. It was also made of several pieces and attached to the keel with screws. Rather than running to the very stern of the vessel, it ended at the notch near the aft end of the keel (Figure 11 and 12).

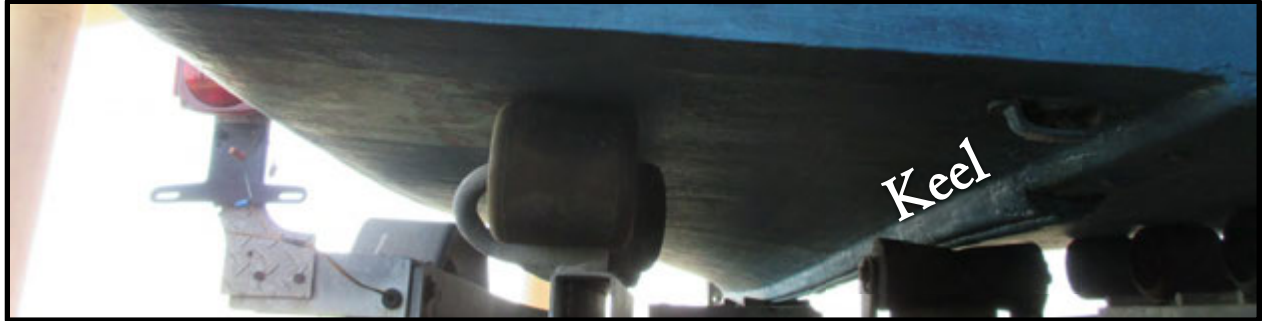
Figure 12. Stern portion of keel (Photo by Jeremy Borrelli, 2013).

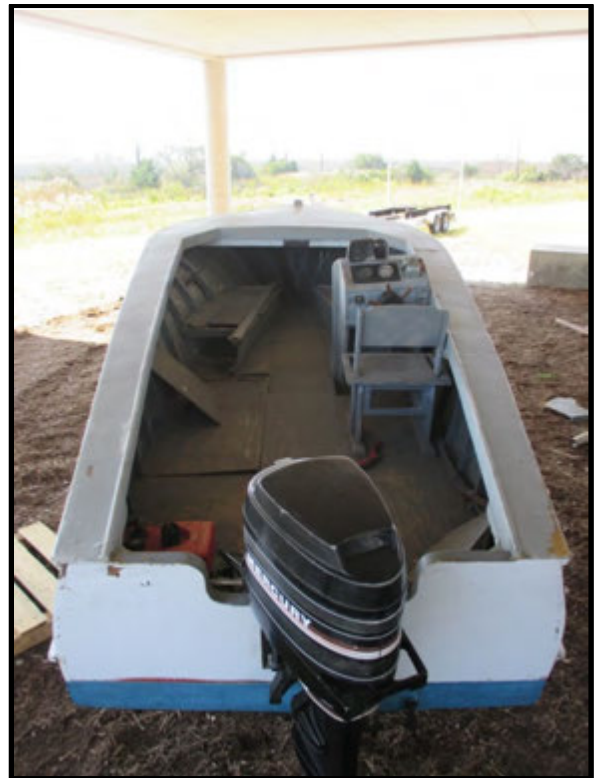
Figure 13. Upper deck and transom of *Rebecca* (Photo by Jeremy Borrelli, 2013).

The upper deck lies flush over the hull planking and extends into the interior of the vessel. At the stern it measures 10 cm (3.94") wide and is supported by a lodging knee on each side. Two-thirds of the way up the vessel it begins to broaden, quickly becoming a solid piece from side to side. From the stem, where it is a full piece, it extends 118 cm (46.5") towards the stern ending, allowing for the open area of the interior. Under the upper deck it is further supported by top timbers which join to the frame sets, small triangular hanging knees that join to the forward face of the top timbers, and a deck beam which joins to the forward face of the hanging knee running perpendicular to the hull. A batten then joins to the forward face of the deck beam and aft face of the next top timber. It appears that the deck is made of three pieces of wood. Each long side is a single piece and the board bow section is also a single piece. The upper deck is also fibreglassed and painted white (Figure 13).

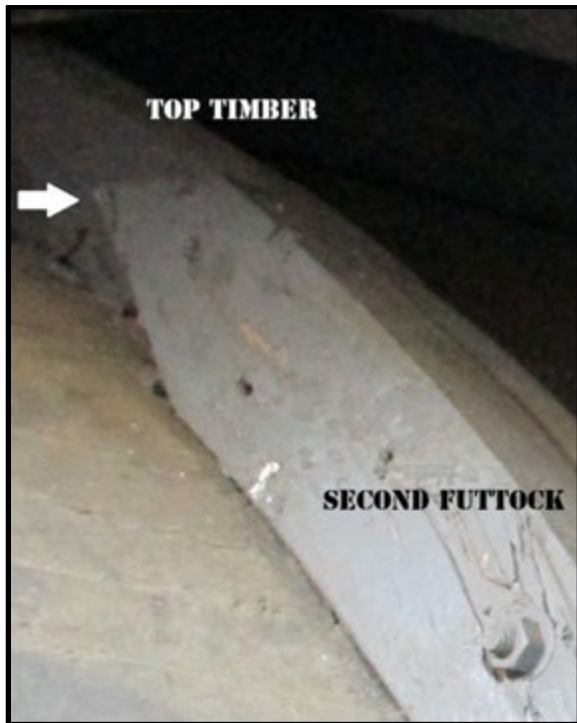
Figure 17. Image showing the beveled end of the second futtock in the second frame set (Photo by Jeremy Borrelli, 2013).

general, these dimensions for the futtocks are also similar throughout the boat. The end of the second futtock is beveled, however, a feature which is not present in the other frames. This is indicative of a change in the shape of the hull outlined below (Figure 17). A little more than halfway up the second futtock, a top timber is bolted to its forward face. The top timbers have a sloping edge on their lower end and extend upward another 60 cm (23.6") to the deck, where they are bolted to a deck beam. These have a sloped edge on the lower side of the timber and are in the same general location frame to frame.

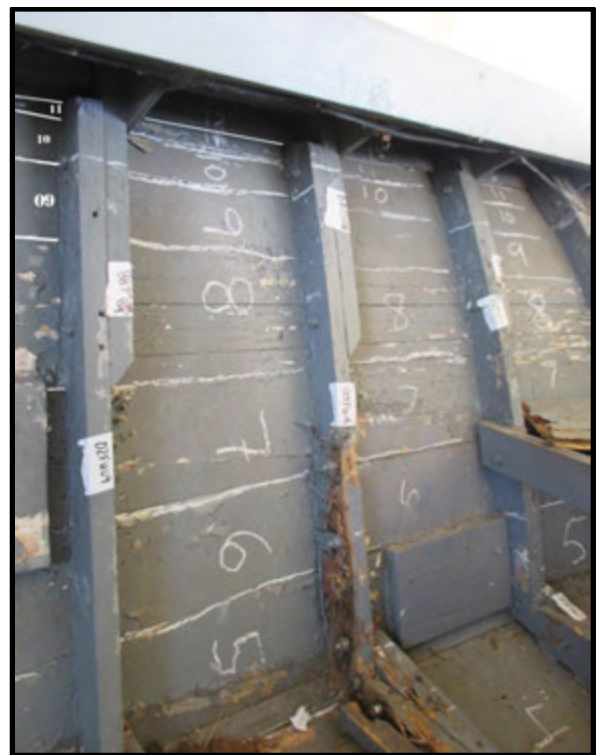
Figure 20. Image showing the port planking above the chine, with the beginning of the eleventh strake in line with the tops of the second futtock indicating the original height of the hull (Photograph by Jeremy Borrelli, 2013).

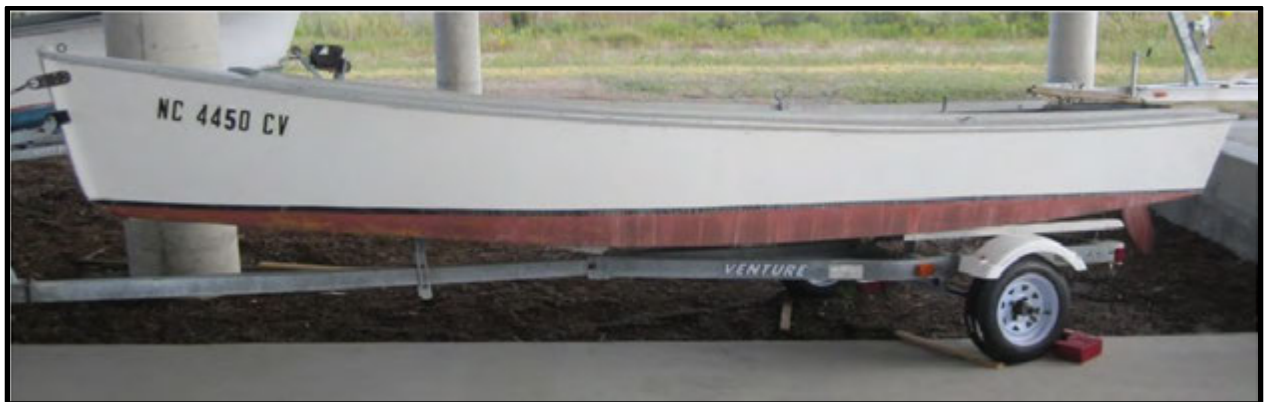
Figure 22. Vessel Number 2013.09.04 in its position to be measured (Photograph by Alyssa Reisner, 2013).

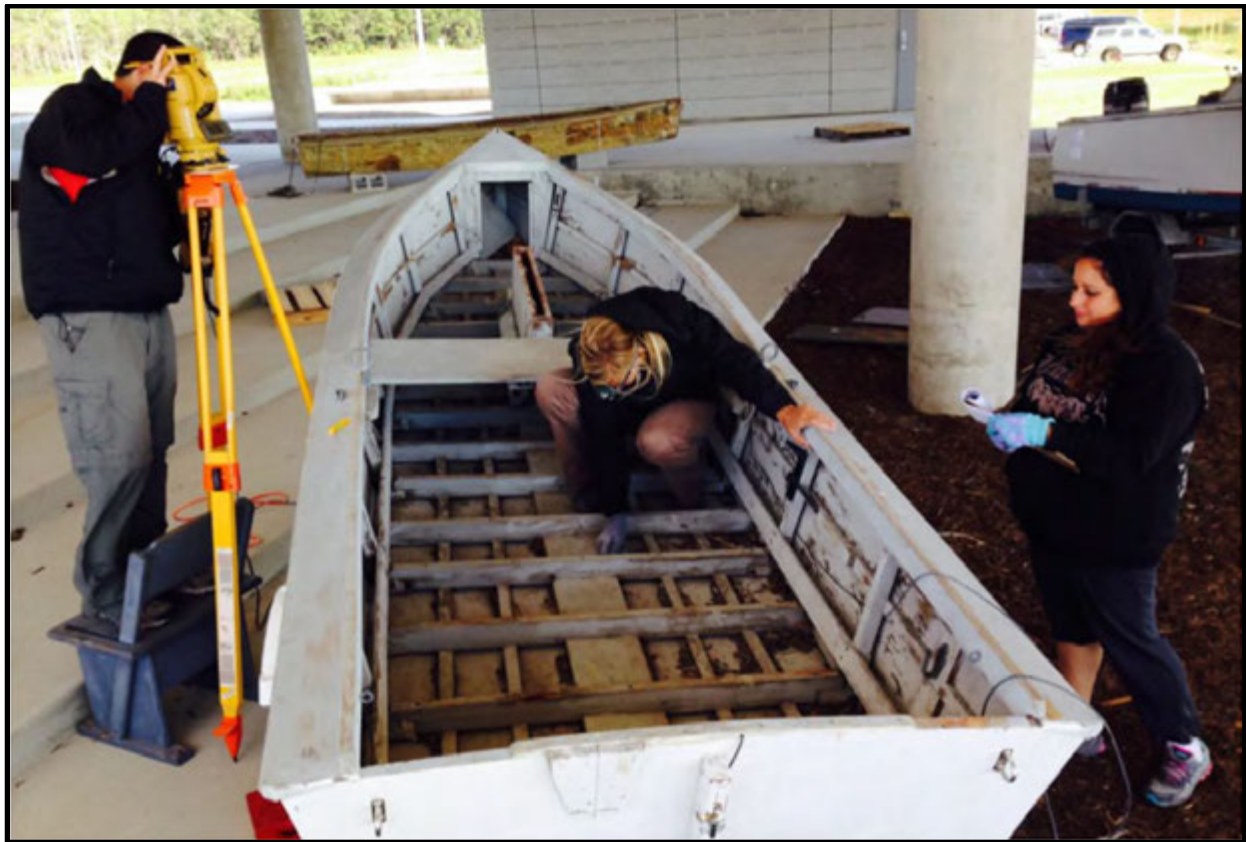
Figure 26. The authors at work shooting total station points (Photograph by Caitlin Zant, 2013).

best recording position—allowing the total station to record on an elevated level looking down into and around the boat. Similarly, it allowed the total station to be lowered to the ground with access to the bottom of the boat. The boat’s location also provided more innovative recording techniques using the assistance of a truck—capturing points through the elevated deployment of the total station in the bed of the truck and on a stool (Figure 26).

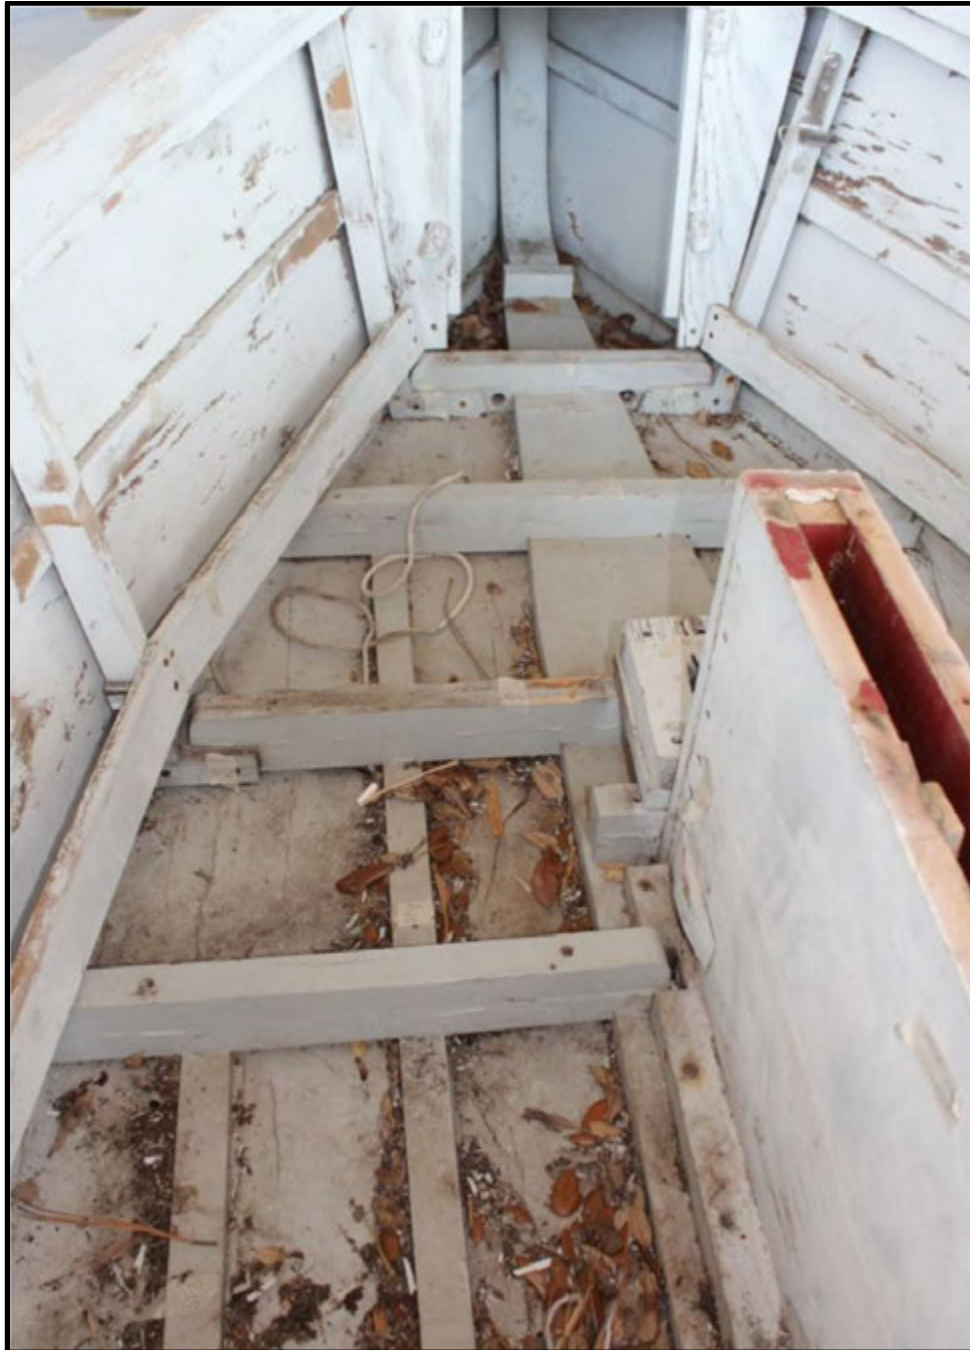
Figure 32. Bow of the vessel, including the floors, centerboard, and storage locker (Image courtesy of Caitlin Zant, 2013).

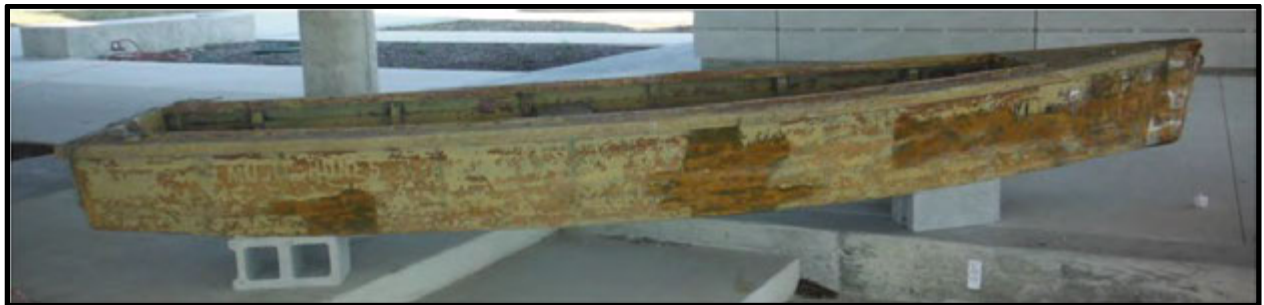
Figure 39. *MoJo Bones* setup for recording (Photo by Ryan Bradley, 2013).

The goal of this project was to record *MoJo Bones* in as much detail as possible in the allotted time; there were five working days to record the 467 cm (183.86") flat bottom boat (Figure 39). The final project entailed the creation of a three-dimensional model through the use of the computer program *Rhinoceros*. To transfer data from the field to the program required the use of a total station and hand-drawn recordings.

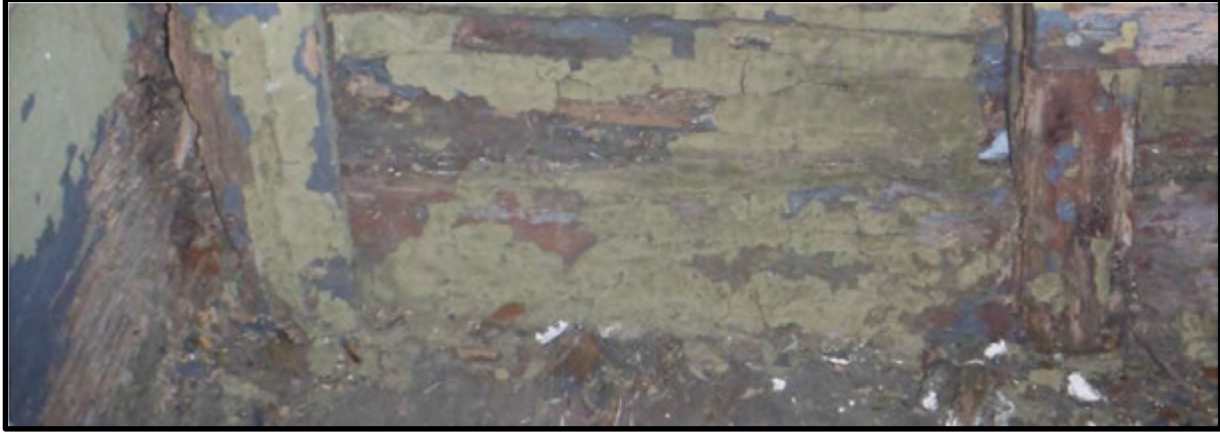
Figure 45. Deteriorated condition of aft port stringer. (Photo by Ryan Bradley, 2013).

The deterioration of both the starboard and port side aft stringers suggests that the stern of the vessel faced more stress or use than other sections of the boat. The portside stringers also show paint deterioration similar to their starboard counterparts (Figure 45). Overall, it appears that the stringers on the starboard and port sides are mirror images of one another, minus the deterioration.

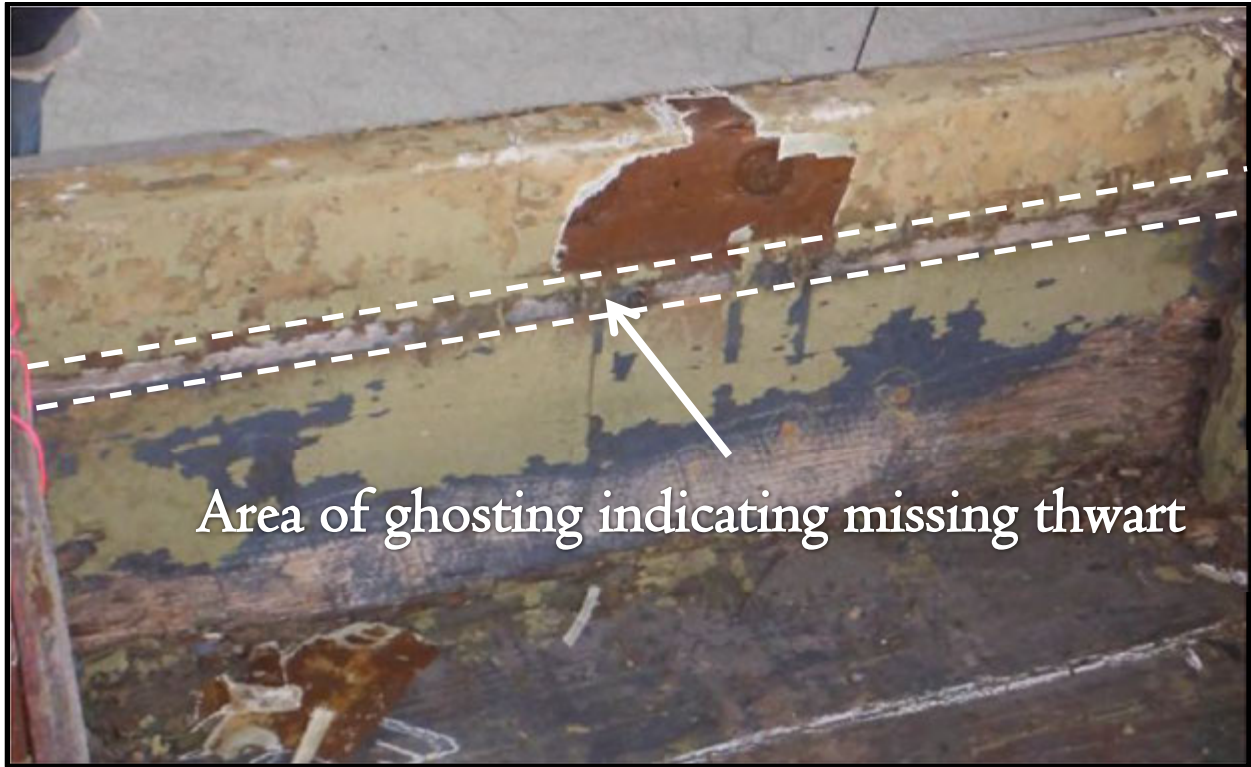
Figure 46. Example of ghosting, indicating missing stern thwart. (Photo by Ryan Bradley, 2013).

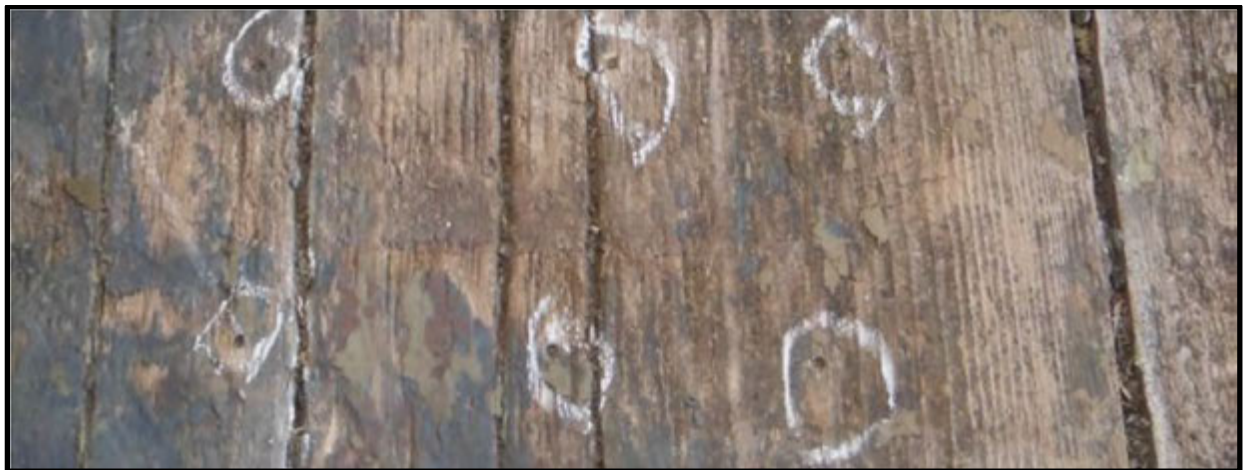
Figure 47. Fastener holes in the hull planking (circled with chalk) associated with stanchion braces in the stern. (Photo by Ryan Bradley, 2013).

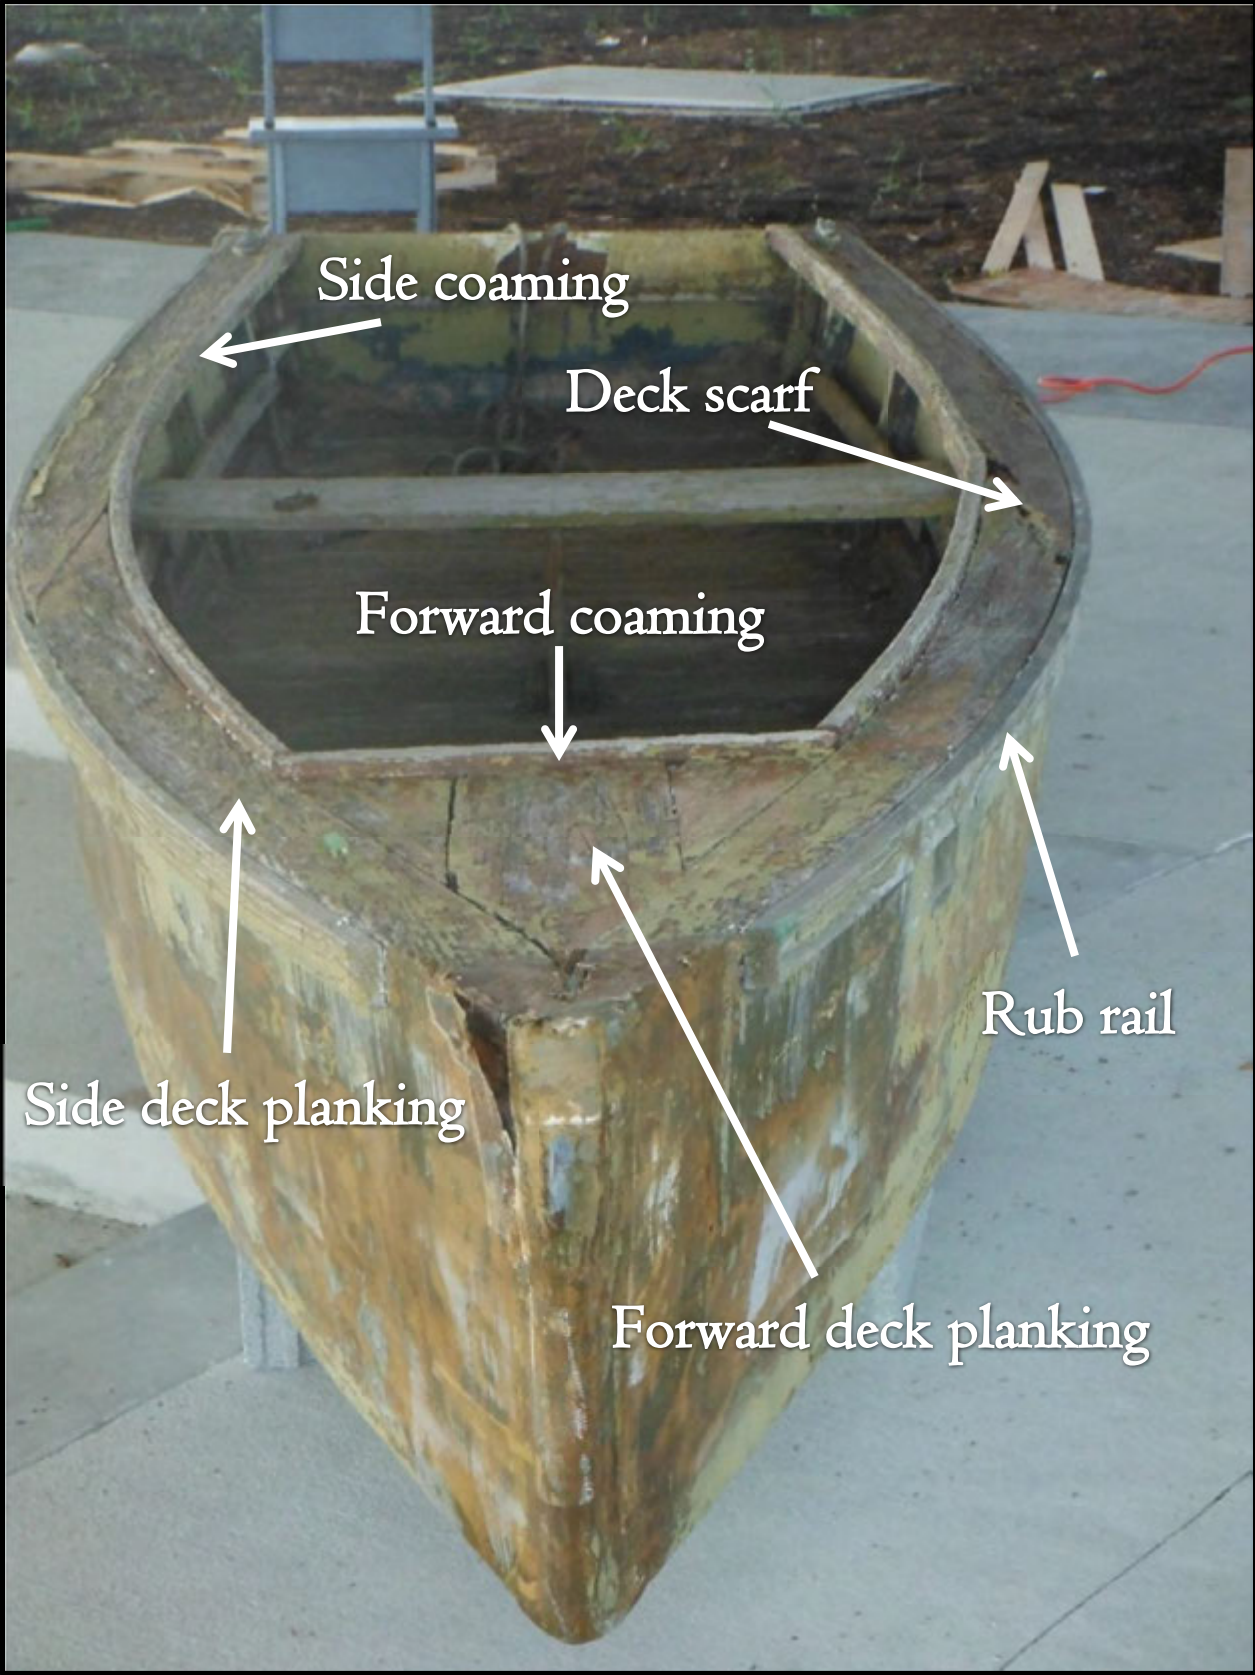
Figure 48. Forward deck, side deck, coaming, and rub rail (Photo by Ryan Bradley, 2013).

The weather deck structure includes the deck's planks, deck beams, coaming, and rub rail (Figure 48). There are three deck beams at the bow of the boat, used to support the forward and side deck planking. The first deck beam is located slightly aft of the stem and the third beam located slightly forward of the

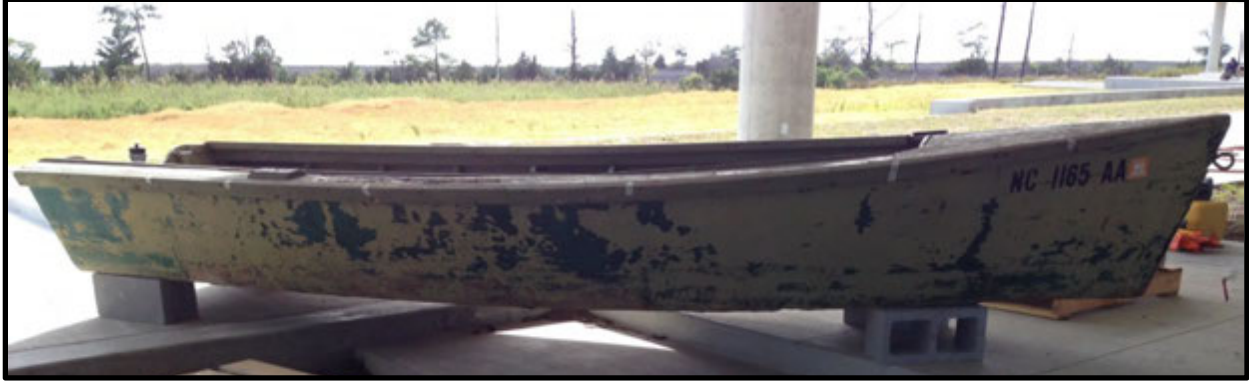
Figure 50. Photograph of North Carolina Skiff WPT#2013.09.09 (Photograph by William Sassorossi, 2013).

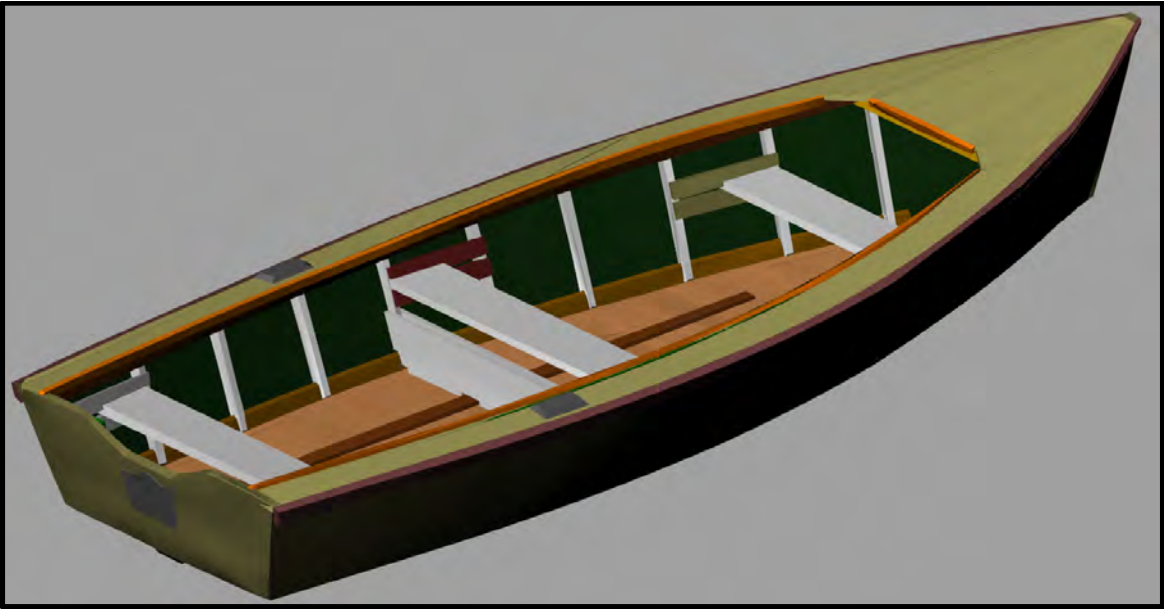
Figure 52. Perspective view of final rendered virtual model of North Carolina Skiff WPT#2013.09.09 (Image by Nathan Richards).

From 11 October through 4 December, 2013, the team organized their point data, reviewed every point to ensure it was on the correct feature layer and imported the data set into *Rhinoceros 4* software. The goal was to construct a three-dimensional model from the point cloud and hand measurements which could be used both for archival purposes and to assist in the examination of structural properties. The recorders divided the work by construction features, each working with separate layer groups. After features were thus individually constructed within the software, the vessel was virtually reassembled according to an hypothesized building sequence (Figure 52).

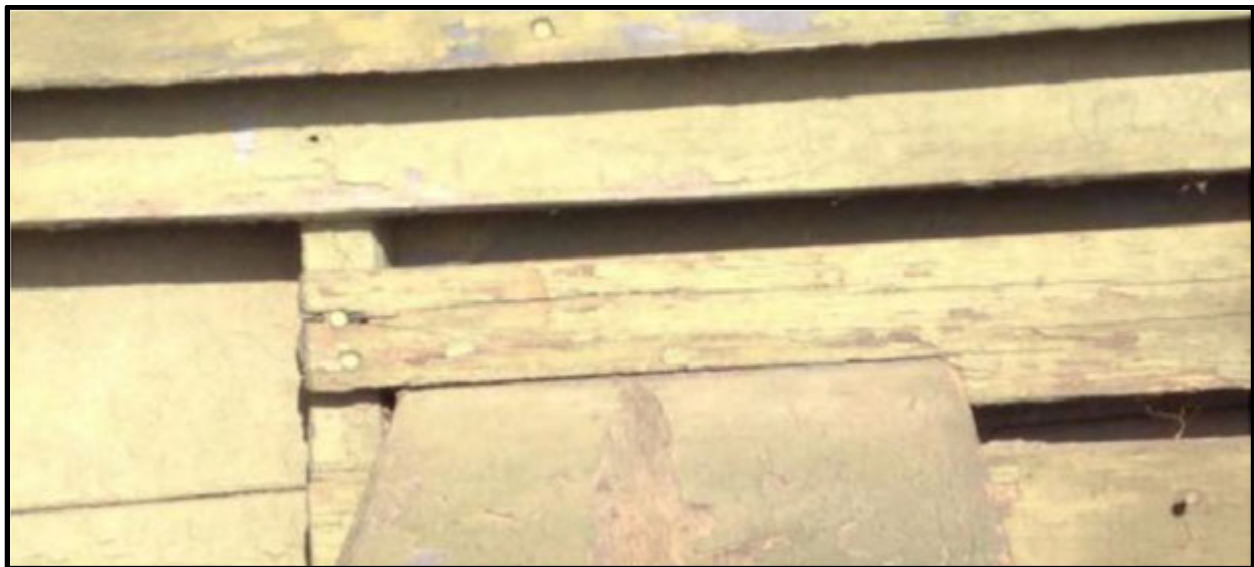
Figure 58. Thwart 3 on the starboard side showing its placement between the notched thwart support and the frame (Photo by William Sassorossi, 2013).

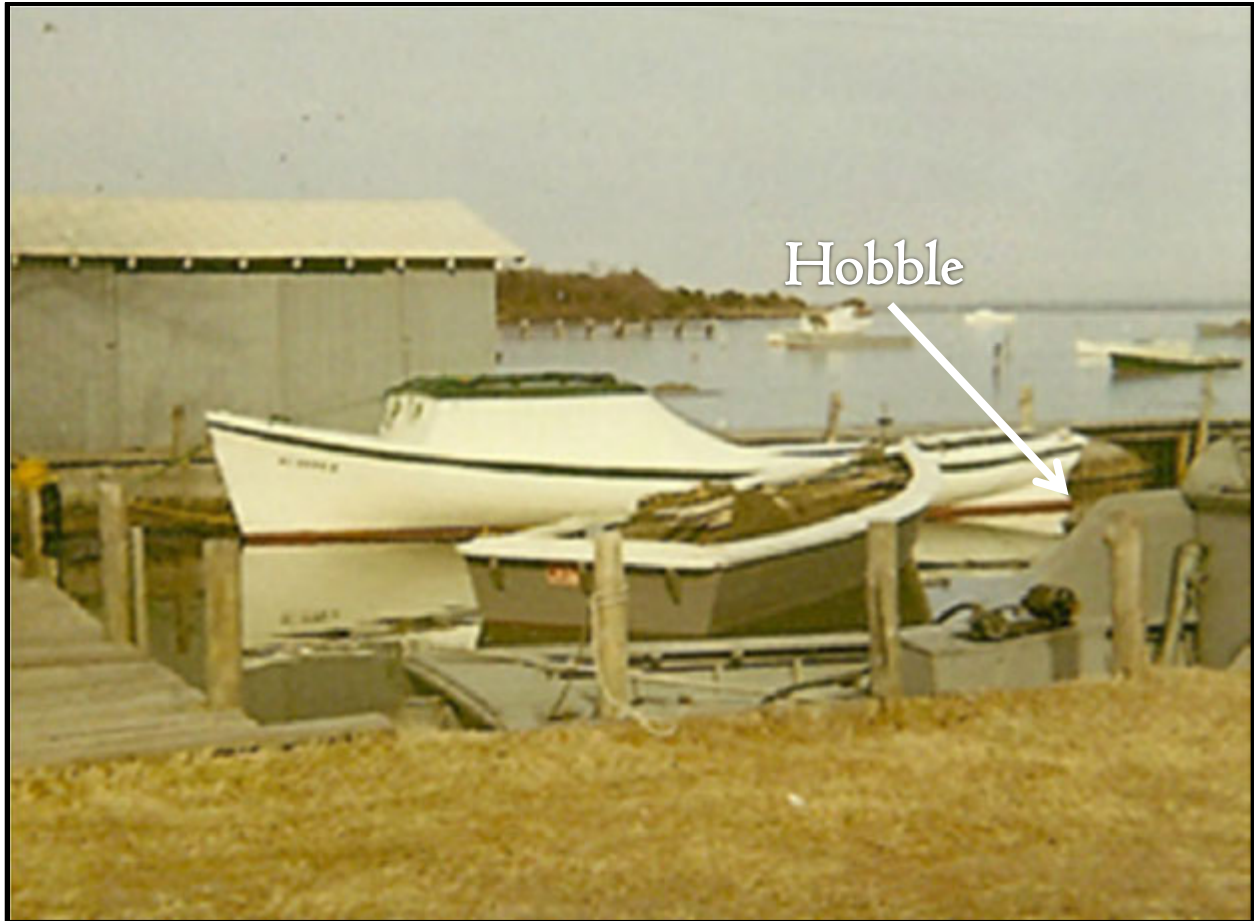
Figure 63. Picture of Hambone's Shad Boat with the hobble still attached (Photo courtesy of Travis Morris).
