In the fall of 2013 and the summer of 2014, graduate students from East Carolina University's Program in Maritime Studies, in collaboration with the UNC-Coastal Studies Institute, carried out a project recording six watercraft from a collection of historical small watercraft collected and maintained by the Whalehead Preservation Trust in Currituck County, North Carolina.

Boats of Currituck:

An Analysis of Six Watercraft from the Whalehead Preservation Trust Collection

East Carolina
UNIVERSITY
Research Report No. 23 (2016)

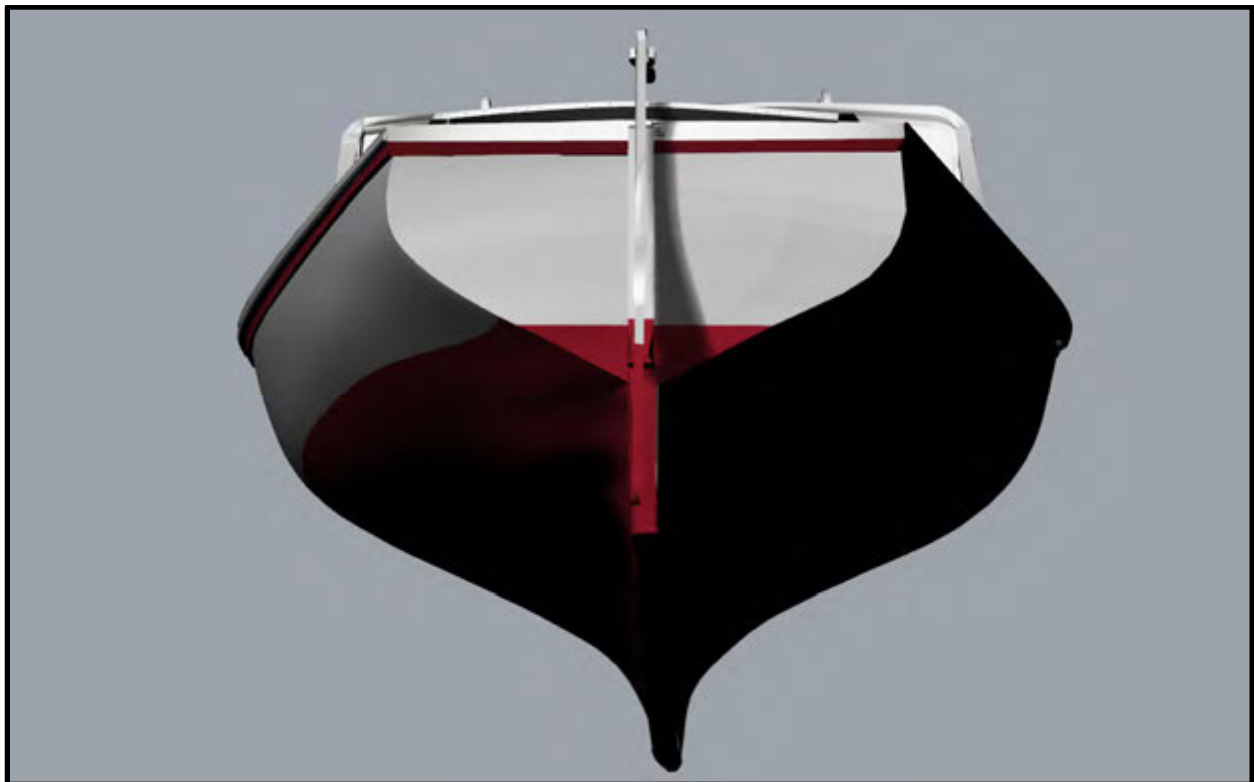
Figure 65. Heart-shaped stern from the 3D model (Image by Ryan Bradley and Jeremy Borrelli).

Another modification that was necessary to make these craft engine adequate was the addition of the “hobble.” Daniels likely figured out quickly the boat was unable to get up on a plane thanks to the significant tuck of the heart-shaped stern (Harrison 2012) (Figure 65). An unknown individual managed to solve this problem by boxing in the stern with a series of squat boards (Figure 66).

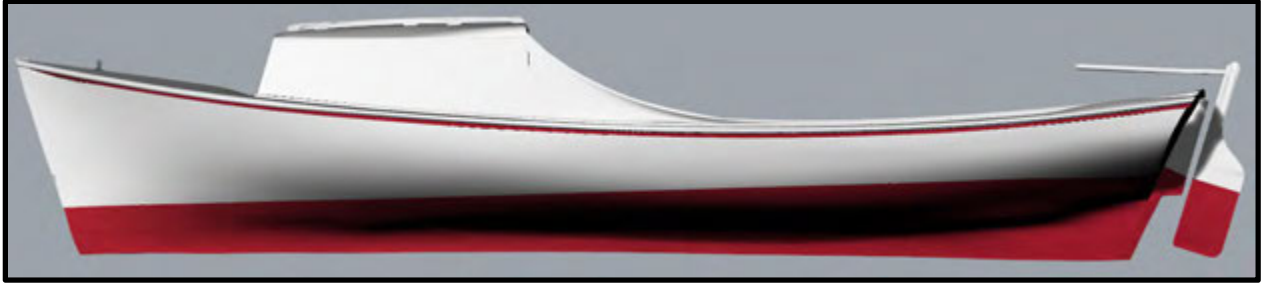
Figure 66. *Rhinoceros* model of Hambone's boat without the hobble (Image by Ryan Bradley and Jeremy Borrelli).

This flattened out the aft-hull section forcing the stern to rise up on top of the water at higher speeds. Builders such as Dough altered the construction of the now gas powered shad boats to reduce the tuck. This model could be compared to other examples of shad boats to see if the tuck on this boat is reduced. Given the fact that its building date preceded the introduction of gas motors by two years, it should be closer to the sailing vessel variety. As the horsepower increased, the shad boat still relied on the hobble for proper planing at higher speeds. Despite the advantages offered by the hobble it did have its drawbacks. A significant downside was the constant threat of rot. Because it was an aftermarket alteration there was a separation between the hull and hobble which trapped water and leaked (Harrison 2012).

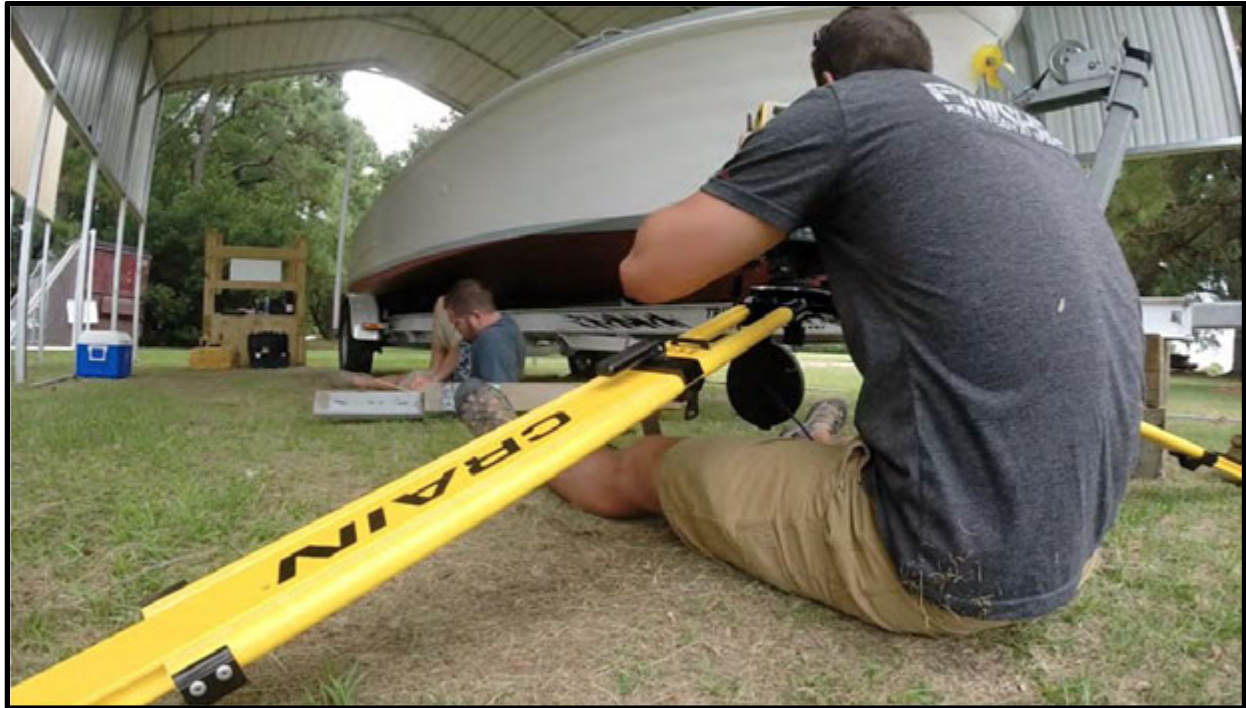
Figure 70. Photo illustrating the two-person team digitally mapping the exterior hull of the boat. Spotter Ryan Bradley catalogues the points on the hand drawings and shooter Jeremy Borrelli maneuvers the total station to the locations on the boat indicated by the spotter (Photography by Jeremy Borrelli, 2014).

To ensure accurate recording, a two person team was needed to operate the total station: a shooter controlled the station and organized the points as they were shot, and the spotter determined and guided the shooter to the best spots on the boat to shoot in. The spotter was also responsible for logging each point taken on the hand drawings so that a detailed record of the points already taken and potential future points could be evaluated (Figure 71). Points were shot first along the exterior of the boat to obtain the curvature of the hull and tunnel shape, and then the interior structure. As points were shot, they were saved

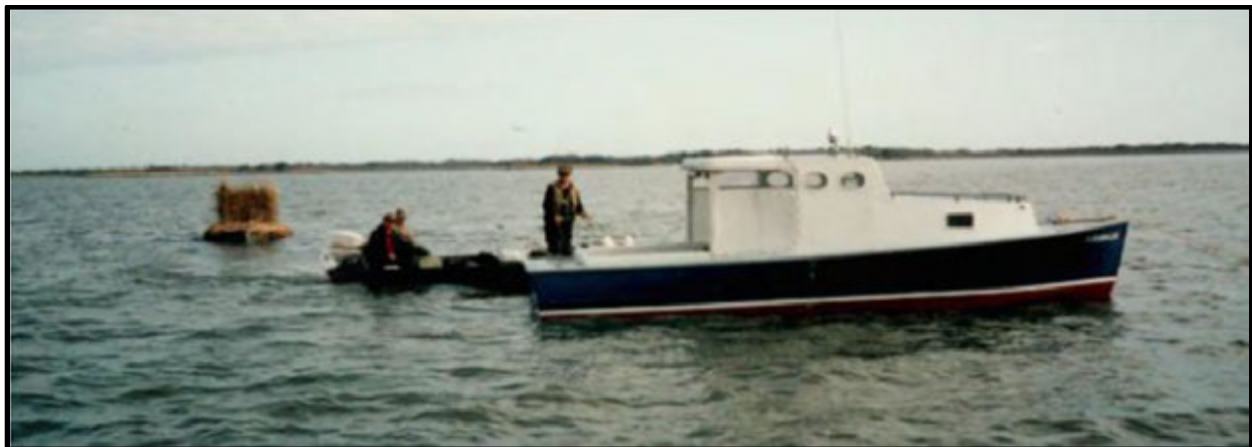
Figure 77. Image showing a tunnel boat in action tending to a hunting skiff and blind during hunting season. The boat depicted was the second concave tunnel boat built by Patrick H. O'Neal for the Bells Island Hunt Club in 1948, named Mother Goose by its second owner at Piney Island (Photo courtesy of Travis Morris).

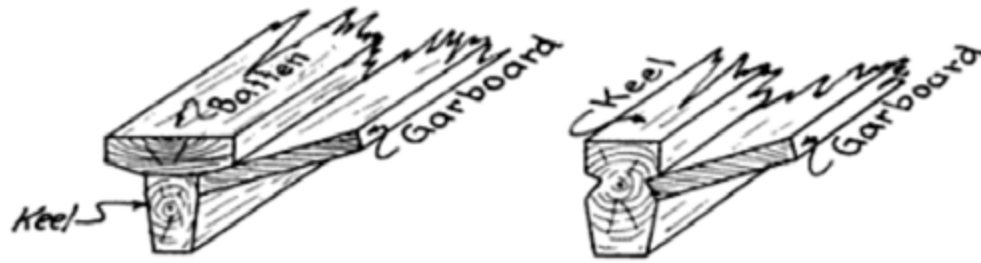
Figure 78. Image of two different types of keel potentially used when building the Slick Boat (Chapelle 1994:43).

The Slick Boat is a 6.48 m by 2.68 m (or 21.25 ft. by 8.75 ft.) concave tunnel wooden motorboat. The hull consists of a complex keel, three-piece stem, flat transom, and a single layer of planks running fore to aft. Juniper is the only type of wood used in the boat, which was common during the time it was constructed due to its natural abundance along the coastline of North Carolina. The fully formed keel is 493 cm (194.09”) long, 5.48 cm wide (2.16”), and 40.19 cm (15.82”) high in the stern and slopes to an estimated 12 cm in height where it meets the stem. On the interior of the vessel the keel widens to 20 cm (7.87”). This widening could be evidence of two possible types of keel: batten and rabbeted (Figure 78). Based on the increased width of the interior keel of the Slick Boat, it is more likely the battened keel technique was used in this instance.

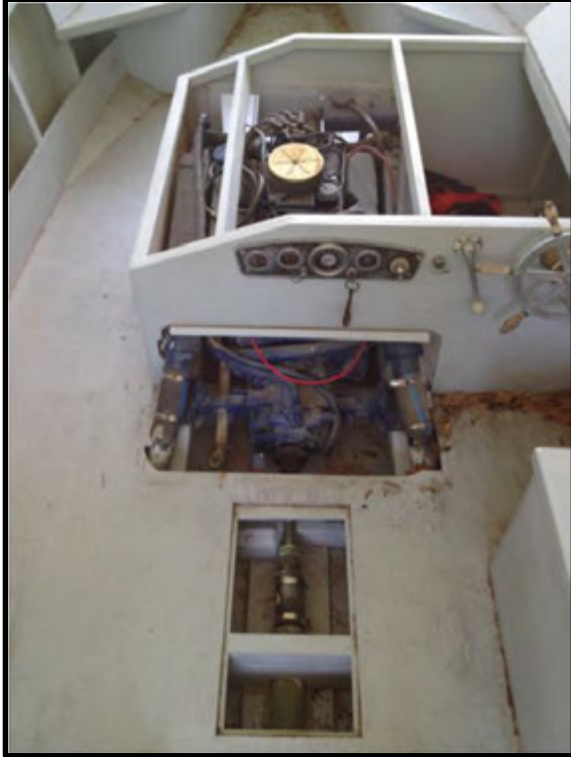
Figure 80. Photo showing the engine compartment and ignition controls (Photo by Jeremy Borrelli, 2014).

To house the engine of the boat, a separate compartment was built with a folding top for easy access to the machinery. The wheel and controls were placed on the aft face of the box (Figure 80). The propeller ran into the keel structure aft of the tenth frame and two exhaust pipes ran aft and through the transom just above the waterline.
