# An Investigation of the Remains of the Confederate Gunboat *CSS Chattahoochee*

Produced for  
The James W. Woodruff, Jr.  
Confederate Naval Museum  
Columbus, Georgia

Produced by  
Gordon P. Watts, Jr.,  
Richard Stephenson,  
William N. Still, Jr.,  
Wesley K. Hall,  
Bradley A. Rodgers  
Kathryn Bequette  
David Beard  
Kevin Foster

The Program in  
Maritime History  
and Underwater Research  
Greenville, North Carolina 27858  
1990

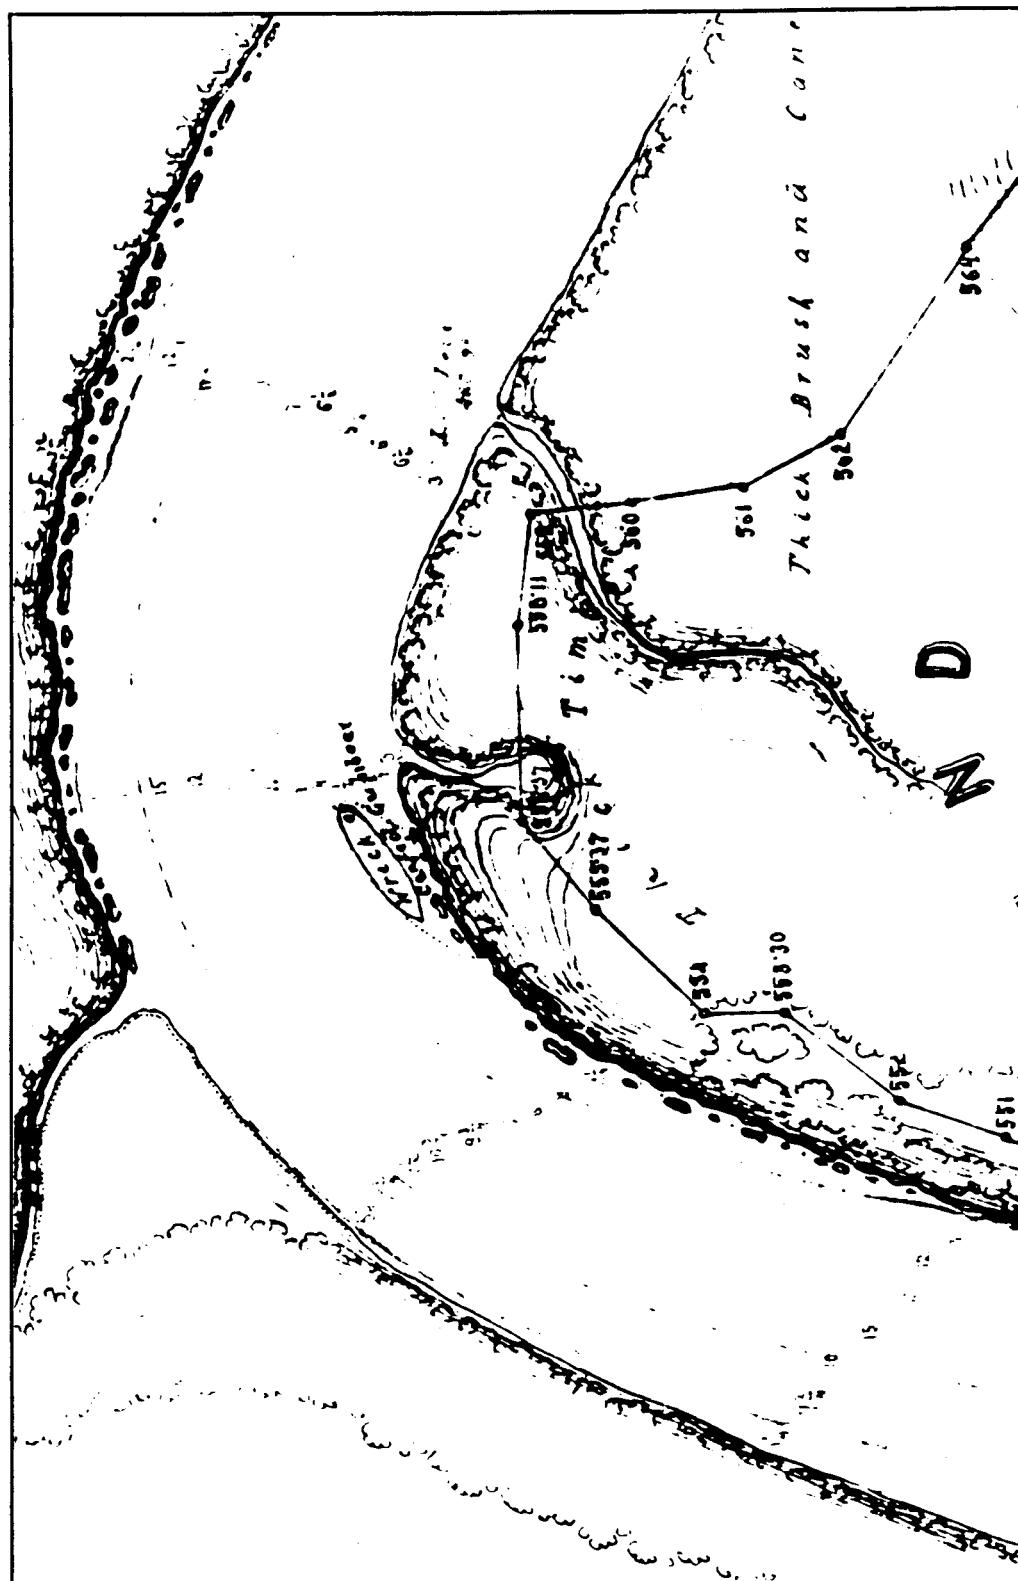
Figure 3. 1870 Chattahoochee River Survey Map.

The location of the CSS *Chattahoochee's* hull was documented during an engineering survey of the river in 1870 (Figure 3). It was located at the upstream end of a point bar along the right bank of the river at Broken Arrow Bend. That location was 13.7 miles downstream from the railroad bridge in Columbus. It seems likely that when the gunboat was towed downstream from the Columbus Navy Yard it grounded by the bow on a sand bar on the west bank of the river. The current forced the stern toward the west bank. There the CSS *Chattahoochee* burned almost to the waterline and sank. In April 1865, the stream was probably above its normal level due to spring rainfall and related flooding. The heavy water flow around the remaining hull structure scoured a depression in the unconsolidated river bottom sediments and the wreck settled into the bottom.

Subsequent flooding probably scoured out sand around the CSS *Chattahoochee*, and the hull was forced downstream from its original location by the current. It is possible that this happened more than once. Known floods in 1886, 1901, 1907, 1919, and 1929, appear to have contributed not only to change in the location of the boat, but the configuration of the river itself (Figure 4). For example, the discharge at Columbus on 15 March 1929 was 198,000 cubic feet per second, with a river level of 53.2 feet above river bottom (Table 1). Under these extreme conditions it is very likely that the wreck could slide along the bottom as the sand was scoured away, and move downstream with the current. In contrast to the flood of 1929, the average flow of the river is 6,620 cubic feet per second. As the boat found another resting place downstream and the flood level decreased, the wreck was surrounded by sand again. This could have happened with each flood. It is also possible that the remains of the CSS *Chattahoochee* were moved during attempts to recover the wreck in the 1960's. Today the location of the CSS *Chattahoochee* is about one hundred and fifty feet from the wreck location established in 1870.

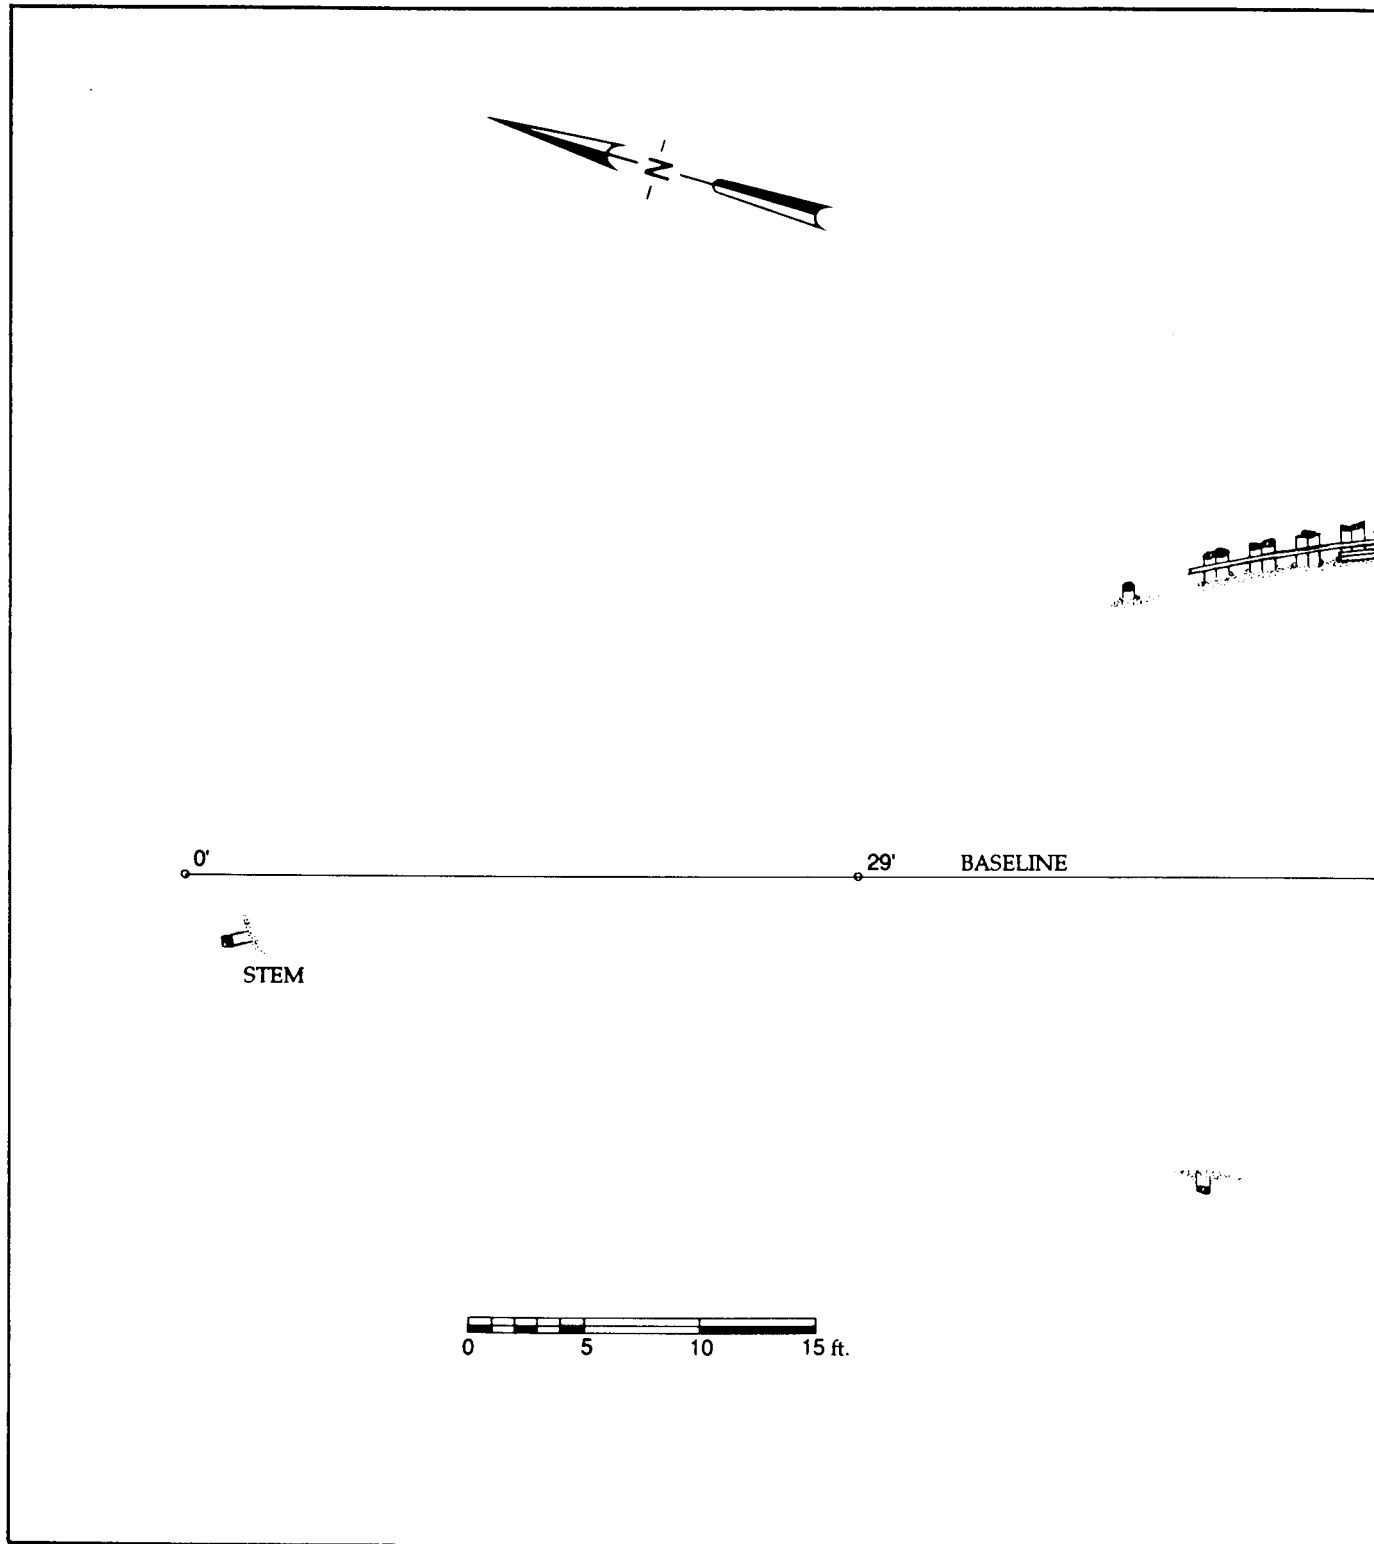
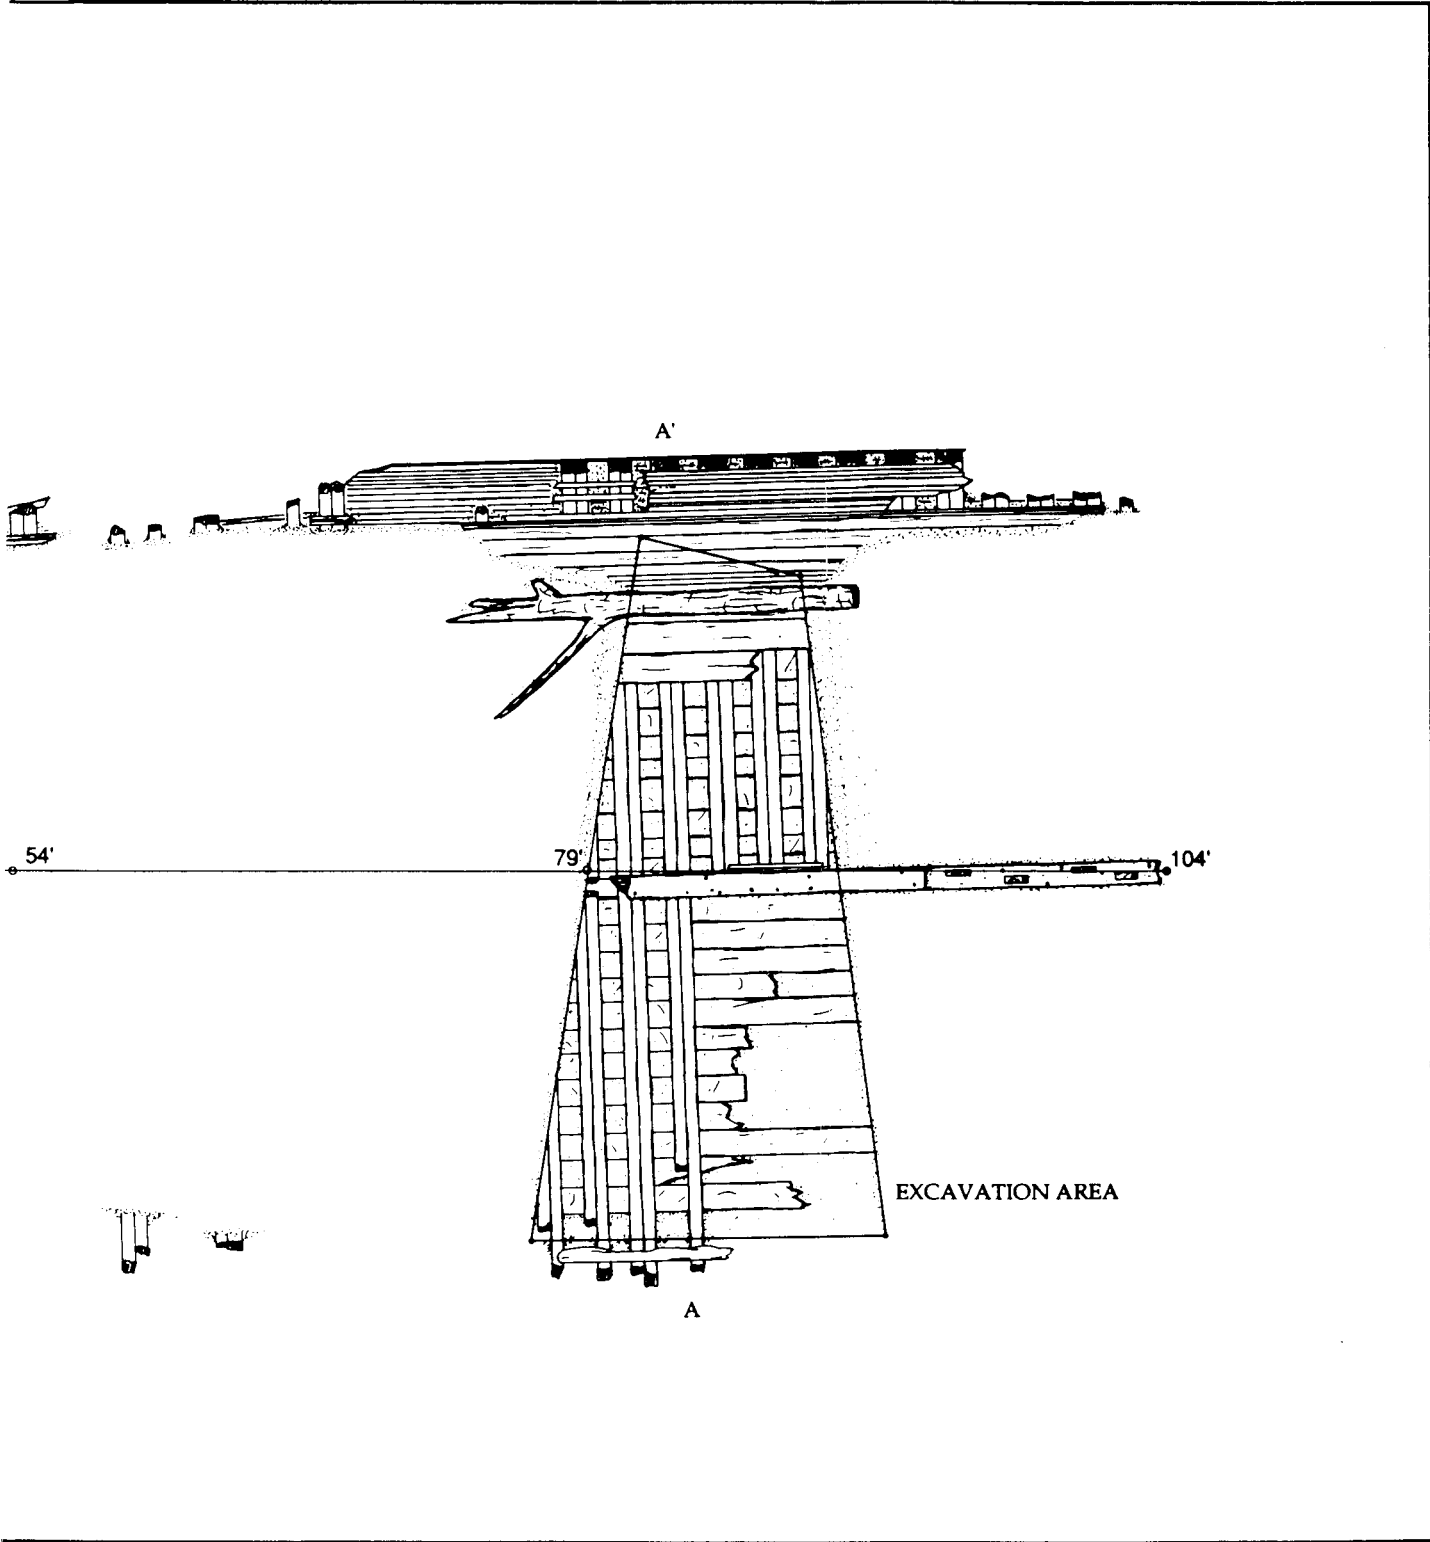
Figure 14. Site Plan of Exposed Remains of the CSS *Chattahoochee* Illustrating the Location

Once the pontoon platform was configured to support diving operations, more complex mapping and testing of the wreck was initiated. On 22 June, an on-site baseline was deployed through the wreck site on an axis aligned as closely as possible with exposed sections of the keelson. The baseline extended south 152 feet 2 inches from a point estimated to correspond with the northern extremity of vessel structure to a point well beyond the southern extremity of exposed articulated hull. Each end of the baseline and a series of points along its length were identified by sections of pipe driven into the bottom. These references would provide reliable stations for mapping, probing, and control of a test excavation (Figure 14).

measurements. By taking measurements from two or more stations along the baseline, the position of each exposed element of the wreck could be identified accurately and plotted on a scaled plan. Once this plan confirmed the extent and orientation of articulated hull structure, additional datum stations and reference lines were established to identify the location of a test trench (Figure 16).

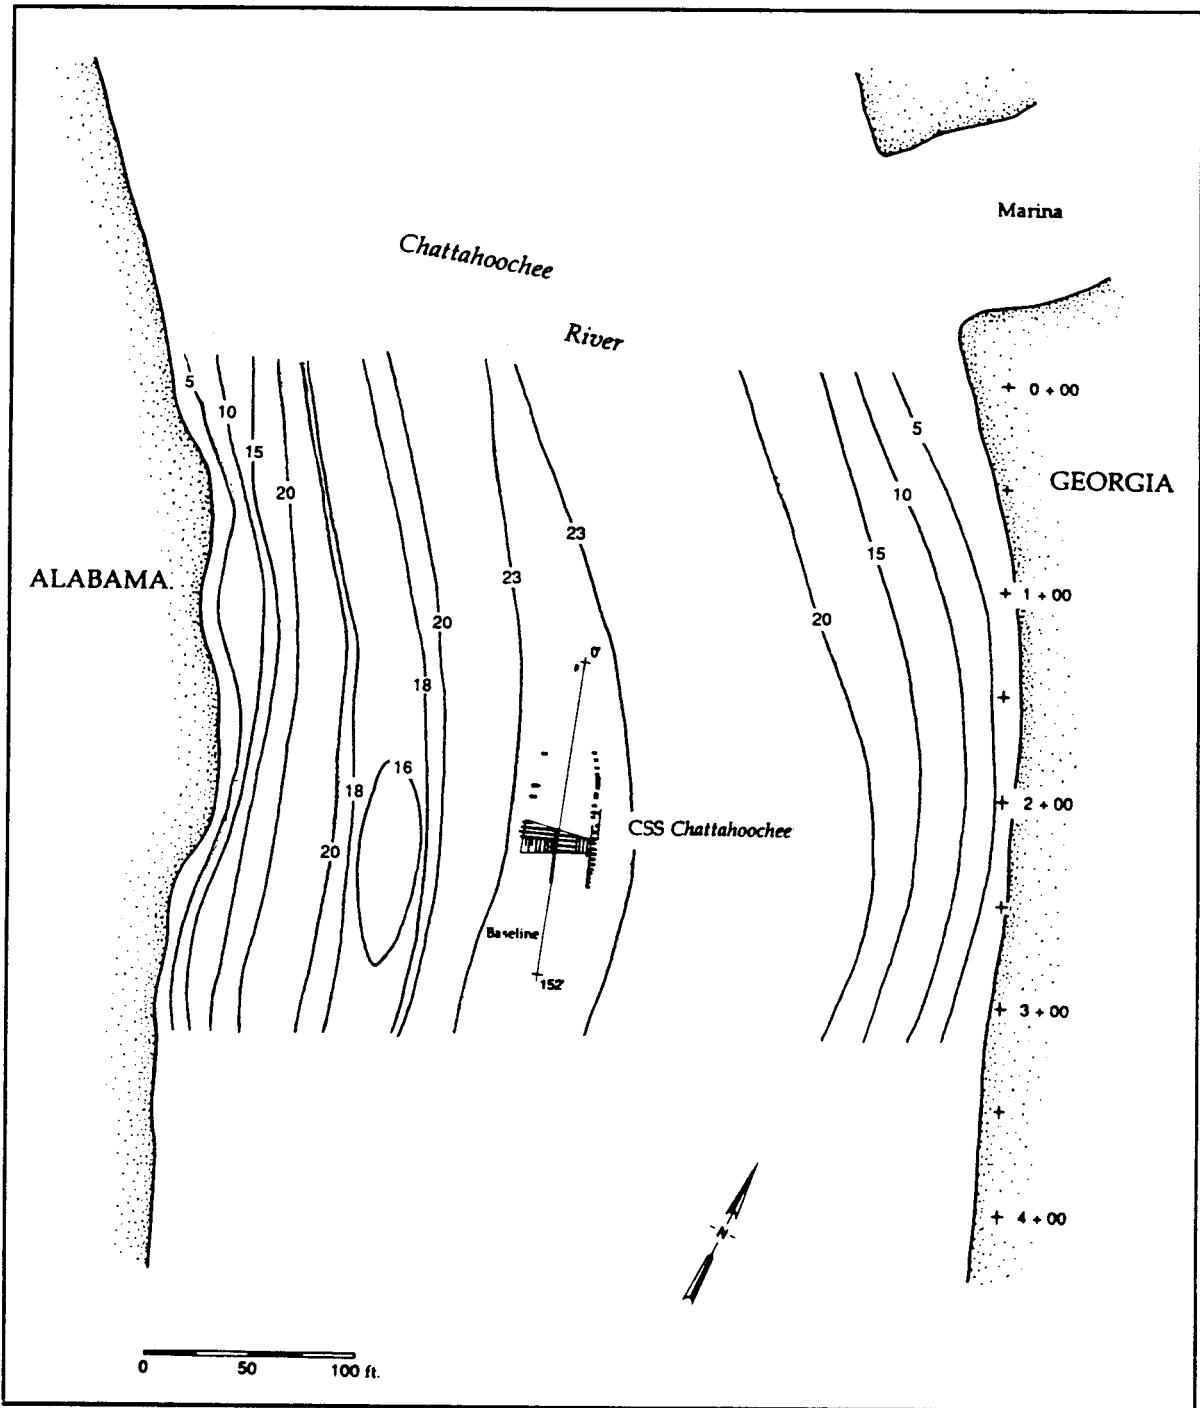
Figure 15. Site Plan Showing River Bathymetry in the Vicinity of the CSS Chattahoochee.

The riverbank baseline was divided into 25 foot segments. At each station a series of transects across the river were run using a precession fathometer. Fathometer data were used to develop a bathymetric map of the wreck site environment (Figure 15). Within this context the remains of the CSS *Chattahoochee* were mapped. Mapping of the wreck site was carried out using trilateration. Using datum stations along the bottom surface baseline, the location of exposed elements of the hull were established by underwater tape

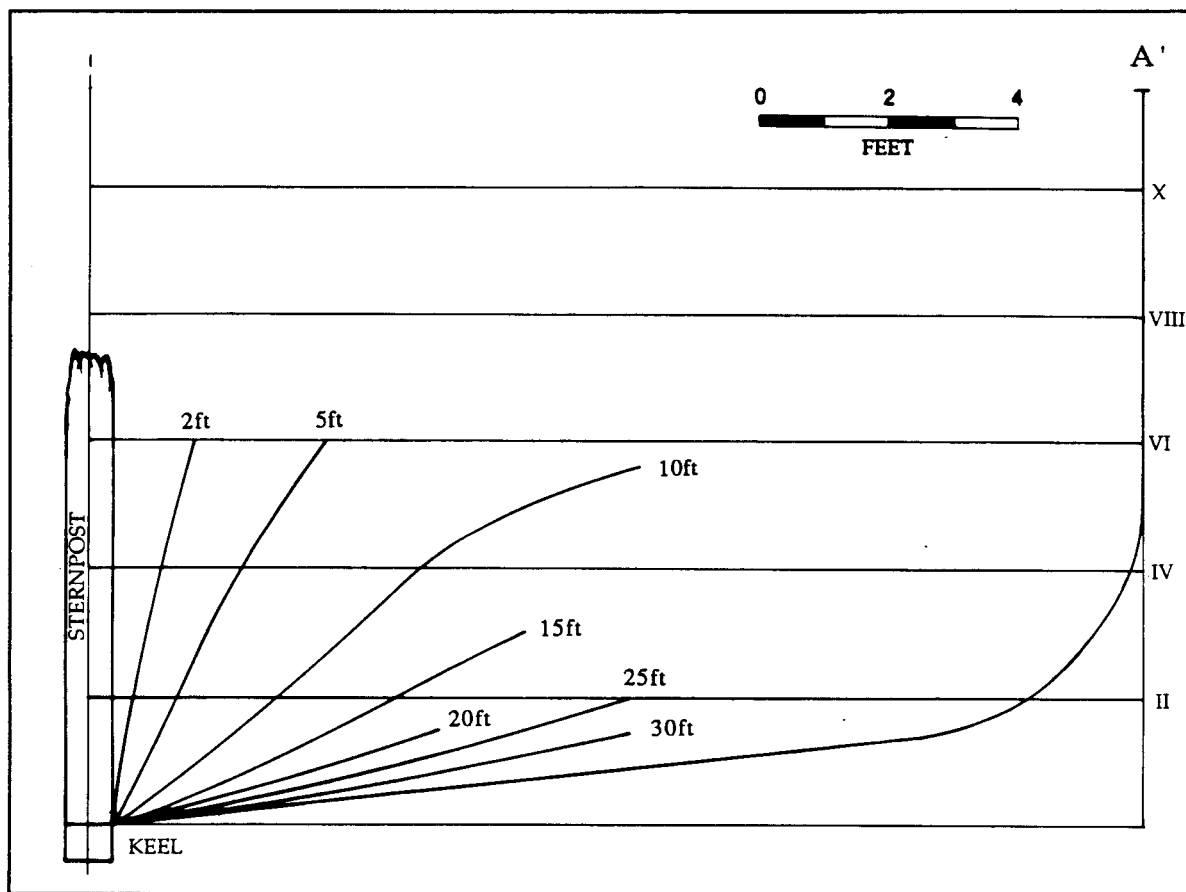
Figure 18. Lines of the CSS *Chattahoochee*'s Stern and Midship Section Taken from the Surviving Hull Remains.

At the same time work was being carried out on the remains of the CSS *Chattahoochee* at Broken Arrow Bend, previously recovered material from the wreck was being cataloged at the Confederate Naval Museum. Artifacts associated with the CSS *Chattahoochee* and parts of the ship's machinery were identified and documented. Remains of the CSS *Chattahoochee's* stern and steam machinery on display at the museum were recorded photographically and with measured drawings. Finally, lines of the stern section were recorded using a three dimensional XYZ coordinate system (Figure 18). That system consisted of a baseline laid out beneath and parallel to the keel. At five foot intervals along the baseline perpendiculars were extended from the centerline of the hull to the extremity of the starboard side of the surviving hull structure. At intervals of six inches or a foot measurements were made from the perpendicular to points on the hull directly above each station. These measurements were made using a plum bob to increase accuracy. Variations in height from the baseline were taken along the bottom of the keel at each perpendicular to permit correction of distortion of the hull caused by the varying elevations of concrete pilings supporting the CSS *Chattahoochee's* stern. The configuration of the hull was

recorded as a table of offsets that were plotted to produce the after hull lines. These data were combined with that taken from the submerged hull remains and developed into a set of hypothetical hull lines.

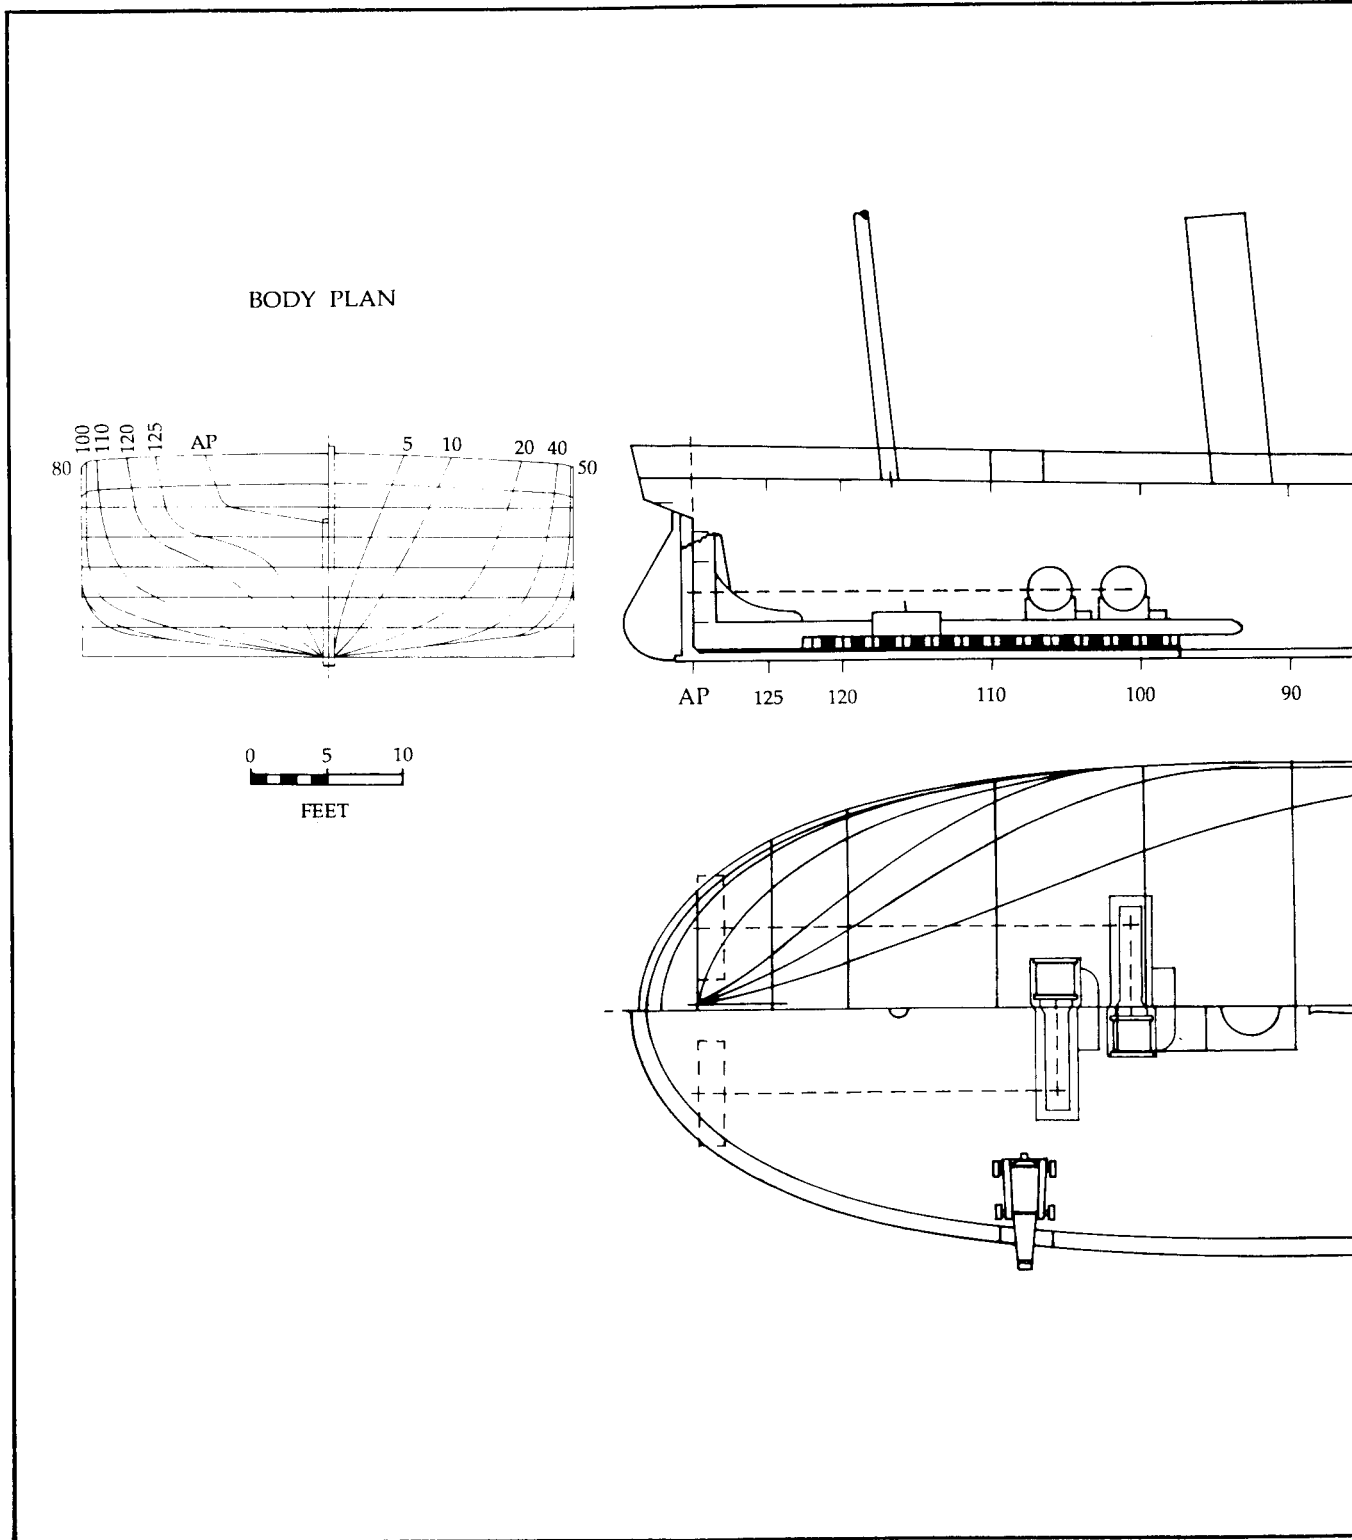
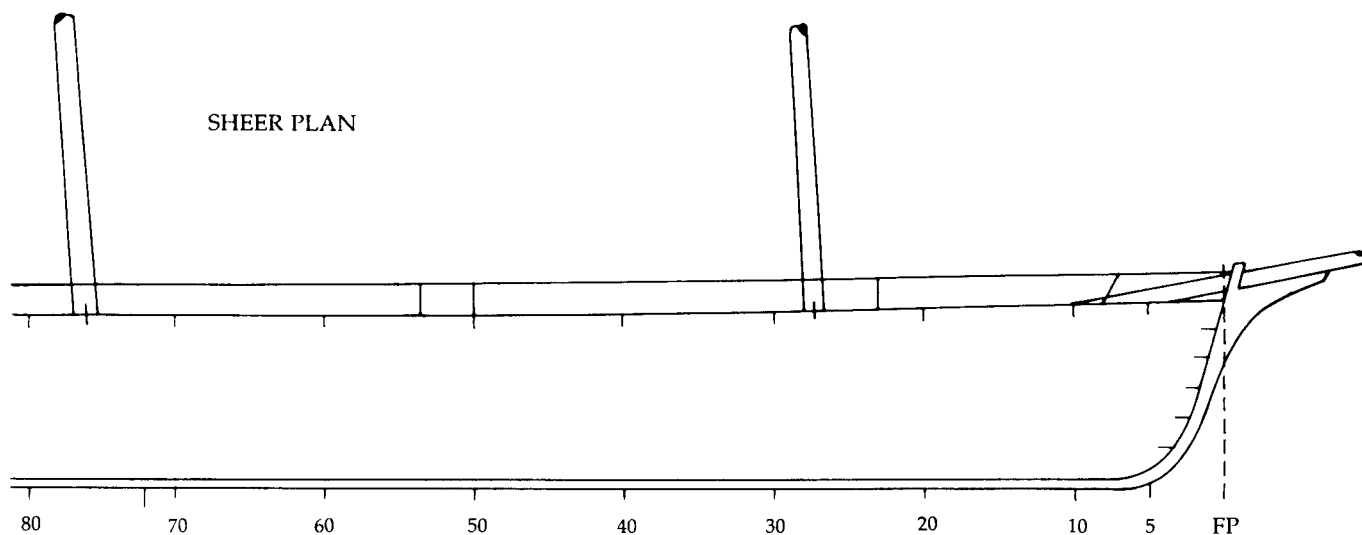
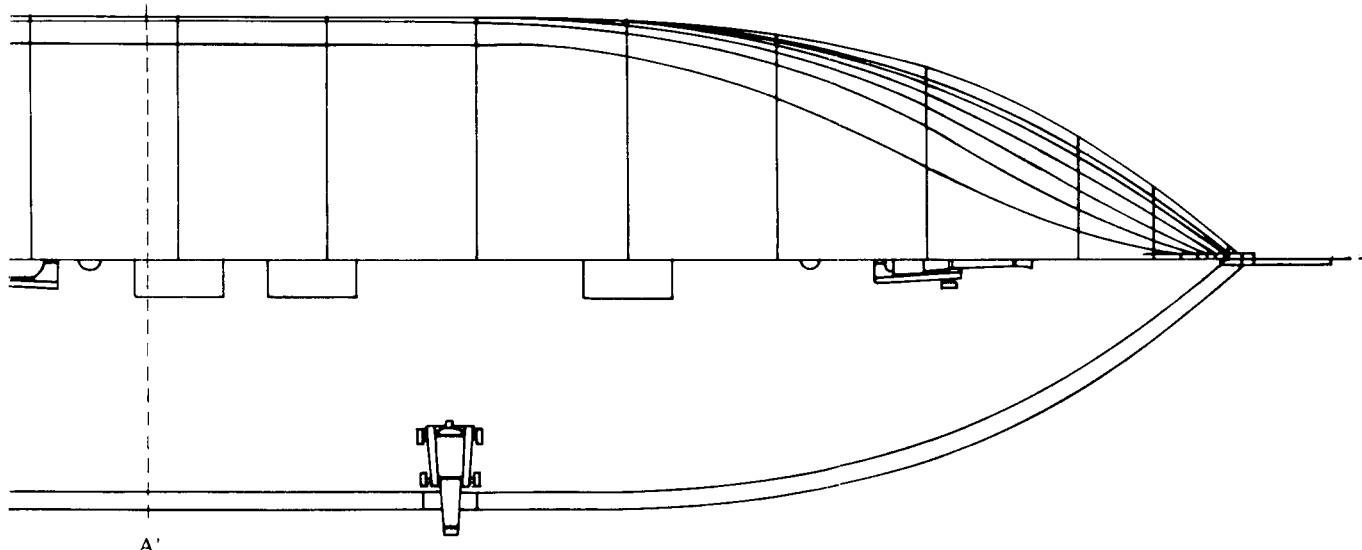
Figure 19. Lines of the CSS *Chattahoochee* Developed From Available Historical

While on-site investigation confirmed that the vessel was built according to most of the contract specifications, documentation revealed several significant variations. The most significant of these was in the moulded beam of the vessel. While the contract called for a maximum moulded dimension of 30 feet, on-site measurements confirmed that the ship was actually built 32 feet in the beam (Figure 17). This would have had a significant impact on the vessel's performance. The increased displacement would have reduced draft but also created a slower hull speed. Lines of the ship developed from data taken from both the stern section on exhibit at the Confederate Naval Museum and the surviving hull remains at Broken Arrow Creek confirm that the CSS *Chattahoochee* was a beamy vessel with 12 degrees of deadrise amidships (Figure 17). Lines of the hull were generated using the limited archaeological data (Figure 19). The configuration of the stern confirmed a short run aft and suggested a rather full body forward. This configuration seems to confirm J. Horry Dent's suspicions that the CSS *Chattahoochee* would be "a very

uncomfortable sea boat as she is very shallow and bottom so [?] broad." (Dent, 6 September 1862). Unfortunately, no information concerning the displacement of the CSS *Chattahoochee* survives in the historical record making it even more difficult to determine accurately the configuration of the ship's hull. Data from surviving Macon Class gunboat plans was used to develop the CSS *Chattahoochee's* deck arrangement. While the lines may not be an entirely accurate reflection of the vessel launched by David S. Johnston's Saffold, Georgia, shipyard, they can only be refined by additional historical or archaeological data.

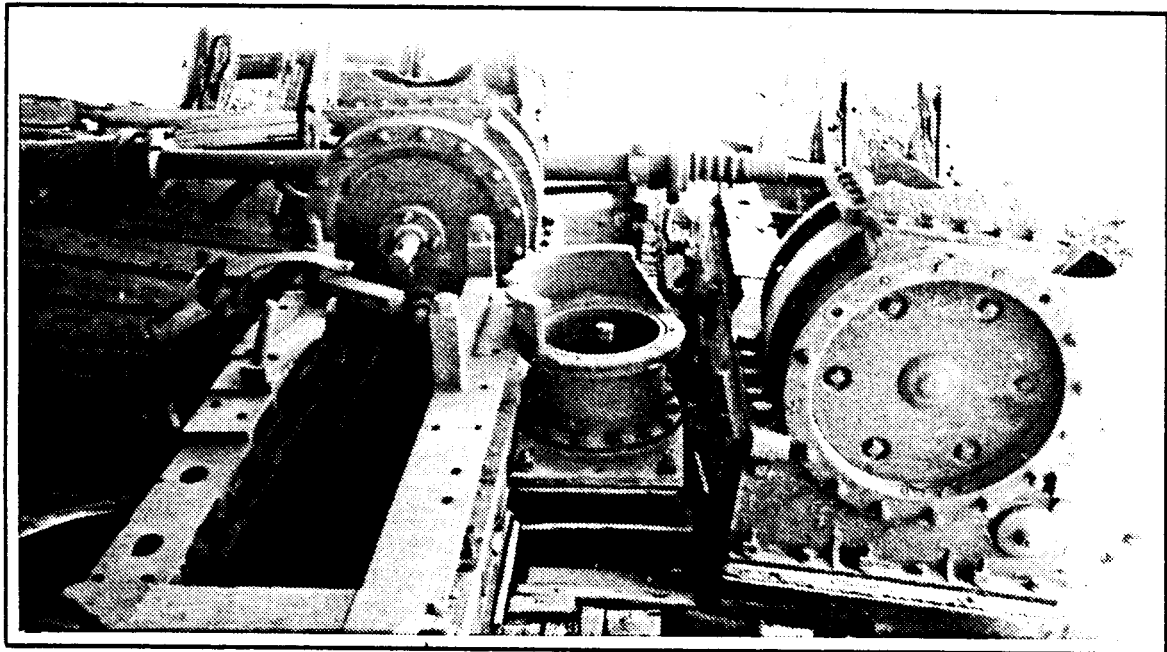
Figure 21. Athwartships Configuration of the CSS *Chattahoochee's* Engines

CSS *Chattahoochee* was powered by two horizontal direct-acting, low-pressure, condensing, reciprocating steam engines (Figure 21). Each engine has a single cylinder 28-inches in diameter with a 20-inch stroke. The cylinders are attached to iron engine beds which were attached to wooden engine timbers. The engine beds are attached to the hull by heavy bolts extending through the engine beds and hull. Engine mounting bolts were all hand forged, with square-heads, and square nuts. Each bolt was driven through a square washer and the hull from the outside of the vessel. Each was secured on the inside by a round washer and square nut. The outside bolt heads were counter sunk and protected by wooden blocks inlet flush with the surface of the hull. Engine parts requiring periodic removal all employed hexagonal bolt heads, round washers, and hexagonal nuts.

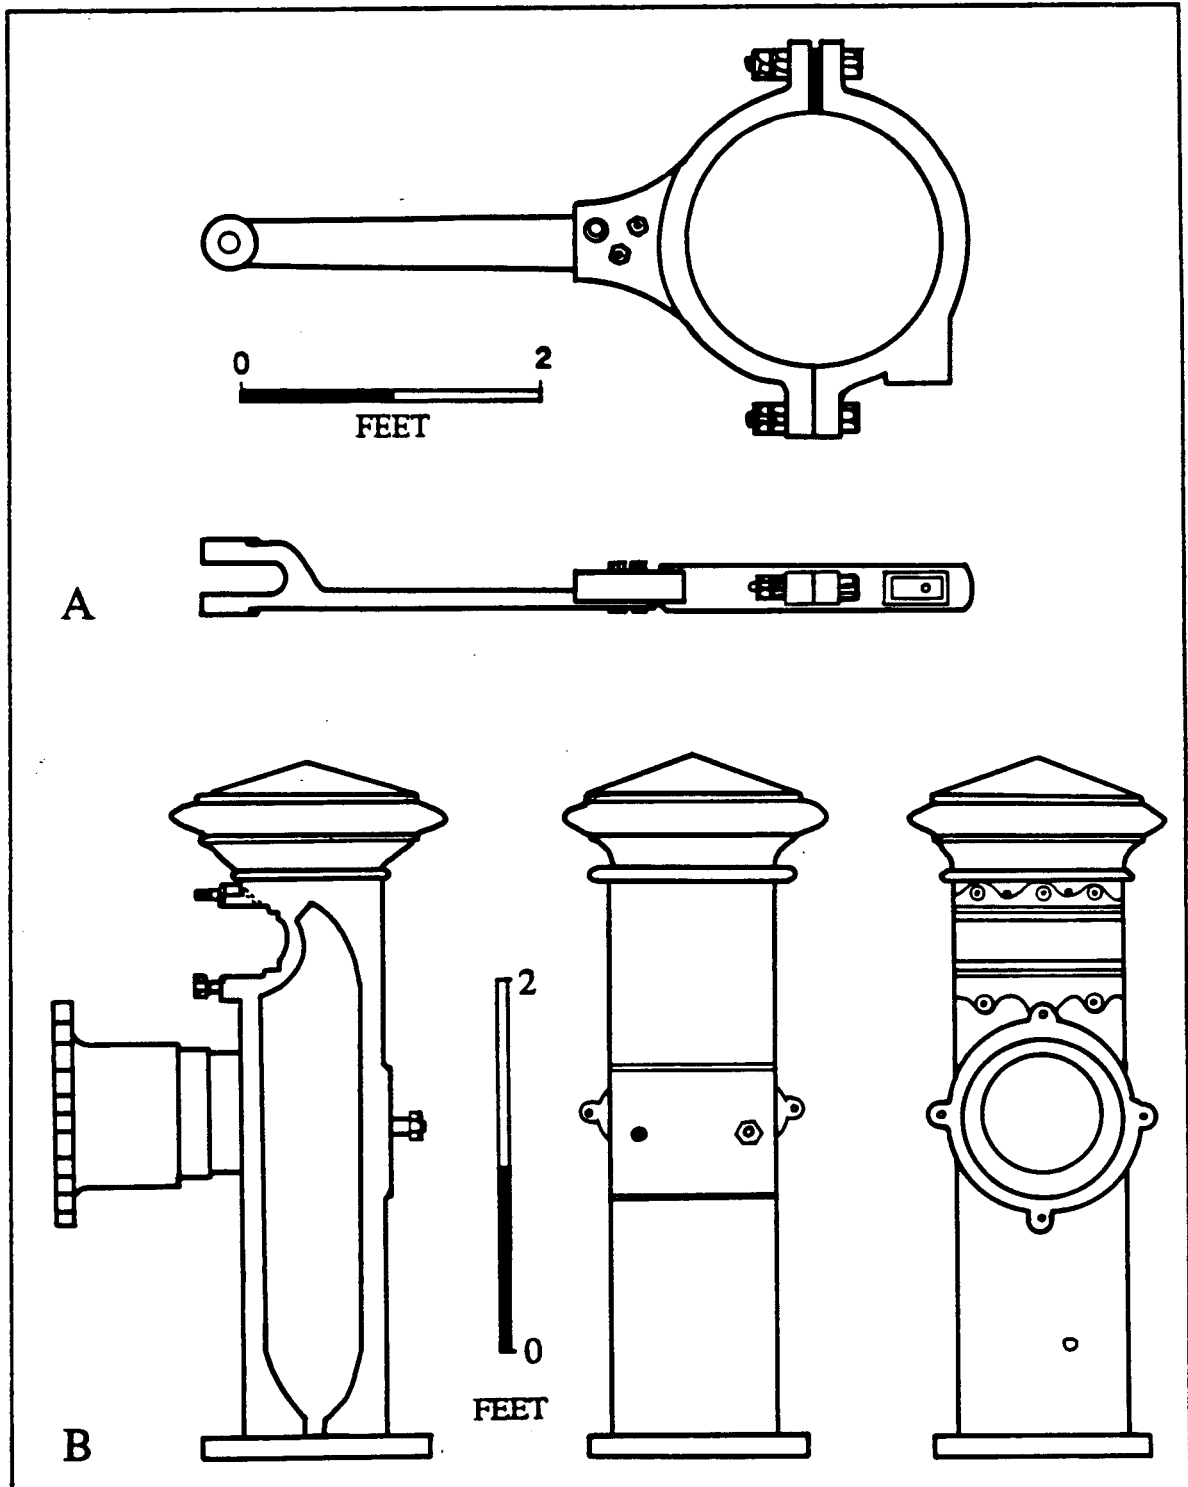
Figure 24. Illustration of one of the CSS *Chattahoochee's* Eccentric Rods (A) and an Orate Casting Designed to Serve both as a Pillow Block for the Air Pump Bell Crank Shaft and a Steam Pipe Elbow.(B)

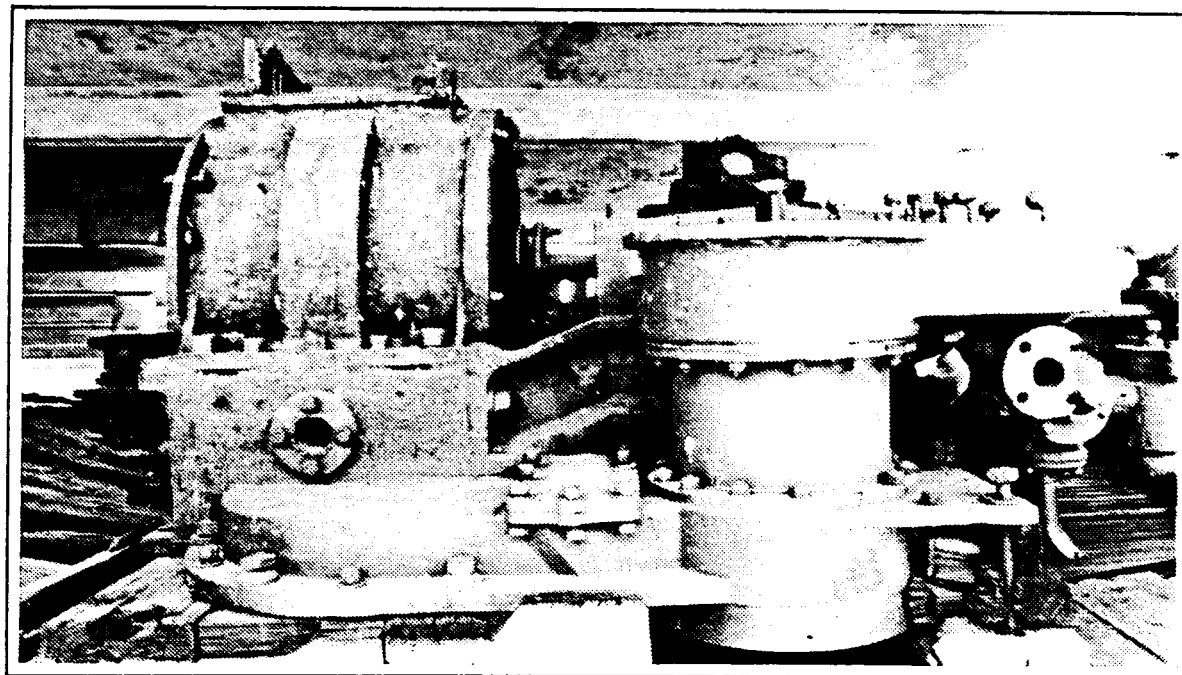
A water jet condenser served each of the CSS *Chattahoochee's* cylinders and converted steam to water that could be returned to the boilers. The condensers were placed directly under and bolted to the steam cylinders (Figure 26). The condenser casting formed a direct connection with an air pump located adjacent to the crosshead slide. The steam vented into the condenser was cooled by raw water from a through-hull fitting which fed through a series of strainers (Figure 27). A small pump exhausted discharge water by way of a through-hull fitting.

Figure 26. Port Steam Cylinder Showing the Condenser Underneath and its Associated Air Pump.

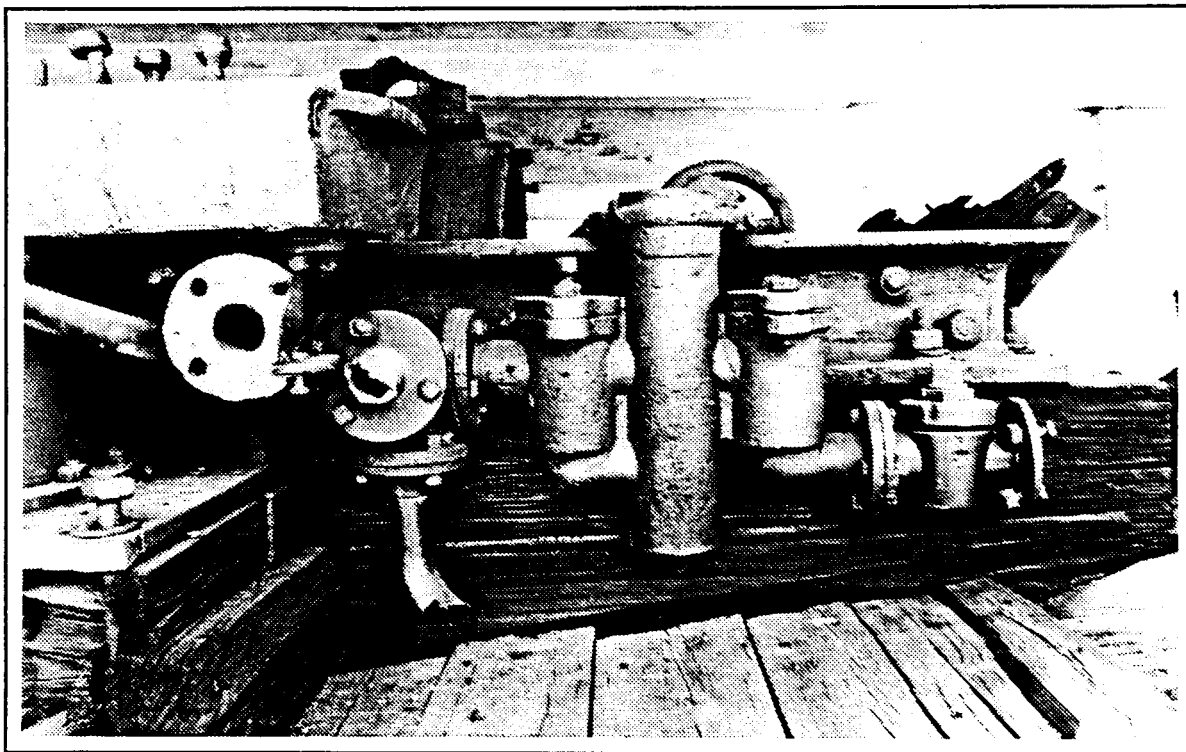
Figure 27. A Complex Valve and Strainer Serving the Port Condenser Raw Water Intake.
